SUBJECT: **Abbreviated Safety Assessment Report:
SH 50B: MP 386.00 - 397.00, Las Animas West**

Abbreviated Safety Assessment Report

SH 50B: MP 386.00 - MP 397.00
March 2008

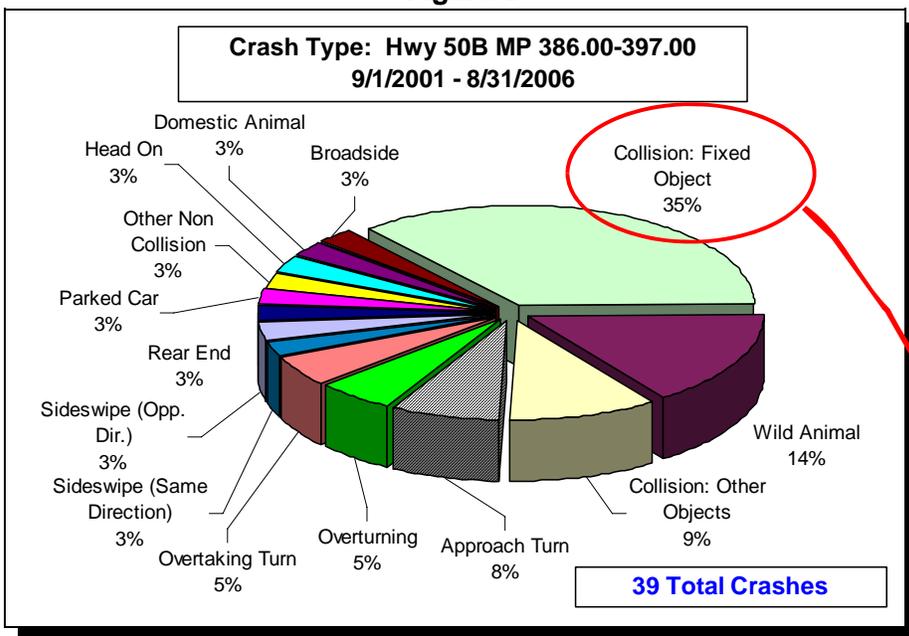
Figure 1 presents a breakdown of the accident type detected along this highway. Running off the road and colliding with various fixed objects was the most frequently occurring type, accounting for 14 accidents or 35% of the total. Among the fixed objects struck, delineator posts and roadside fencing were most common. Collisions with deer or other wild animals were next in frequency of occurrence, accounting for an additional 5 of the 39 total accidents. Various other crash types were identified, all of which were reported at frequencies of 3 or less during the 5 year study period.

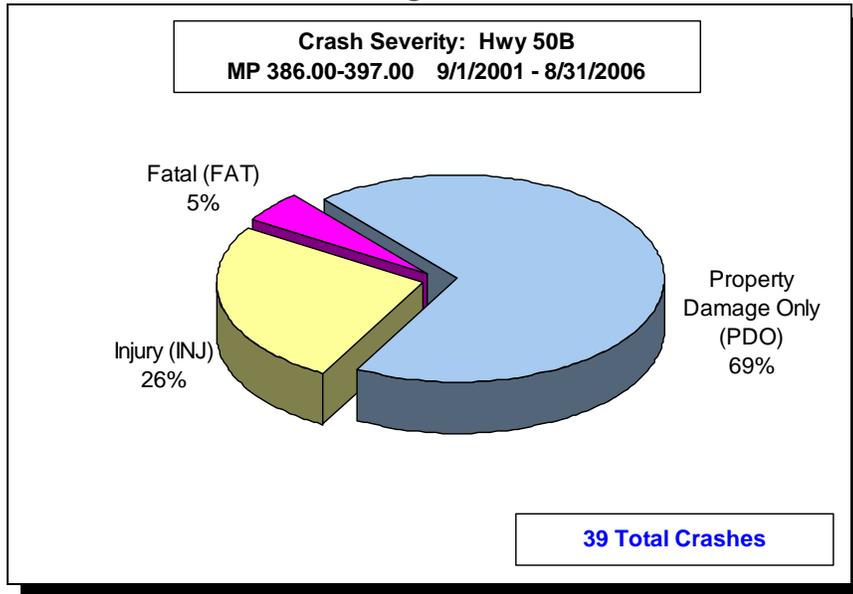
Figure 2

Crash severity is shown in **Figure 2**. The 27 property damage collisions accounted for 69% of the total while just over 25% (10) of the total were injury accidents. There were two fatal accidents along the corridor. A 2004 fatal crash involved an eastbound vehicle whose driver was ejected after falling asleep, losing control and overturning. Alcohol may have been involved. The second fatal crash occurred in 2005 when a westbound driver fell asleep, drifted into the eastbound lane, colliding head on with a semi truck.

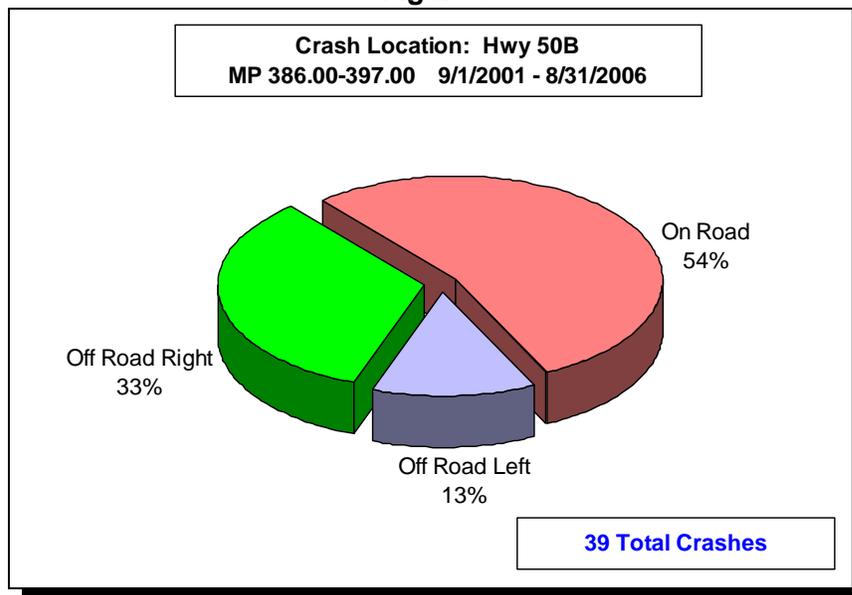
Figure 3 presents the accident distribution by location. Within this highway segment, drivers who run off the road appear to exhibit a tendency to run off on the shoulder side of the road as indicated by the higher fraction of off right incidences.

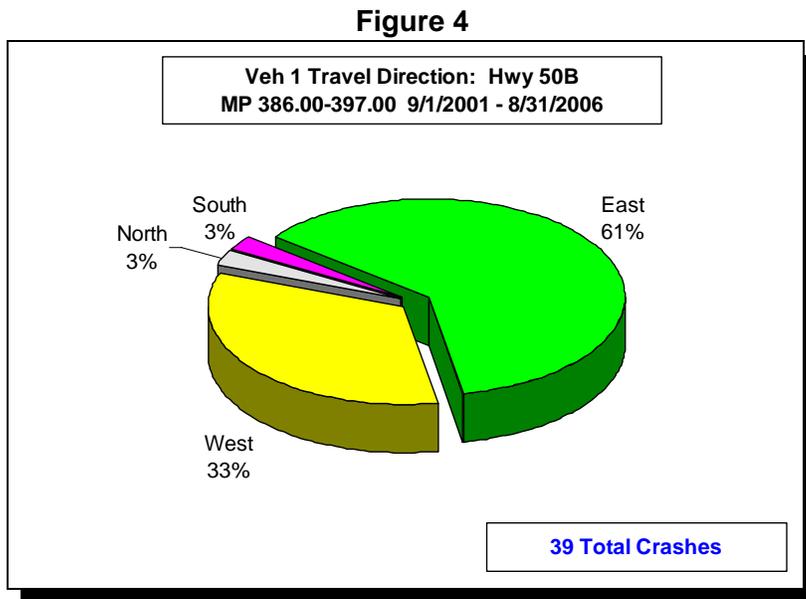
Figure 4 shows the travel direction of the at-fault vehicle (vehicle 1). During this study period, eastbound vehicles were involved in nearly twice as many accidents as those in the westbound lanes. This may be due in large part, to the directional volume difference as the eastbound lanes carry, on average, 10% - 20% more traffic.

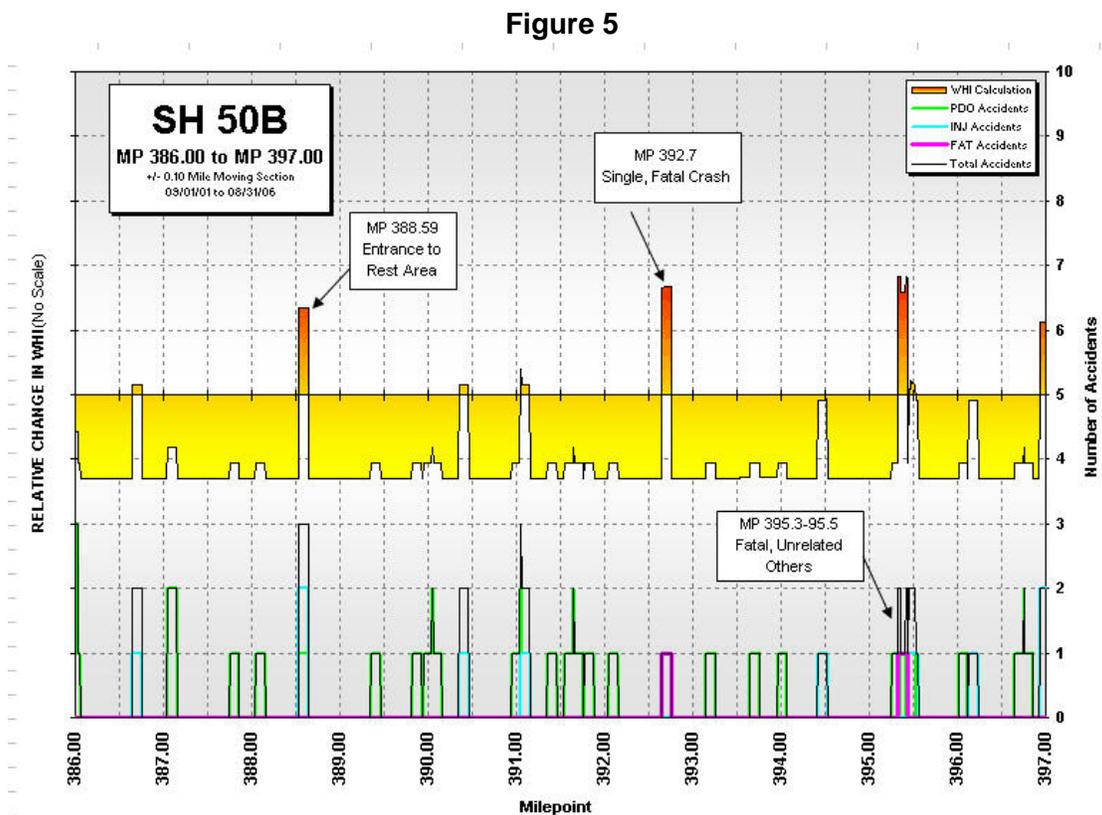
Figure 5 shows the location of accidents and the change in weighted hazard index (WHI) along the study segment.

The WHI graph of **Figure 5** does not indicate that there are locations with severe or unusual accident concentrations. The minor spikes shown at MPs 388.59, 392.7 and 395.4 correspond to locations with 3 crashes (2 injury, 1 PDO), a single fatal crash and a fatal crash with adjacent PDO and injury collisions respectively.

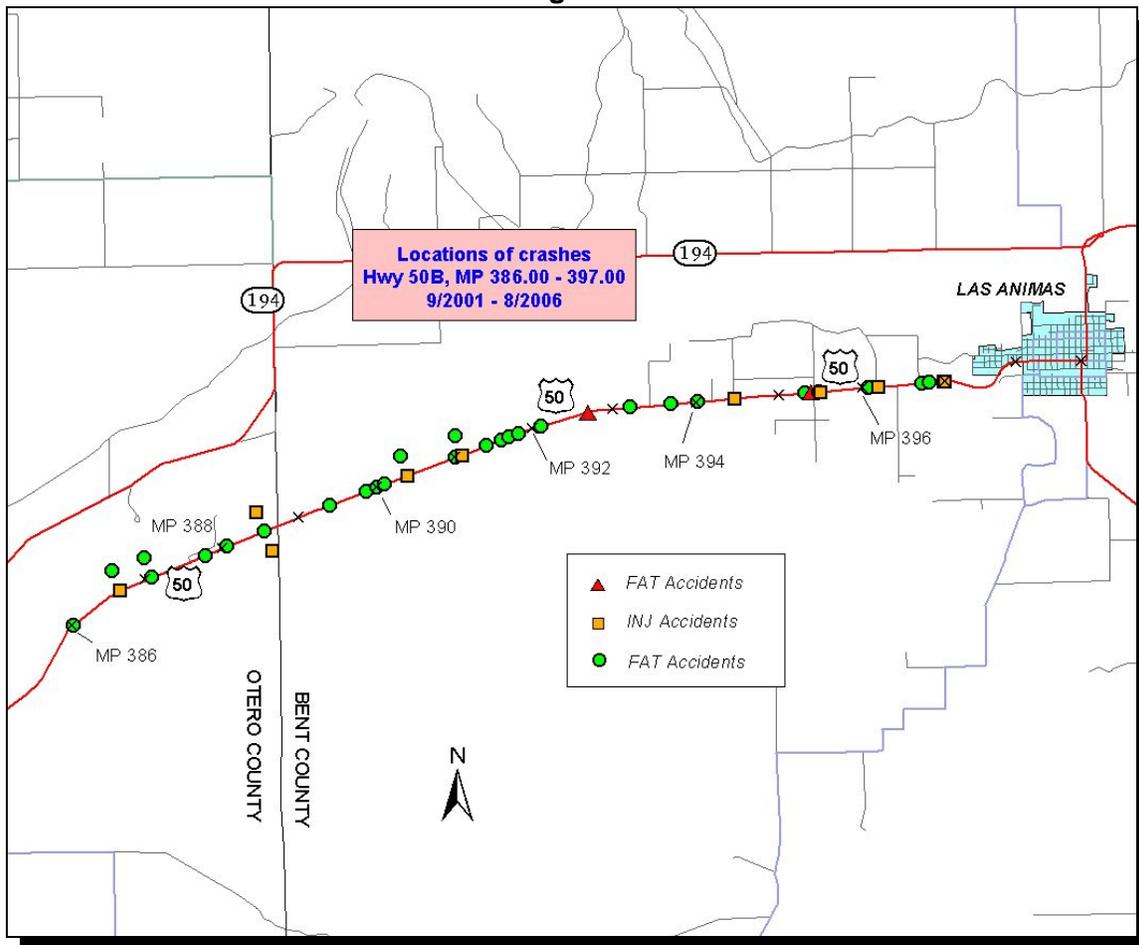
Figure 6

A map depiction of accident location and severity is shown below. Again, the 39 crashes appear to be distributed in a generally uniform pattern throughout the corridor.

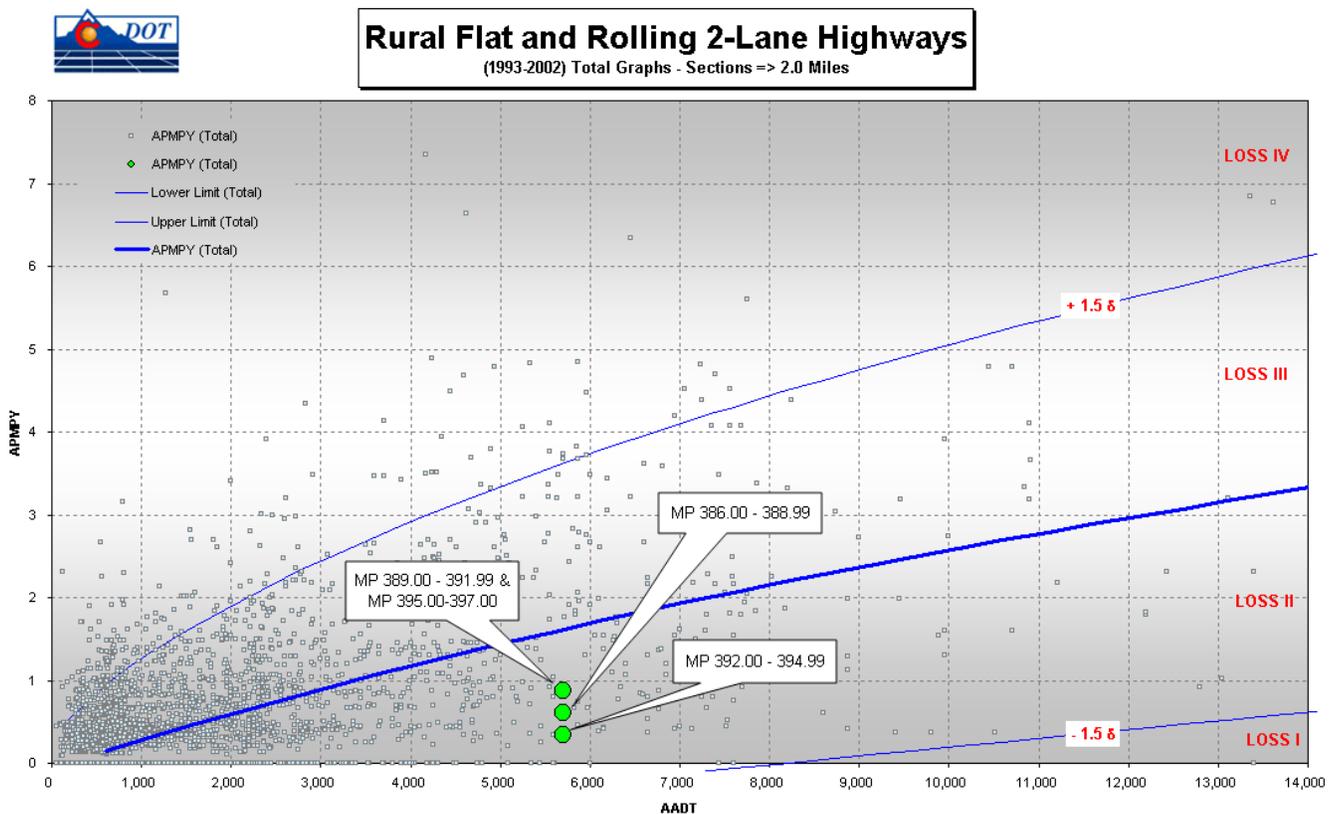
Figure 7

The study segment of Hwy 50 was partitioned into 4 sub-sections of either 2 or 3 miles each and the non-intersection crash history of each was plotted on the following SPF models for analysis. In **Figure 7**, the SPF for total accidents is shown. Accident data for all four of the sub-segments (note: two of the points are over-lain) falls in the LOSS II envelope, suggesting better than expected safety performance. In this case, accidents are occurring less frequently (on a per mile, per year basis) than on similar highway types throughout the state.

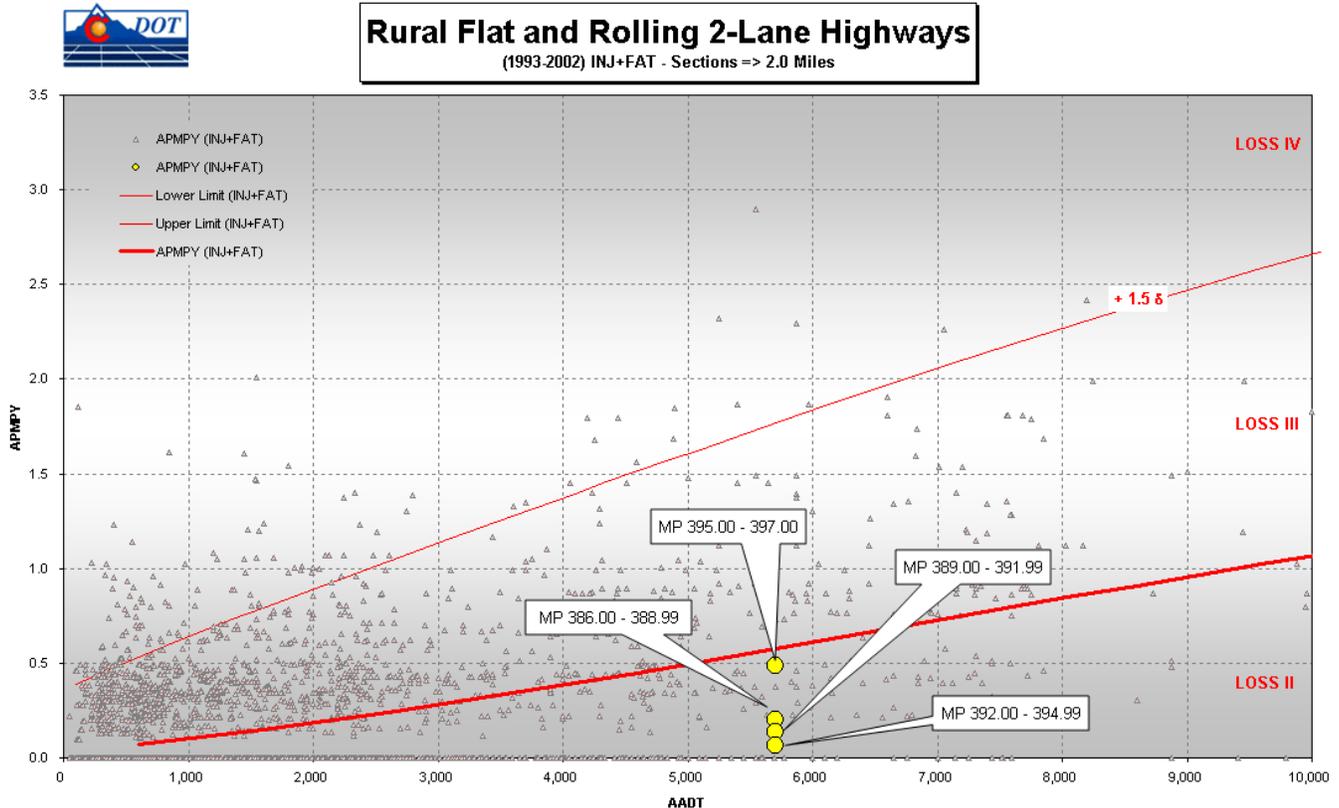
Figure 8 shows the SPF analysis for the injury and fatal accidents only. As with the total crash analysis above, all four sections are performing at a LOSS II level (better than expected), with a severe crash frequency less than the statewide average among similar highway types.

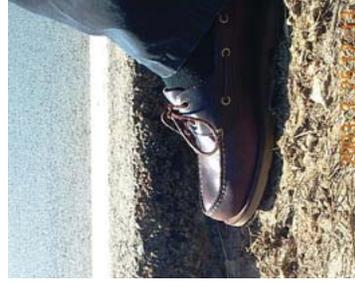
Sharp, steep pavement edge dropoffs can contribute to crashes.

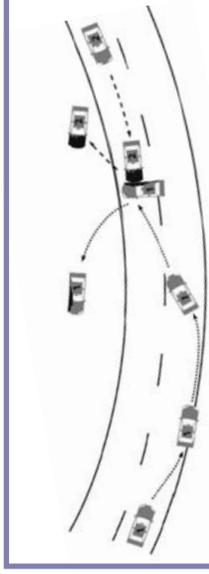
This is a typical diagram for a crash caused by tire scrubbing. The vehicle at left scrubbed the edge of the pavement, and when it returned, the driver overcorrected, lost control, crossed into the adjacent lane, and struck an oncoming vehicle.
