REPORT NO. CDOH-P&R-R-77-7

PERFORMANCE OF CULVERT MATERIALS IN
VARIOUS COLORADO ENVIRONMENTS

Final Report
September 1977

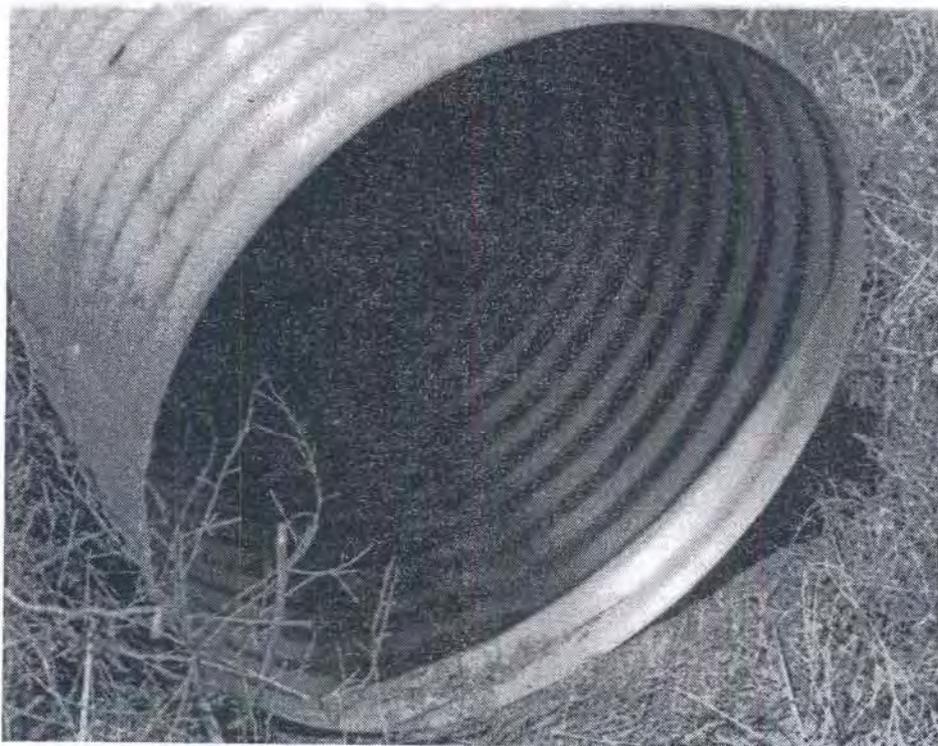
Photograph No. 1

This aluminum pipe at Punkin Center is as good today as it was when it was installed in 1962.

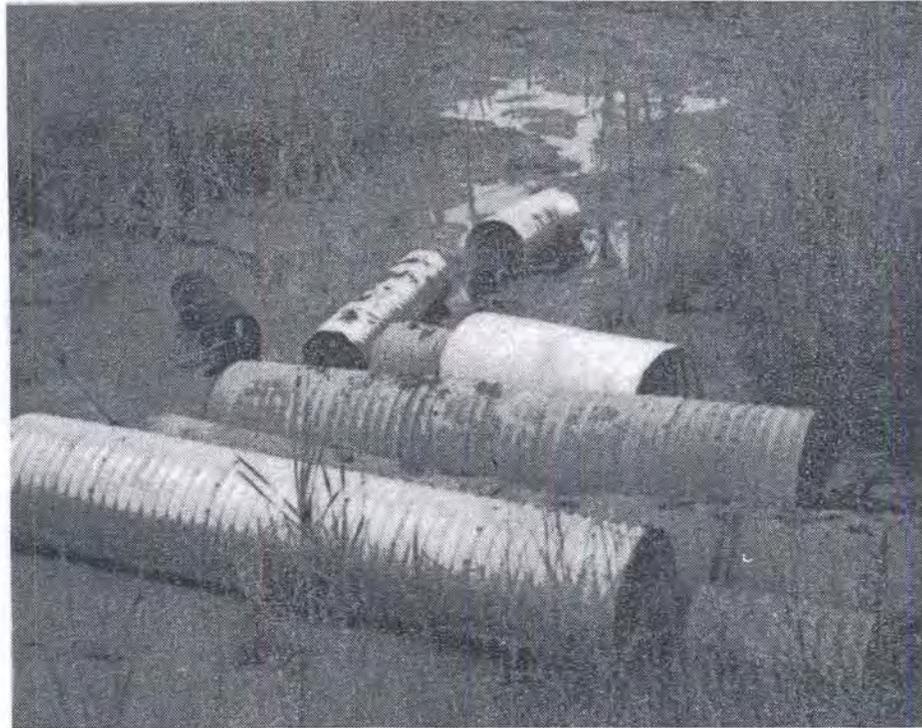
Photograph No. 2
General view of pipe samples at
Fossil Creek

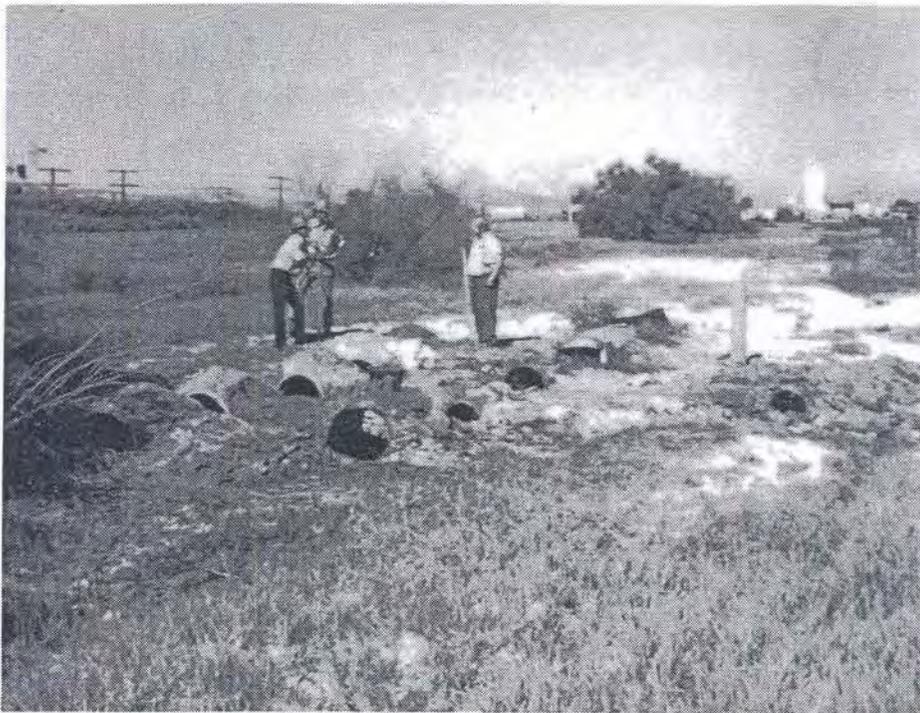
Photograph No. 3
General view of the Fruita
site with pipe samples.
Note alkali on the surface.

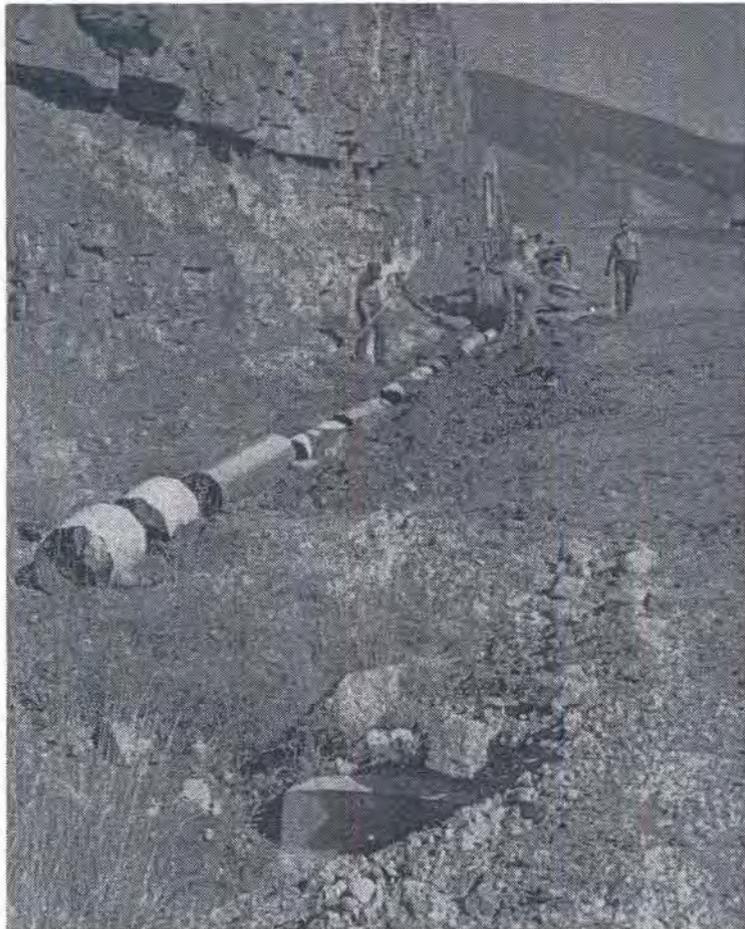
Photograph No. 4

General view of pipe samples at Straight Creek.

The concrete end section to the cross culvert under the highway is at the lower center.

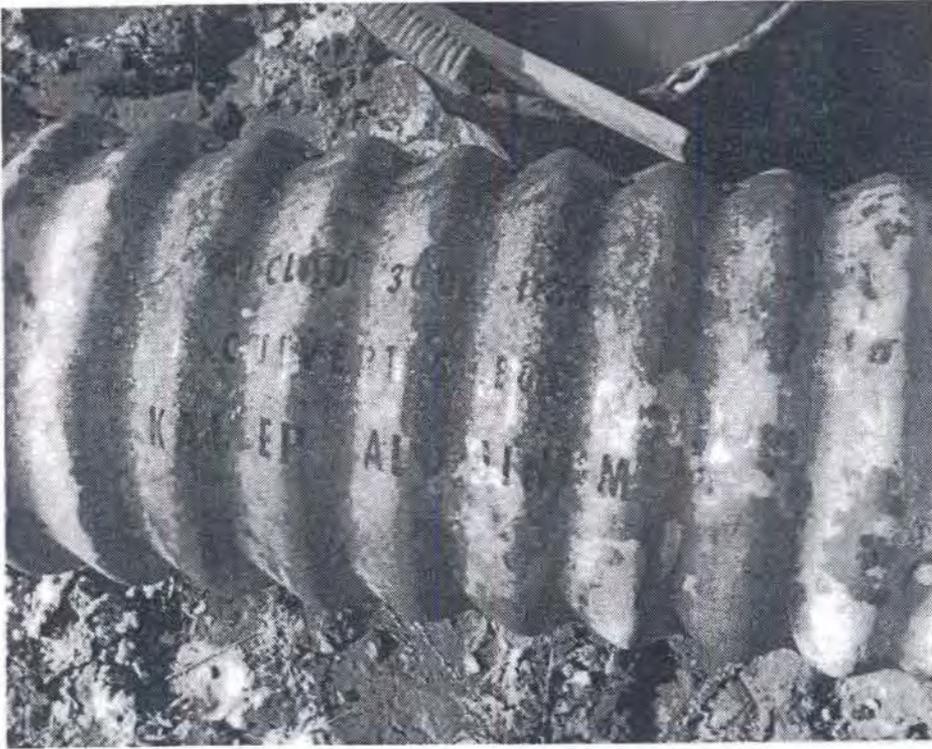
Photograph No. 5

This is an aluminum sample at Fruita.

It has been in place since 1962. There has been attack and encrustation of the cladding but the base aluminum is still sound

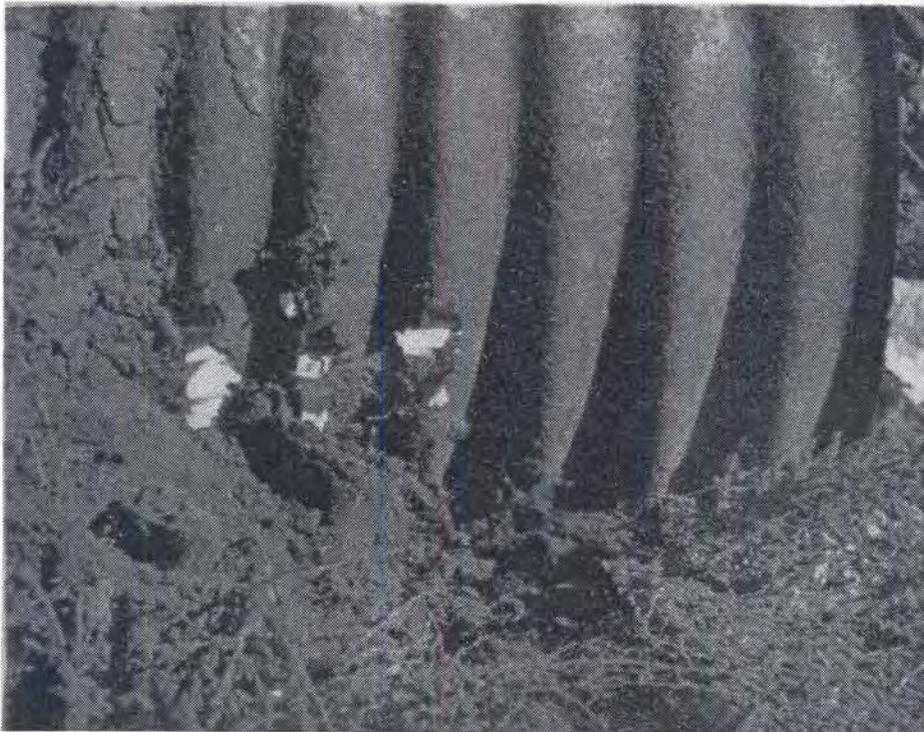
This was a galvanized steel pipe sample at Fruita.

This sample has been in this environment for 14 years. A white cloth inside the pipe shows the holes eroded away. The rest of the pipe is very thin and fragile.

Samples of galvanized metal pipes have been placed at test Sites 5, 6, and 8. The samples in the alkaline environment are badly corroded with many holes rusted clear through. (See Photograph No. 6 above.) The galvanizing has been heavily attacked in large patches about 2 inches (5 cm) in diameter on the Straight Creek sample. Where the galvanizing is gone, the base metal is heavily pitted. No rust color is apparent, however, and attack areas seem to be limited to a few local areas that were underwater.

Galvanized metal should not be used in these extreme environments.

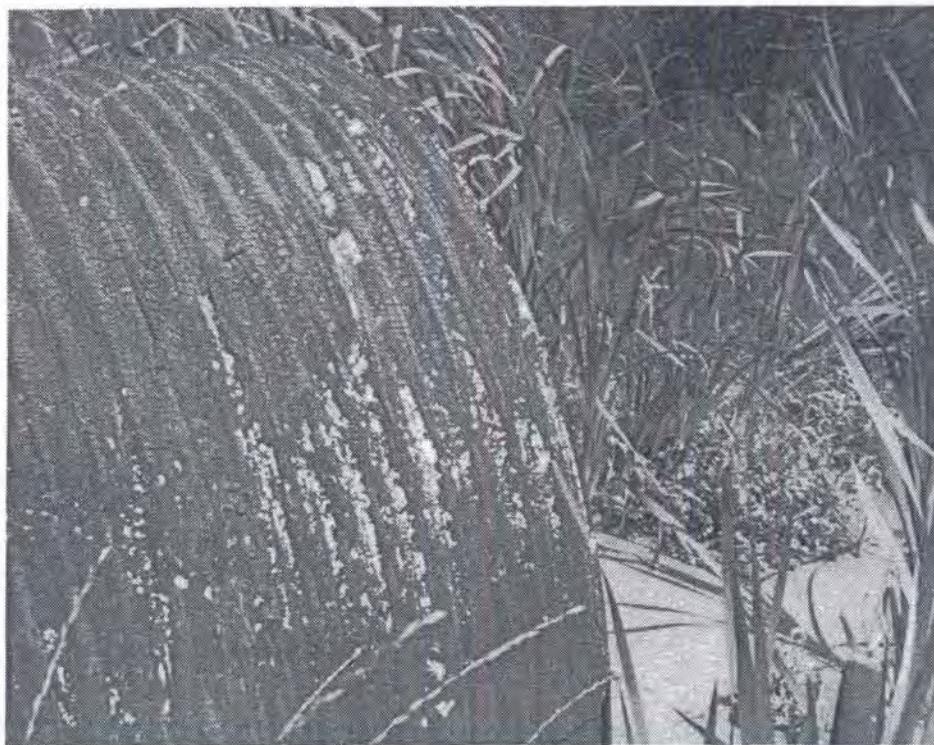
Photograph No. 7

A sample of asbestos bonded pipe at Straight Creek has spots where the asphalt has become brittle and broken off exposing the asbestos bonding. A sample of asphalt dipped pipe also at the Straight Creek site shows cracking and checking of the asphalt where it is exposed to the sun and water. (See Photographs No. 7 and 8.)

This asbestos bonded asphalt dipped cross culvert at Fossil Creek has been in place since 1963.

The exterior is cracked and being eroded away.

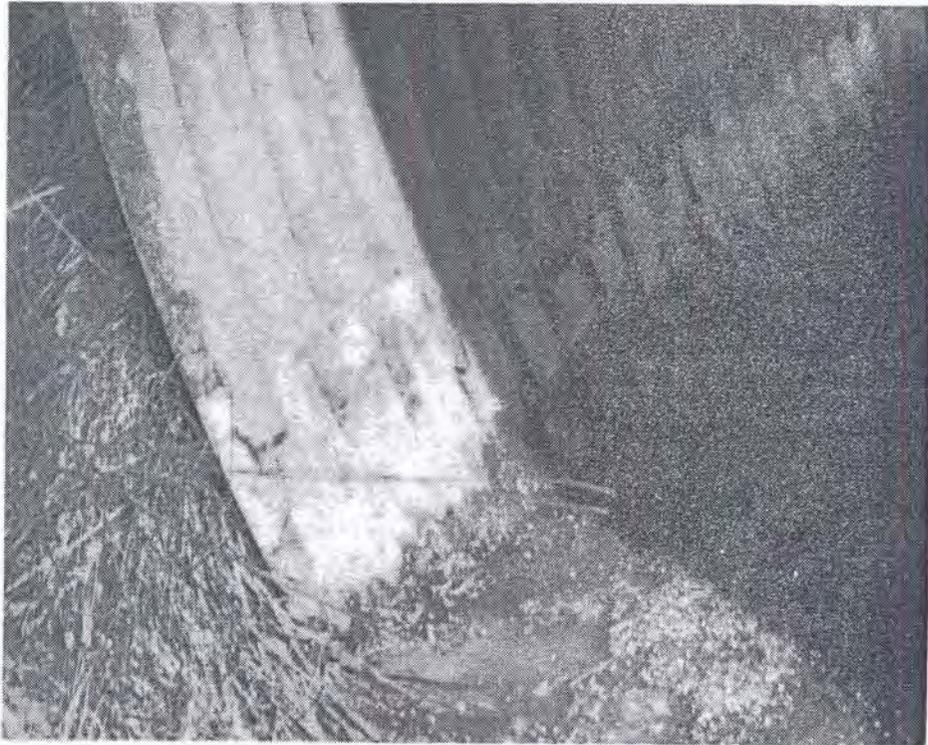
Photograph No. 8

This is the inside of the same asbestos bonded asphalt dipped pipe as shown in Photograph No. 7

Note: The asphalt and asbestos are gone below the high water line.

The metal bottom is corroded through in many places.

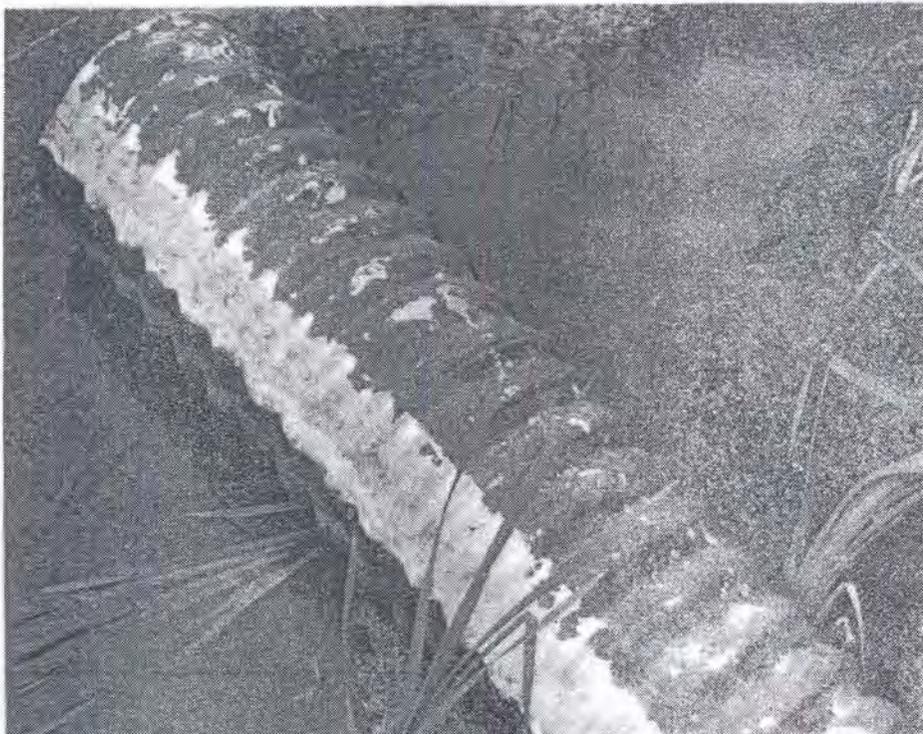
Photograph No. 9

This asphalt dipped sample at Fossil Creek was rolled up for the photograph to show that the asphalt below the water line is gone. The asphalt above the water line is cracked and being eroded off.

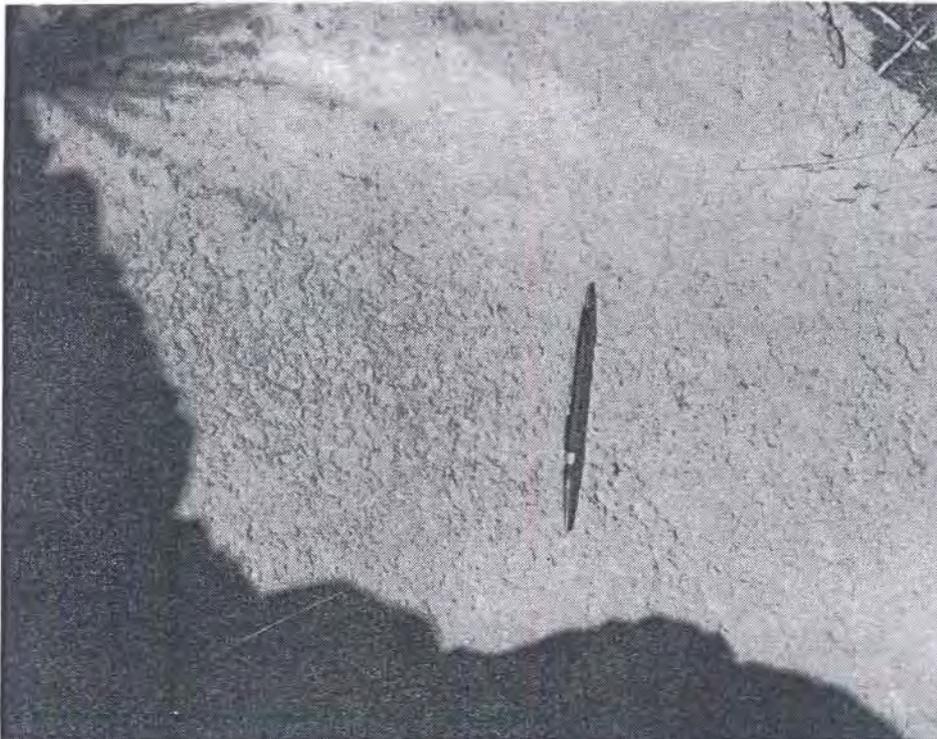
Photograph No. 10

The areas exposed to the water show definite attack by the acid water. Attack has only removed the cement surface, exposing the aggregate. (See Photograph No. 10.)

This is the bottom of the inlet end section of the concrete cross culvert at Straight Creek. This pipe was placed in 1970.

The top .2" (5 mm) of concrete mortar has been etched leaving silicate aggregate exposed.

The attack is not very serious and the pipe under the highway is expected to remain in service for at least another twenty years. The limestone aggregate in the sample listed above has also been attacked.

When and if it becomes necessary to replace this concrete culvert or any other culvert in an acidic environment, it is recommended that a small vitrified clay or plastic pipe be placed at a lower elevation than, or upstream of the inlet of the new culvert. The small pipe would carry the corrosive seep water and the larger standard pipe will carry diluted storm runoff water.

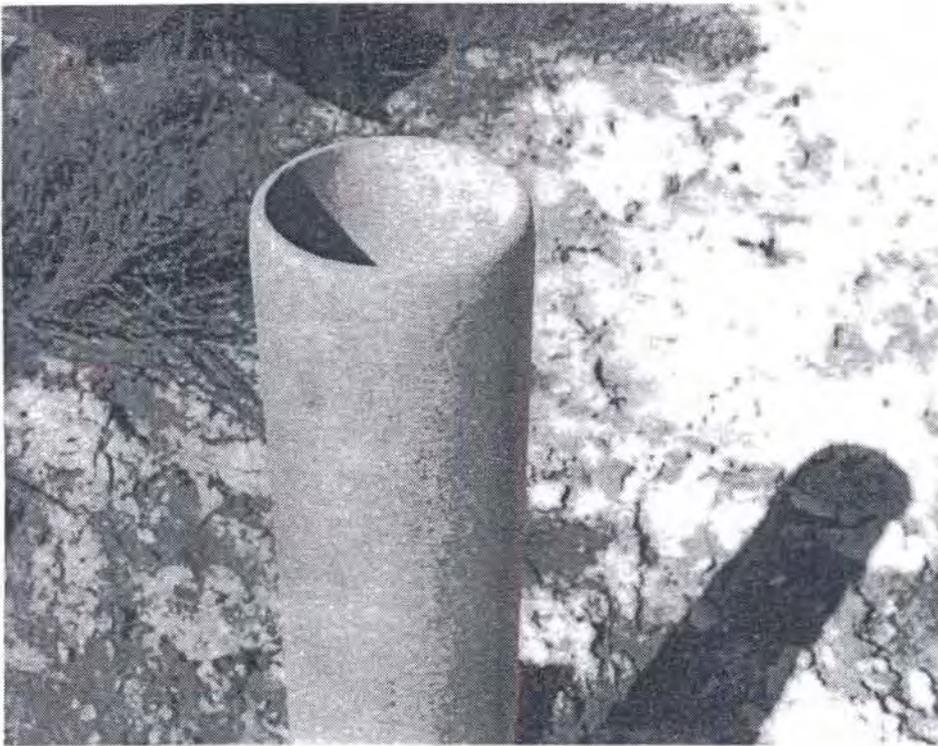
Photograph No. 11

Samples of transite pipe were placed at Fruita and Straight Creek in 1972. They are both in very good condition and show no evidence of corrosion. (See Photograph No. 11.)

This transite pipe at Fruita since 1972 is unharmed by the harsh environment

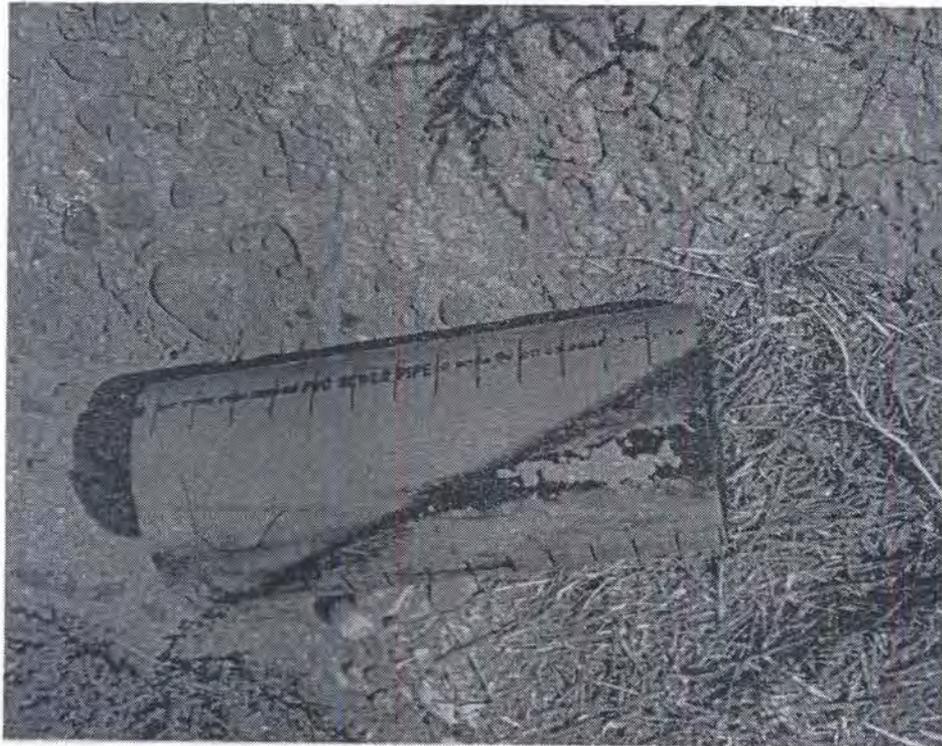
Photograph No. 12

Pieces of plastic pipe were placed at Straight Creek in 1972 and at Olathe in 1975. The sample at Straight Creek was missing after the second year but showed no corrosion until then. The one at Olathe is in excellent condition. (See Photograph No. 12.)

Plastic drain pipes appear unaffected by harsh environments.

The stains are only on the surface.

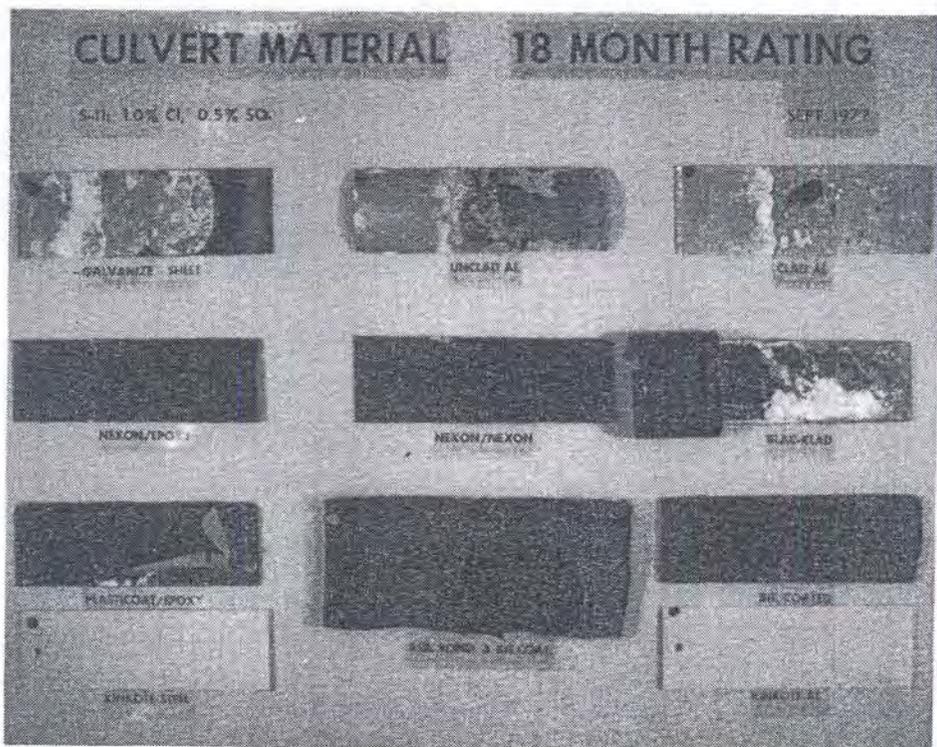
Photograph No. 14
Metal samples after 18 months in
a harsh soil environment

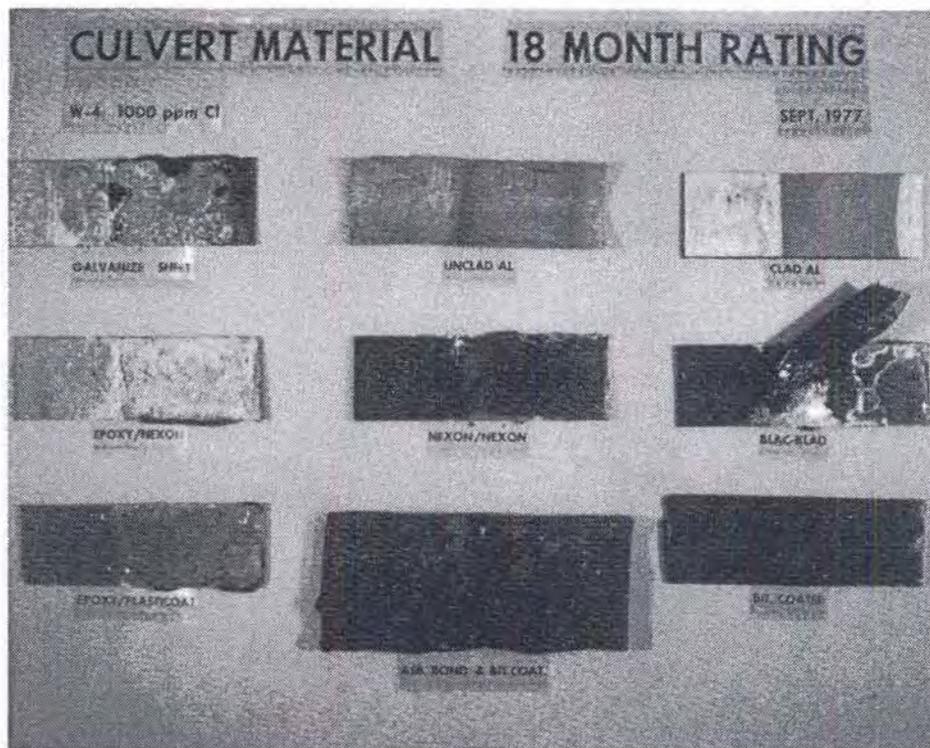
Photograph No. 15
 Metal samples after 18 months in a
 harsh water environment

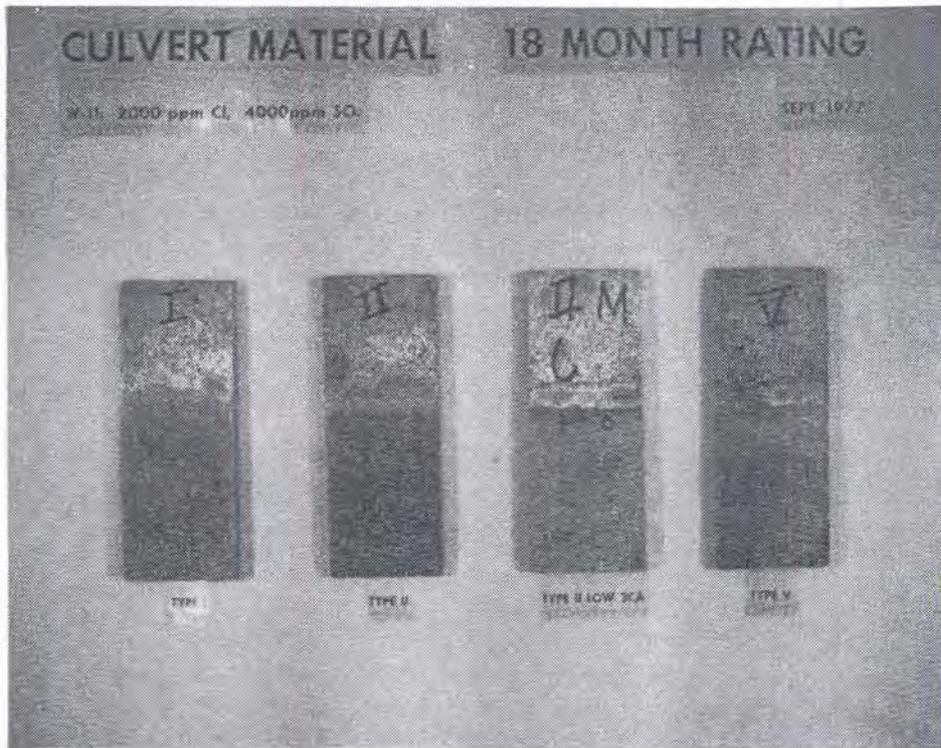
Photograph No. 17
Concrete samples after 18 months in a
harsh water environment

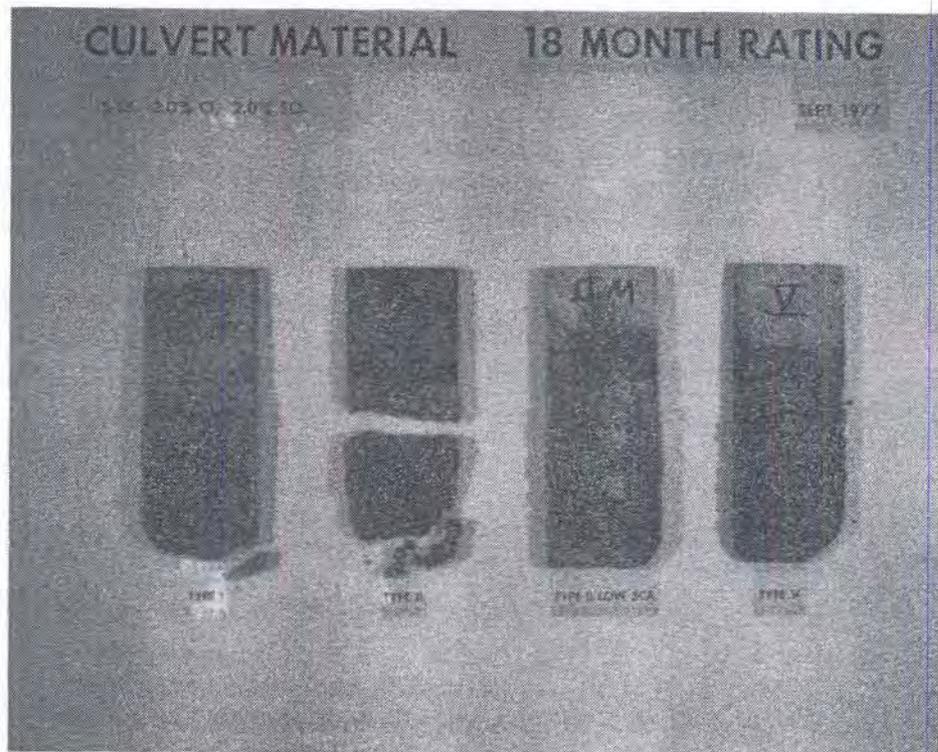
Photograph No. 18
Concrete samples after 18 months in a
harsh soil environment
