Report No. CDOH-DTD-R-89-16

EVALUATION OF HIGH-DENSITY POLYETHYLENE PIPE

Final Report
December, 1989

Construction on project I-IR 70-3(122) was completed during the Summer of 1985 and involved the repair and replacement of corrugated steel pipe (CSP) cross drains and the construction of downdrains in the Hamilton Gulch area of the Straight Creek drainage. The downdrains were needed to prevent erosion on the fill slopes below the I-70 roadway (please see Figure 1 on page 2). The previously installed CSP crossdrains and downdrains were showing severe results of corrosion.

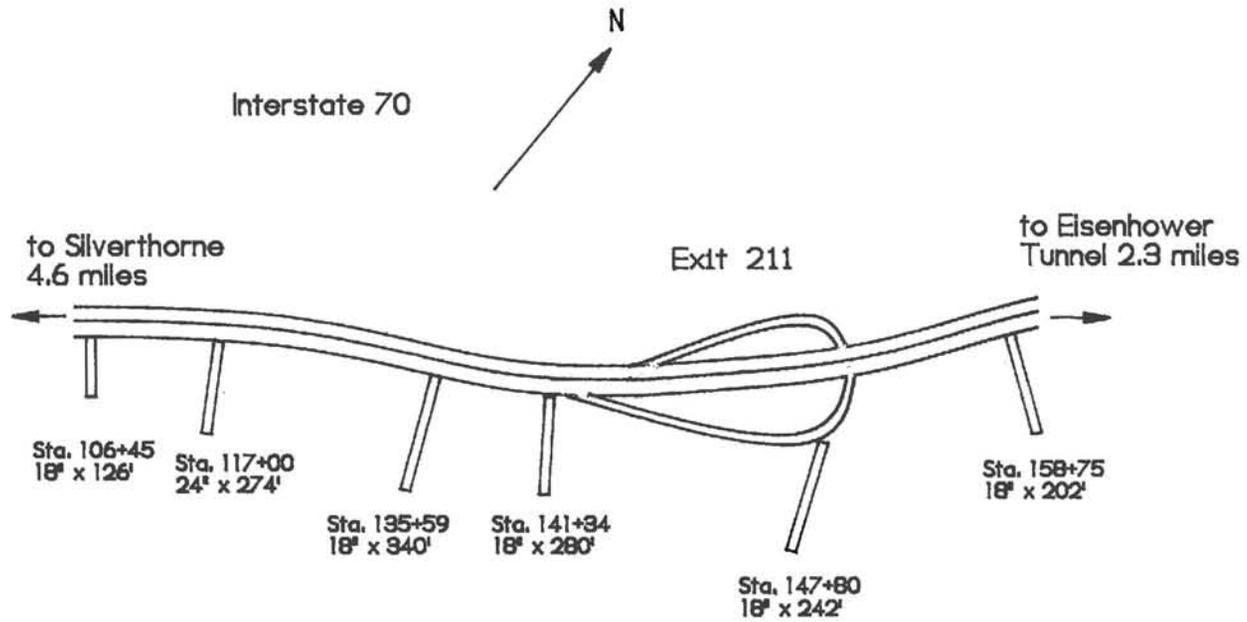
Figure 1.

Location and Dimensions of Plastic Pipe Rundowns
Project I IR 70-3(122)

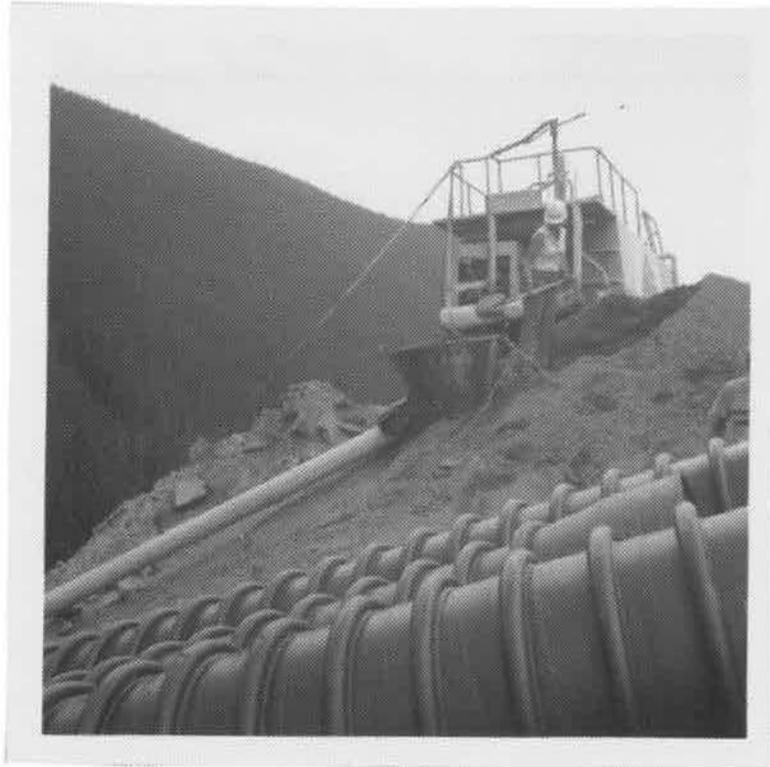
Photograph 1.
Backfill material
was transported
down the slope
in smaller plastic
pipes.
SPIROLITE pipes
are shown in
foreground.

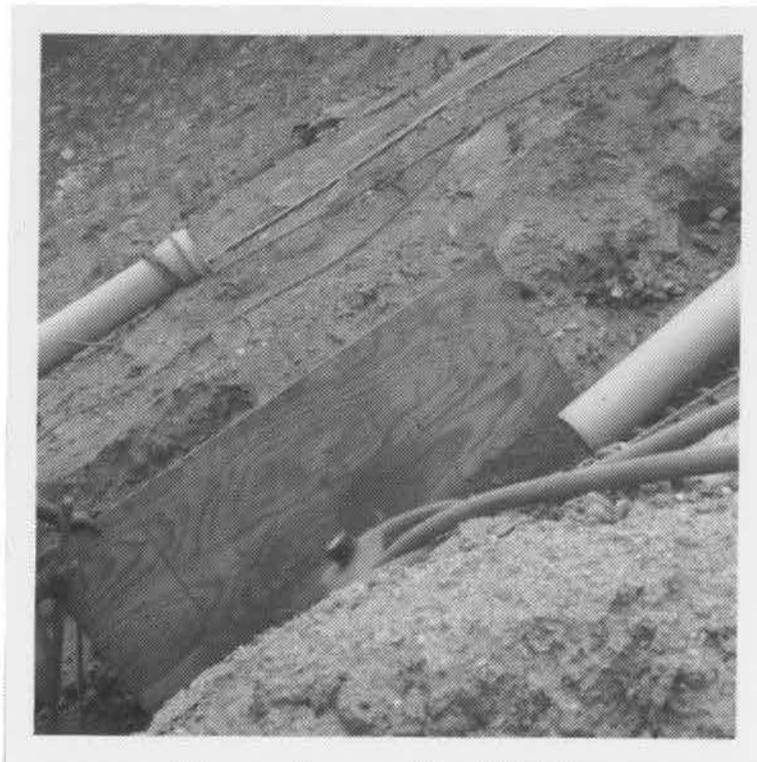
Photograph 2.
The backfill
material was
directed as
needed with
plywood vanes.

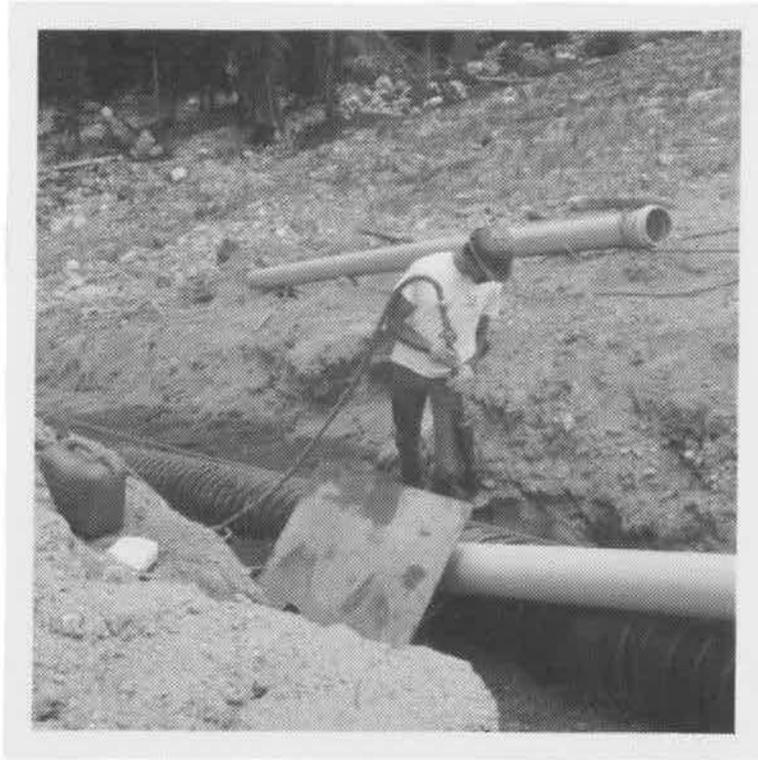
Photograph 3.
Compaction began
at the bottom
of the slope
using a hand-
help pneumatic
tamper.

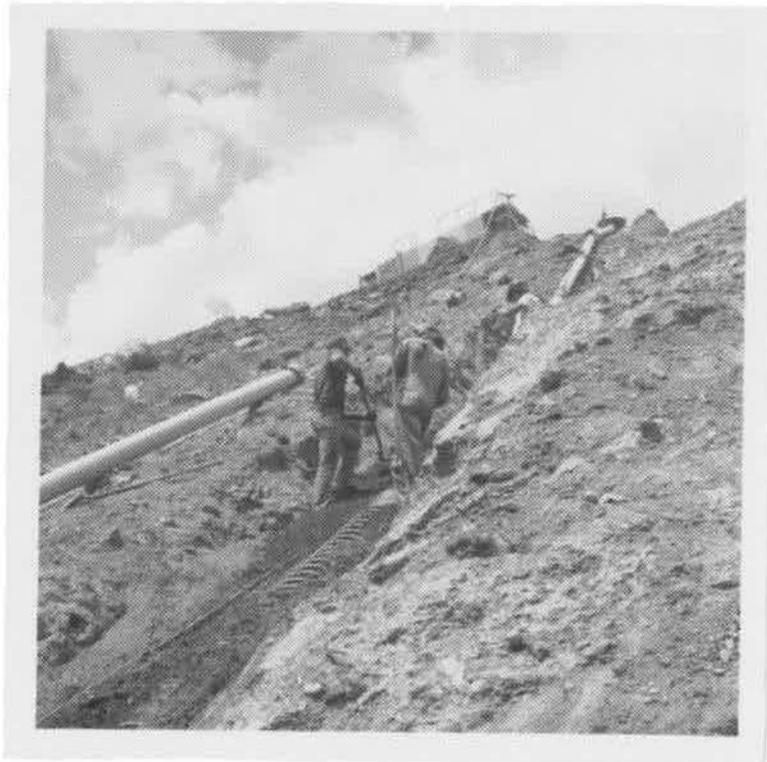
Photograph 4.
Compaction work
progressing up
the slope.

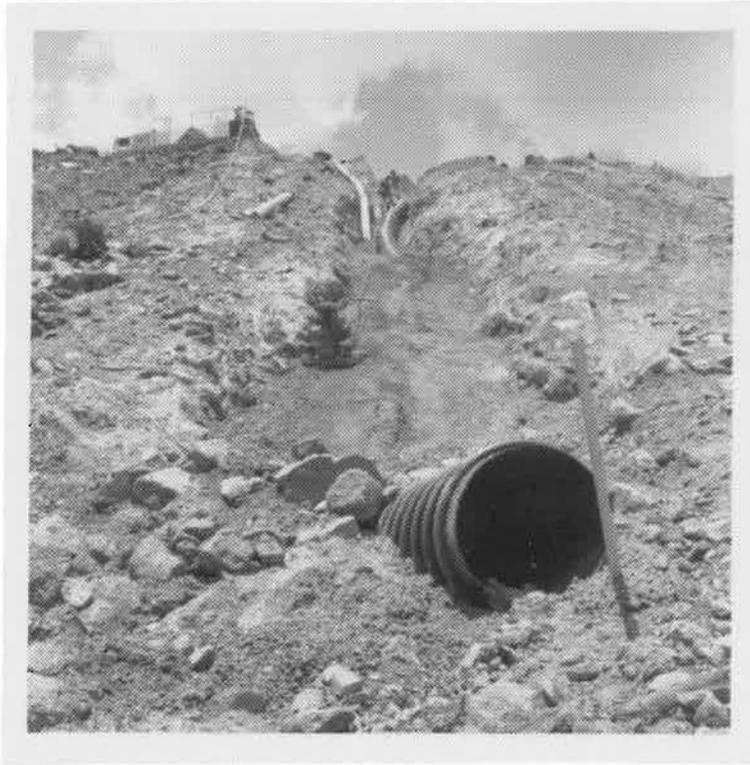
Photograph 5.
Larger tamper
was used once
the backfill
was up to the
level of the
top of the pipe.

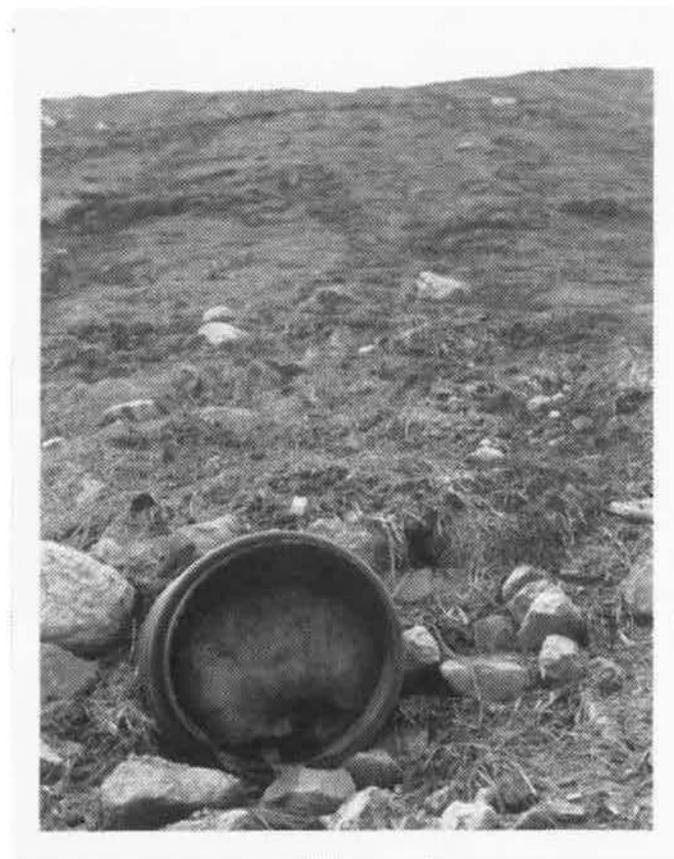
Photograph 6.
Vegetation began
to take hold
the first spring
following
construction.

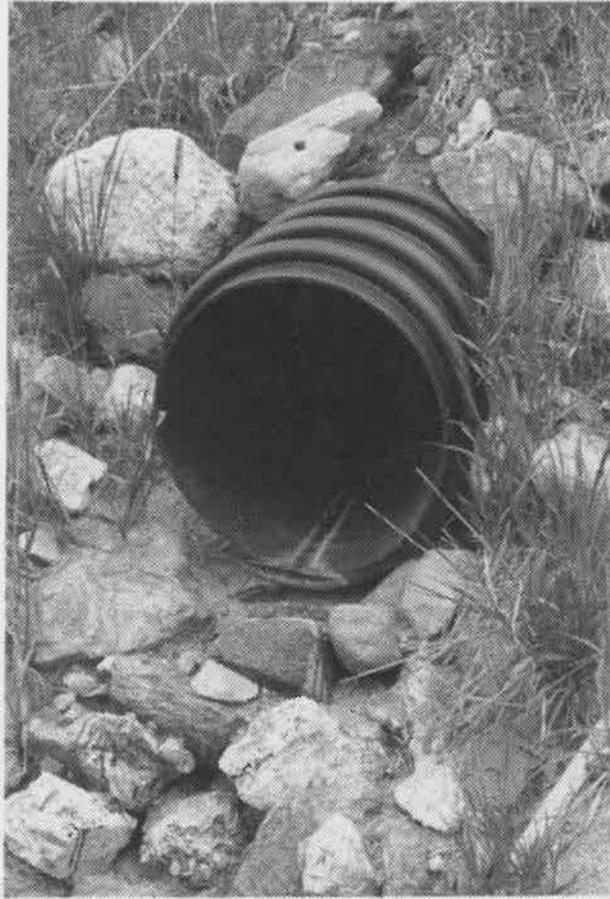
Photograph 7.
End of pipe in
Summer. Large
quantities of
roadside sand
are transported
down the rundowns
in the Spring.

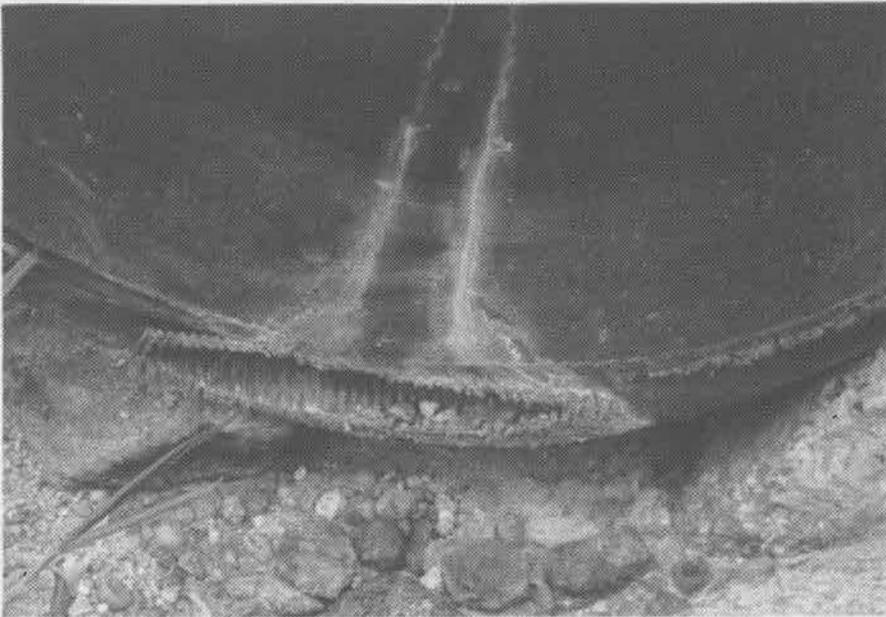
In the four year period following construction, there have been no signs of any defects in the HDPE downdrains. No significant abrasion in the pipes has been observed, although large amounts of sediment have traveled through the downdrains. There is no indication that joints have opened up in the pipe (e.g. seepage or erosion above the pipe) nor that any mass displacement of the rundowns has occurred. The joints between the concrete inlets and the HDPE pipes have all performed well with no movement or leakage observed. The concrete inlet provides the connection between the CSP crossdrains and the HDPE rundowns and eliminated the need for a direct connection of the two different pipes.

Photograph 8.
Closeup of pipe
end. There is
no evidence of
scouring.

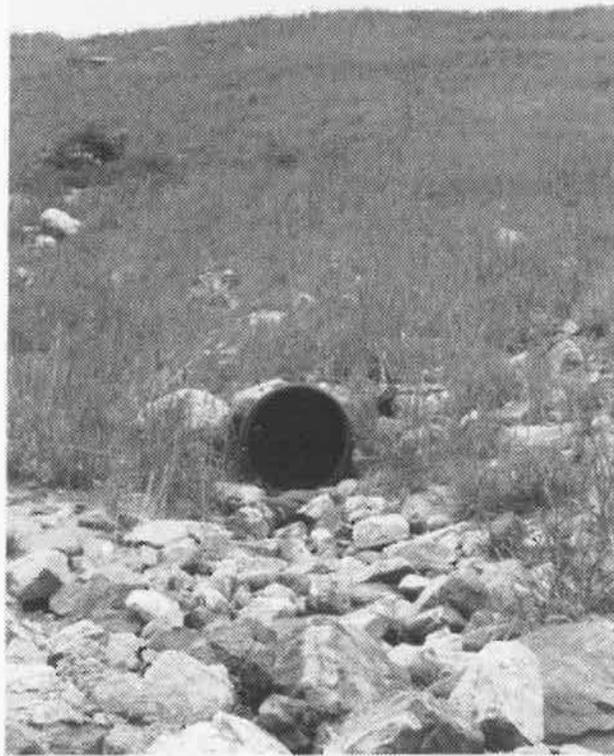
Photograph 9.
The vegetation
is well estab-
lished by the
Summer of 1989.

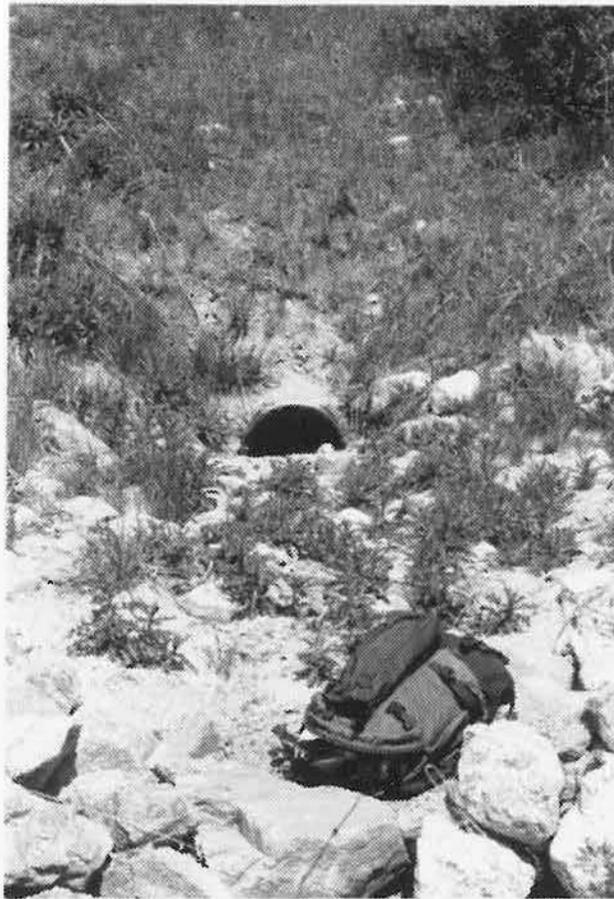
Photograph 10.
Summer 1989.
Note that
settlement pond
is nearly full.

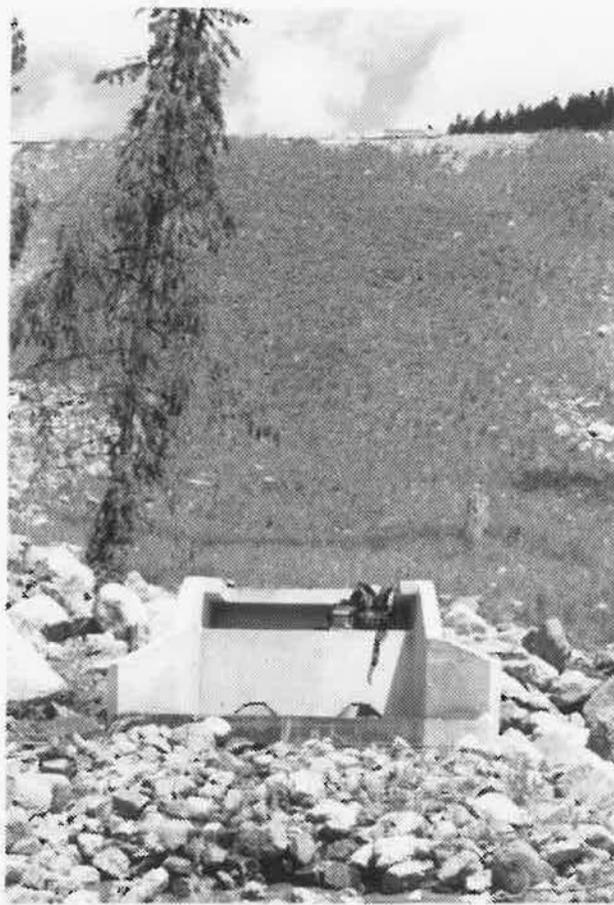
Photograph 11.
Stilling basin
installed at
the bottom of
one of the
rundowns.

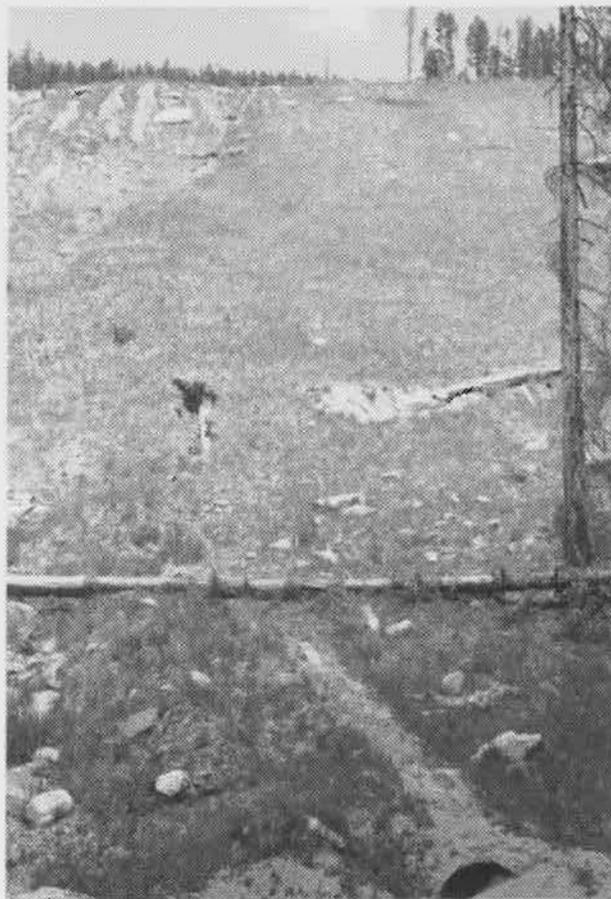
The CSP rundowns installed in 1979, however, have begun to corrode in several places. In viewing the limited number of CSP pipes installed in the study area, it appears that the useful life of the CSP steel rundowns is 10 years in this environment.

Photograph 12.
One of the
corrugated
steel pipes
installed in
1979. Note
washed out
area in middle
of slope where
pipe has
corroded
through.
