**PRE-DEMOLITION/RENOVATION
ASBESTOS AND LEAD-BASED PAINT
INSPECTION REPORT FOR
COLORADO DEPARTMENT OF
TRANSPORTATION BRIDGE STRUCTURE
H-17-L**

**I-25 Southbound and Black Squirrel Creek
Mile Marker 153.948**

STRUCTURE ID: H-17-L

July 13, 2012

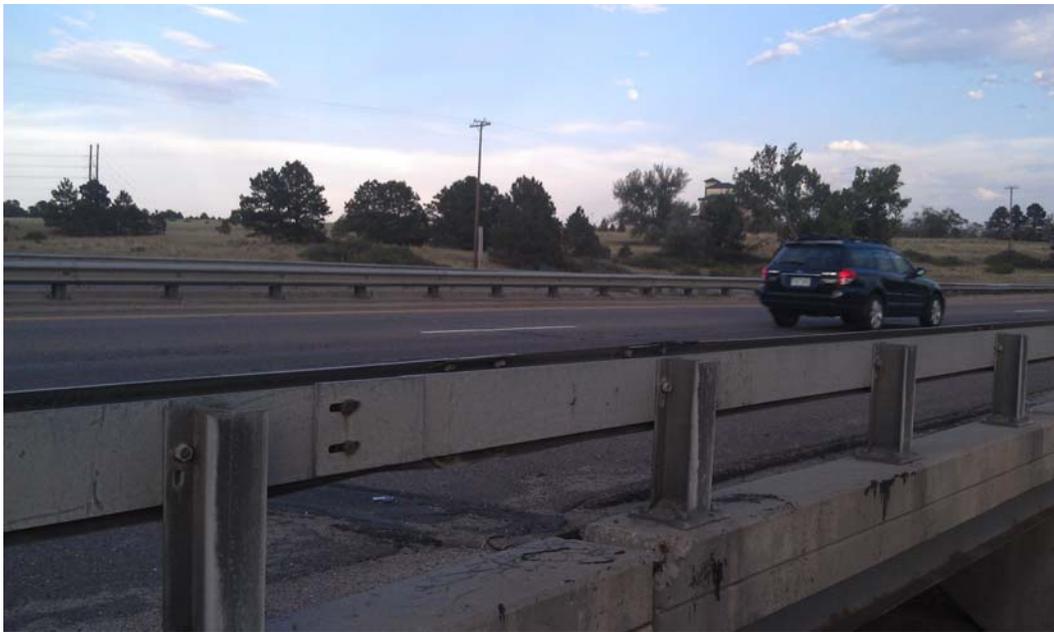
Photo 1 – View of Bridge Structure ID: H-17-L.

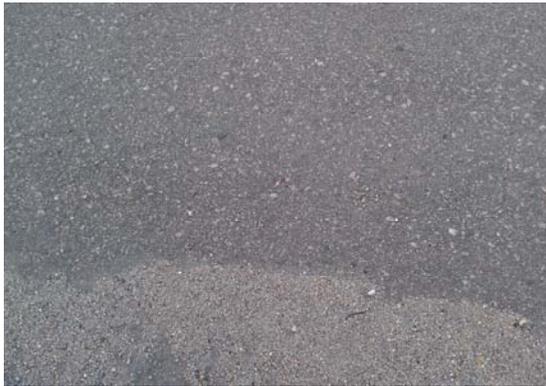
AS01

HOMOGENEOUS AREA	MATERIAL DESCRIPTION	ASBESTOS CONTENT	LOCATION	QUANTITY
H-17-L-AS01	Asphalt Composite	ND	Surface of Bridge	4,368 SF
H-17-L-CN01	Concrete Substrate	ND	Bridge Structure	6,048 SF
H-17-L-PA01	Silver Paint Steel Substrate	ND	On Steel Structure and Overspray on Concrete	5,824 SF
H-17-L-PA02	White Road Lane Paint	ND	Shoulder of Bridge and Main Lanes on Asphalt	156 LF
H-17-L-PA03	Yellow Road Lane Paint	ND	Median Lanes on Asphalt	104 LF
H-17-L-RT01	Black Road Tar	ND	Horizontal Areas on Asphalt	230 LF

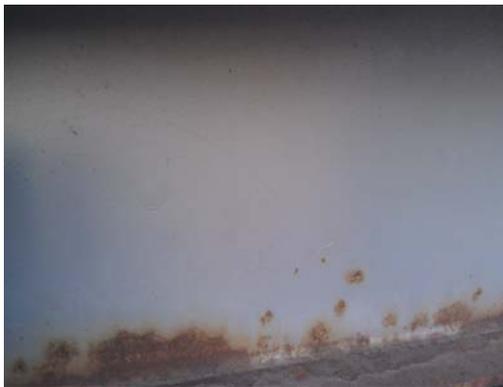
LBP01

SAMPLE ID	LOCATION	SUBSTRATE	COLOR	CONDITION	RESULT (% BY WEIGHT)
H-17-L-LBP01	On Steel I-Beams with Overspray on Concrete	Steel and Concrete	Silver	Poor	5.2
H-17-L-LBP02	On Shoulders and Main Road Lanes	Asphalt	White	Intact	BRL
H-17-L-LBP03	Median of Road	Asphalt	Yellow	Intact	BRL

- Steel Substrate-Silver-On Steel I-Beams.

Renovation and demolition activities involving Lead-Based Paint are covered under the OSHA Construction Industry Standard for Lead (Title 29 of the Federal Code of Regulations, Part 1926.62). This standard addresses such issues as worker training, medical evaluations, personnel protective equipment, exposure assessment, biological monitoring, air monitoring, hygiene facilities and practices, and health and safety plans. OSHA regulations do not define a minimum concentration of lead as a threshold for action. Thus, even concentrations below EPA/HUD/CDPHE levels are covered under OSHA.

Additionally, lead-containing materials require a hazardous waste determination pursuant to 40 CFR 262.11, and 40 CFR 261.24. It is a standard industry approach that demolition waste characterization should be performed on structures containing lead-based paint. This procedure is the Toxicity Characteristic Leaching Process (TCLP), where sample composite representative of all building components to be demolished (i.e. all lead-based paint coated and non-lead-based paint coated materials from the structure) is submitted to the laboratory for analysis. The Toxicity Characteristic (TC) limit for lead is 5ppm in the leachate. Materials that exceed this limit must be disposed of as hazardous waste. Materials that do not exceed this limit may be disposed of as solid waste.
