C-470 & University Blvd. Interchange

C-470 and Quebec St. Interchange

C-470 & Quebec St. Interchange

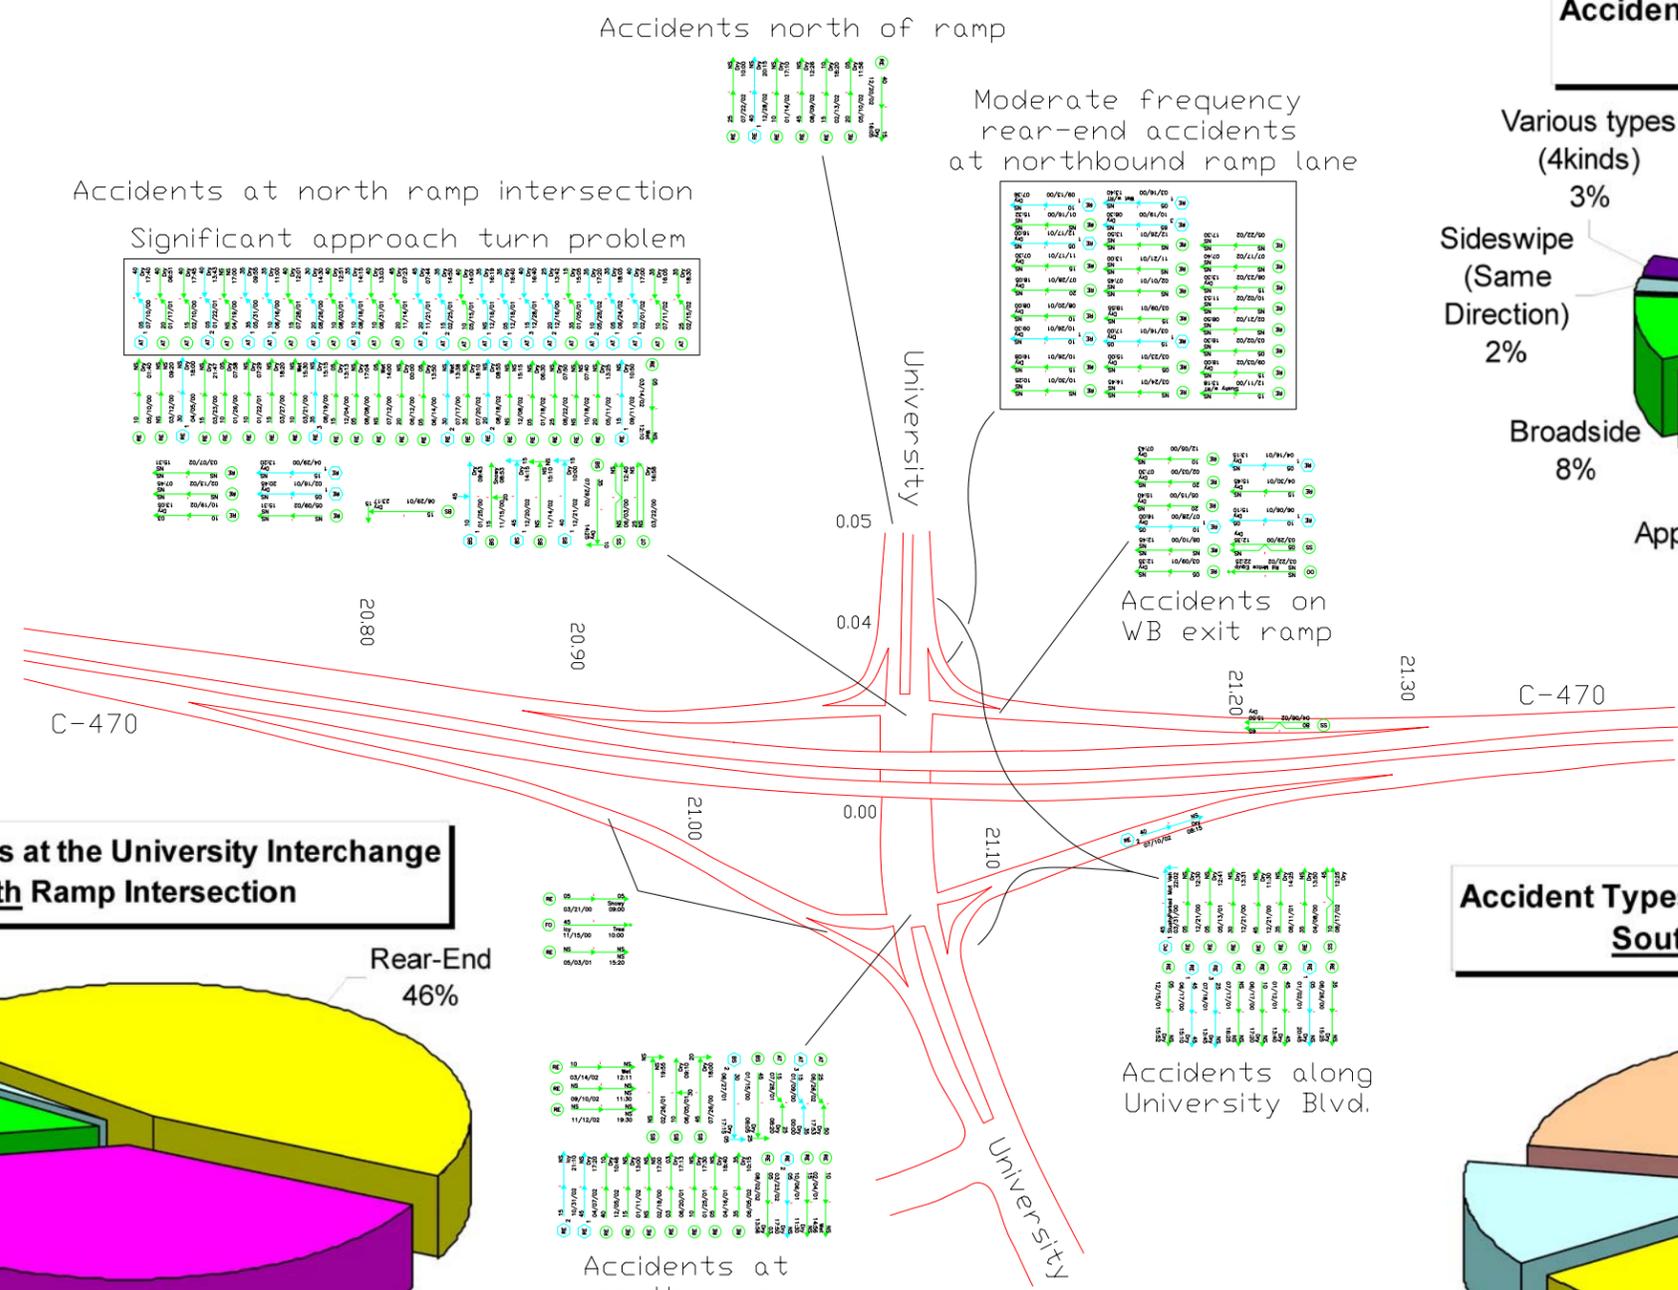
Accidents north of ramp

Moderate frequency rear-end accidents at northbound ramp lane

Accidents at north ramp intersection

Significant approach turn problem

Accidents on WB exit ramp

Accidents along University Blvd.

Accidents at south ramp intersection

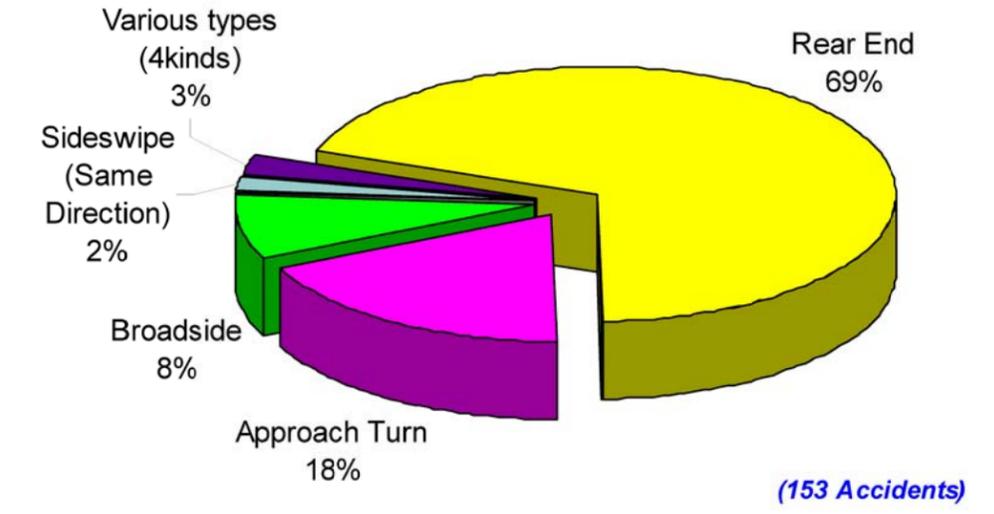
**Accident Types at the University Interchange
Ramps & crossroad only**

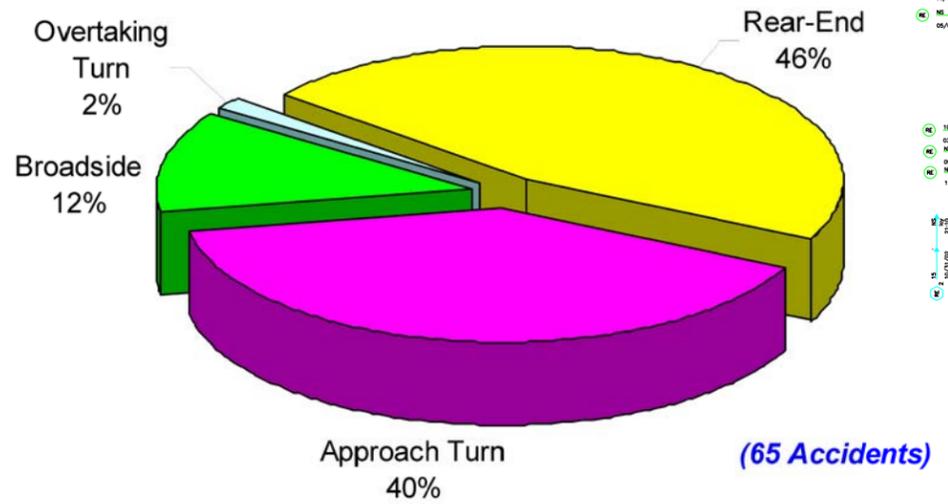
**Accident Types at the University Interchange
North Ramp Intersection**

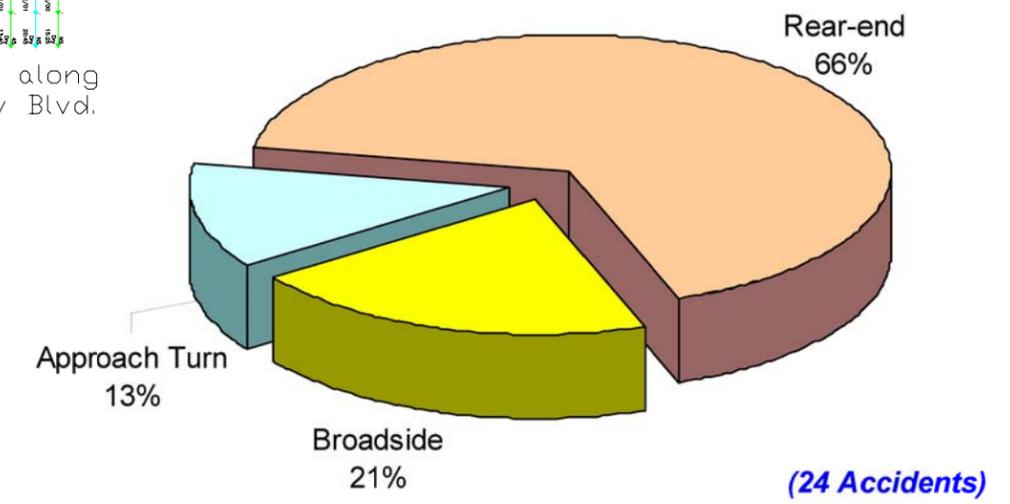
**Accident Types at the University Interchange
South Ramp Intersection**

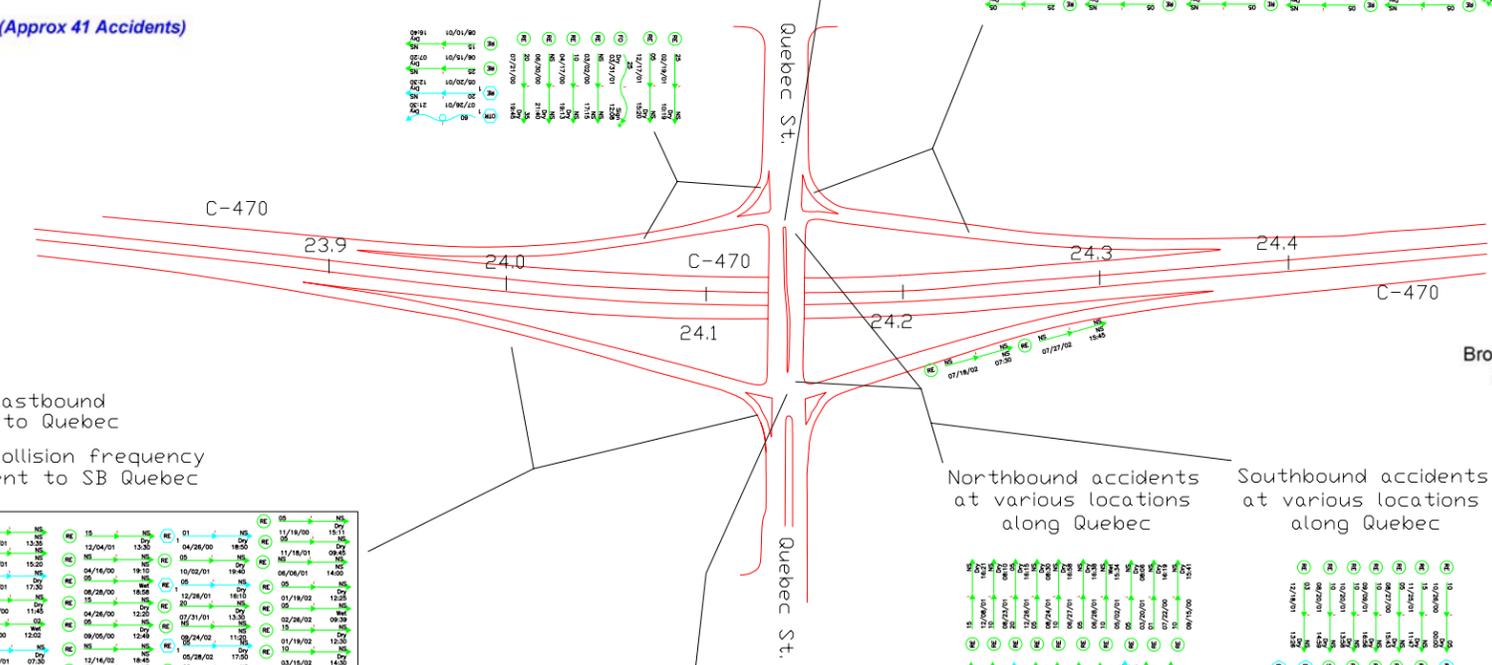
The north ramp intersection at this interchange was experiencing significant approach-turn collision frequency involving northbound vehicles on Quebec St. turning left in front of southbound through vehicles on Quebec. Presently, this left turn movement includes double left turn lanes and protected/permitted signal intervals. Consideration may be given to implementing a fully protected left turn scheme at this intersection.

Accidents at north ramp intersection
Significant approach turn collision frequency at intersection

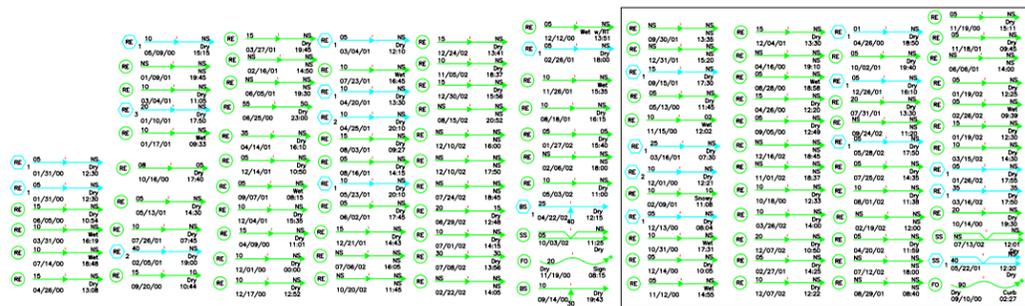
At both north and south ramp intersections we note rear-end collisions occurring in the channelized right turn lanes. Extension of the right turn acceleration lanes, particularly the eastbound to southbound movement at the south intersection, may help moderate this type of collision.

Accidents on eastbound C-470 exit ramp to Quebec
Significant rear-end collision frequency at right turn movement to SB Quebec

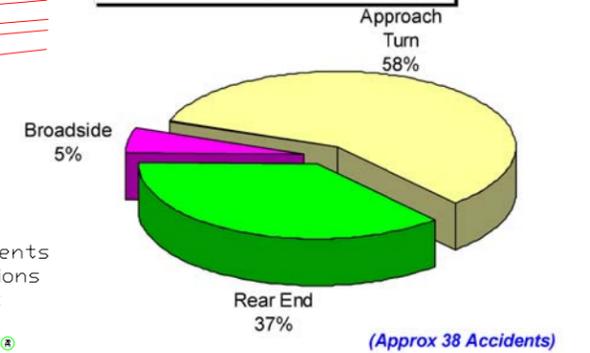
Accident Types at Quebec Interchange South Ramp Intersection
