# CDOT Region 3 Intersection Priority Study

June 2011

**Fehr & Peers**  
621 17th Street Suite #2301  
Denver, CO 80293  
303.296.4300

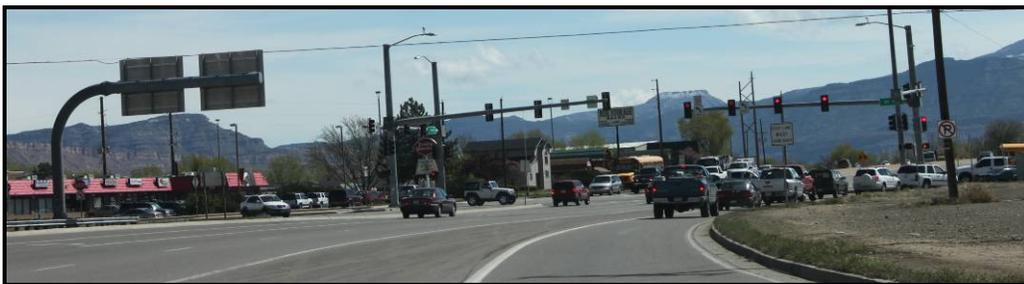
Photo 1: I-70B and 30 Road

- The southbound right-turn lane is a trap lane and may cause some confuse to drivers if they are unaware that they are forced to turn right on either the Frontage Road or I-70 B.
- There are long queues on all approaches during the red phases; however, the queue cleared within the allotted green time. Northbound left-turn lanes had the longest queue, but had adequate green time to clear the vehicles within the queue. Vehicles that arrived at the back of the northbound left queue after the left-turn phase began would sometimes get through the intersection, but sometimes had to wait until the next cycle. The turning movement counts indicate that the northbound left-turn has 656 vehicles in the peak morning hour and 448 vehicles in the peak evening hour.
- The Frontage Road had a minimal amount of traffic.

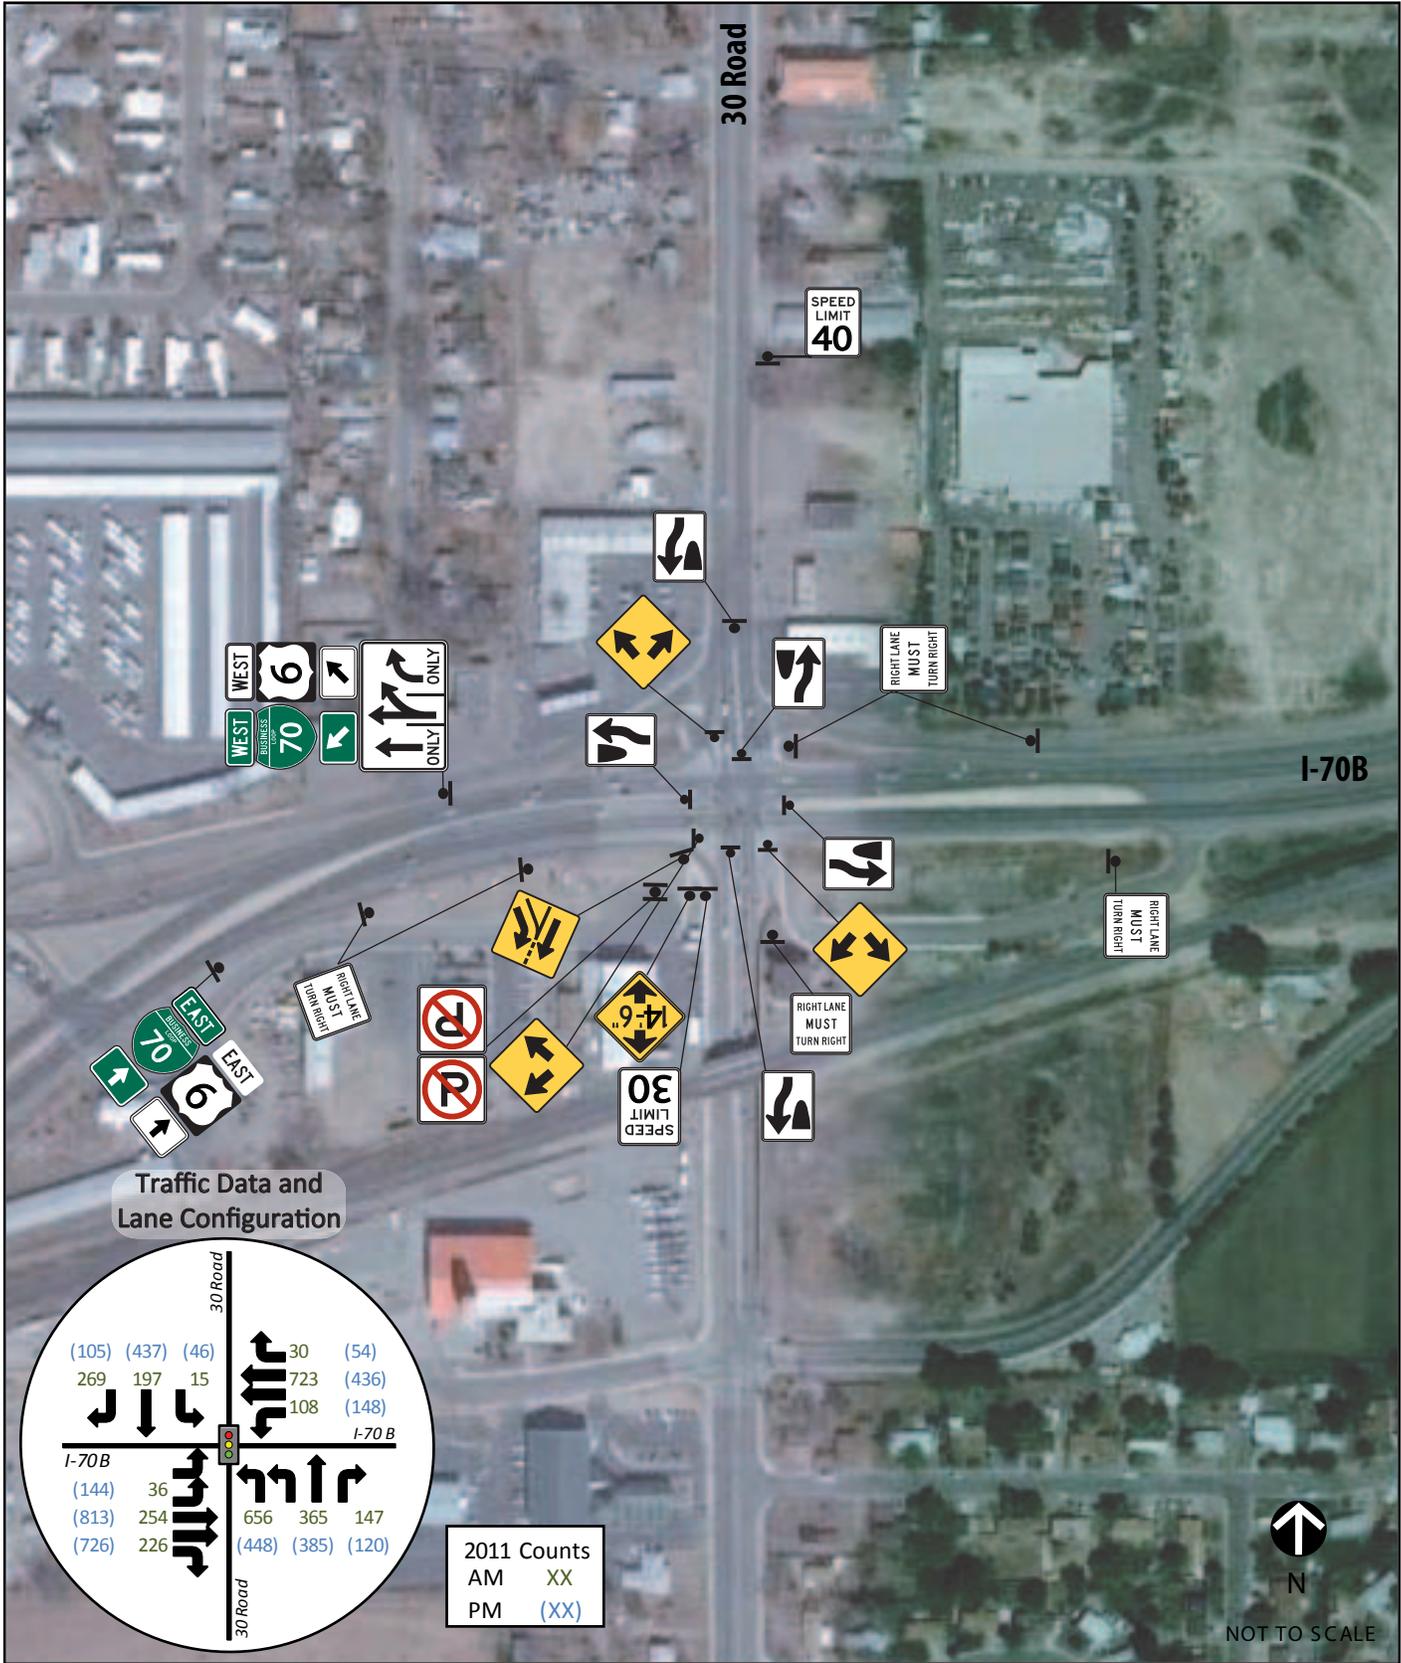
- Reevaluate the traffic patterns and operational needs.
  - Evaluate westbound left-turn volumes to determine the need for a second turn lane. If the current geometry can be stay the same by re-striping the south to have two receiving lanes; however, this will impact the eastbound right-turning vehicles will no longer have a free-flow right. Due to the high volume of eastbound right-turning vehicles, the free flowing operation is desired; therefore, dual westbound left-turn lanes would require the south leg to be widened to three lanes which requires the railroad bridge being widened. As volumes change at this intersection due to 29 Road, the recommended design for these turning movements could be altered.

Estimated Cost = \$100,000 (access management) + \$15,000 (interconnection - wireless) + \$25,000 (detection) + \$30,000 (left-turn) = \$170,000

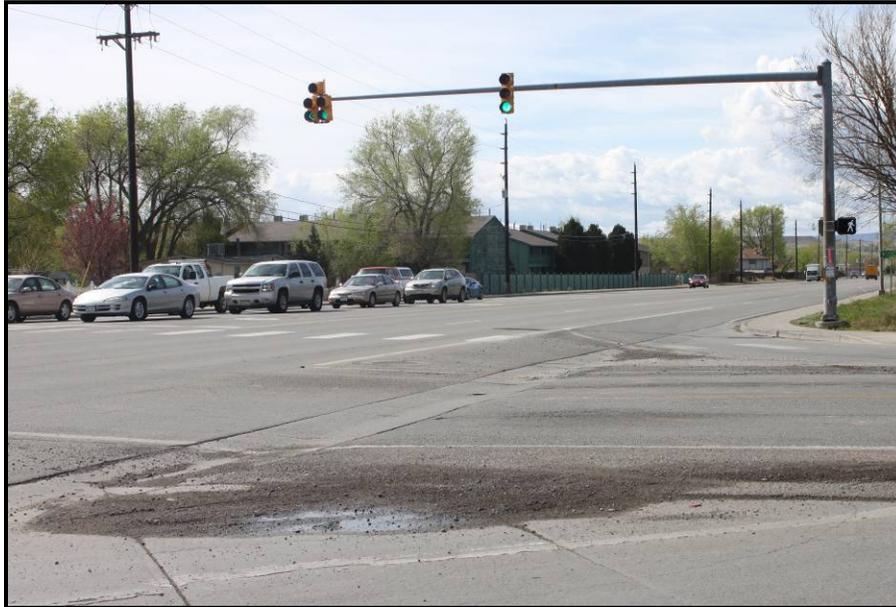
**Photo 2: State Highway 141 and E Road**

- There is an electric utility wire resting upon the mast arm directly above the eastbound approach.
- State Highway 141 has narrow sidewalks on both sides. There are no sidewalks along E Road, except a small portion at the community center on the northwest corner.
- Pedestrians were seen crossing E Road mid-block and not utilizing the pedestrian facilities at the signalized intersection.
- The pavement markings at the intersection are worn and in poor condition.
- There are irrigation ditches on the northeast and southwest corners. Inlets exist on State Highway 141.
- The property on the southwest corner has been sold and may be redeveloped.
- The property on the southeast corner is a historical site.

- Apply access management techniques to E Road.
- Lengthen the deceleration and acceleration lanes to conform to *CDOT Access Code*.

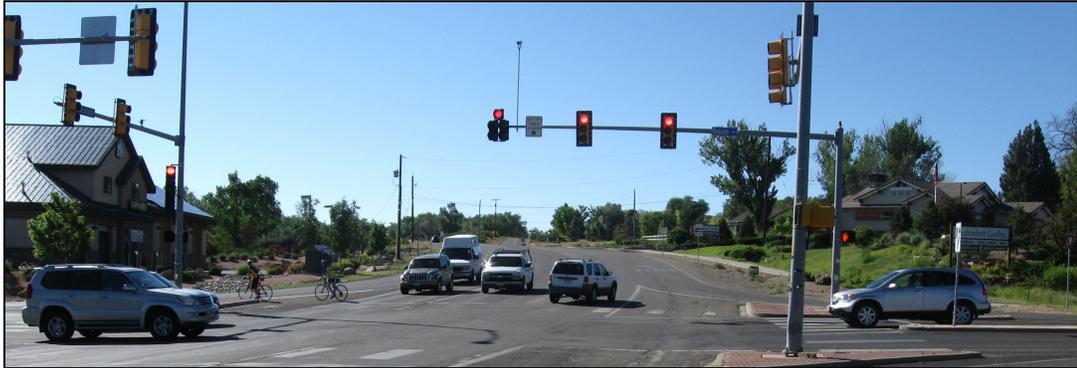
**Photo 3: State Highway 340 and Redlands Parkway**

The signal currently does not have any advanced detection or a left-turn phase for the westbound approach. According to the FHWA guidelines, the westbound left-turn lane should operate as protected+permitted due to the conflicting volumes between the left-turning vehicles and the opposing through/right-turning vehicles. The FHWA guidelines suggest protected+permitted phasing if the left-turning volume multiplied by the opposing through and right-turning volumes is greater than 50,000 during the peak hour. In the PM peak hour there are 181 westbound left-turning vehicles and 459 eastbound vehicles (23 right-turns and 436 through); when multiplied the resulting value is 70,409. For that reason the westbound left-turn phasing should be upgraded.

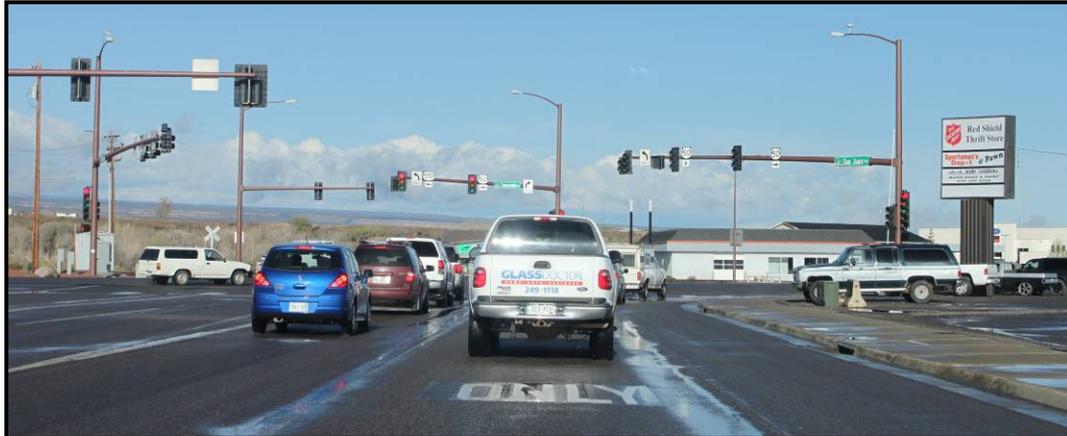
**Photo 4: US Highway 50 and San Juan Avenue/Grand Avenue**

- It is easy for eastbound vehicles to stop on the railroad tracks with the current configuration.
- There are pedestrian signal heads installed for the east, west, and south crosswalks; however, the crosswalk is not painted on the west side.

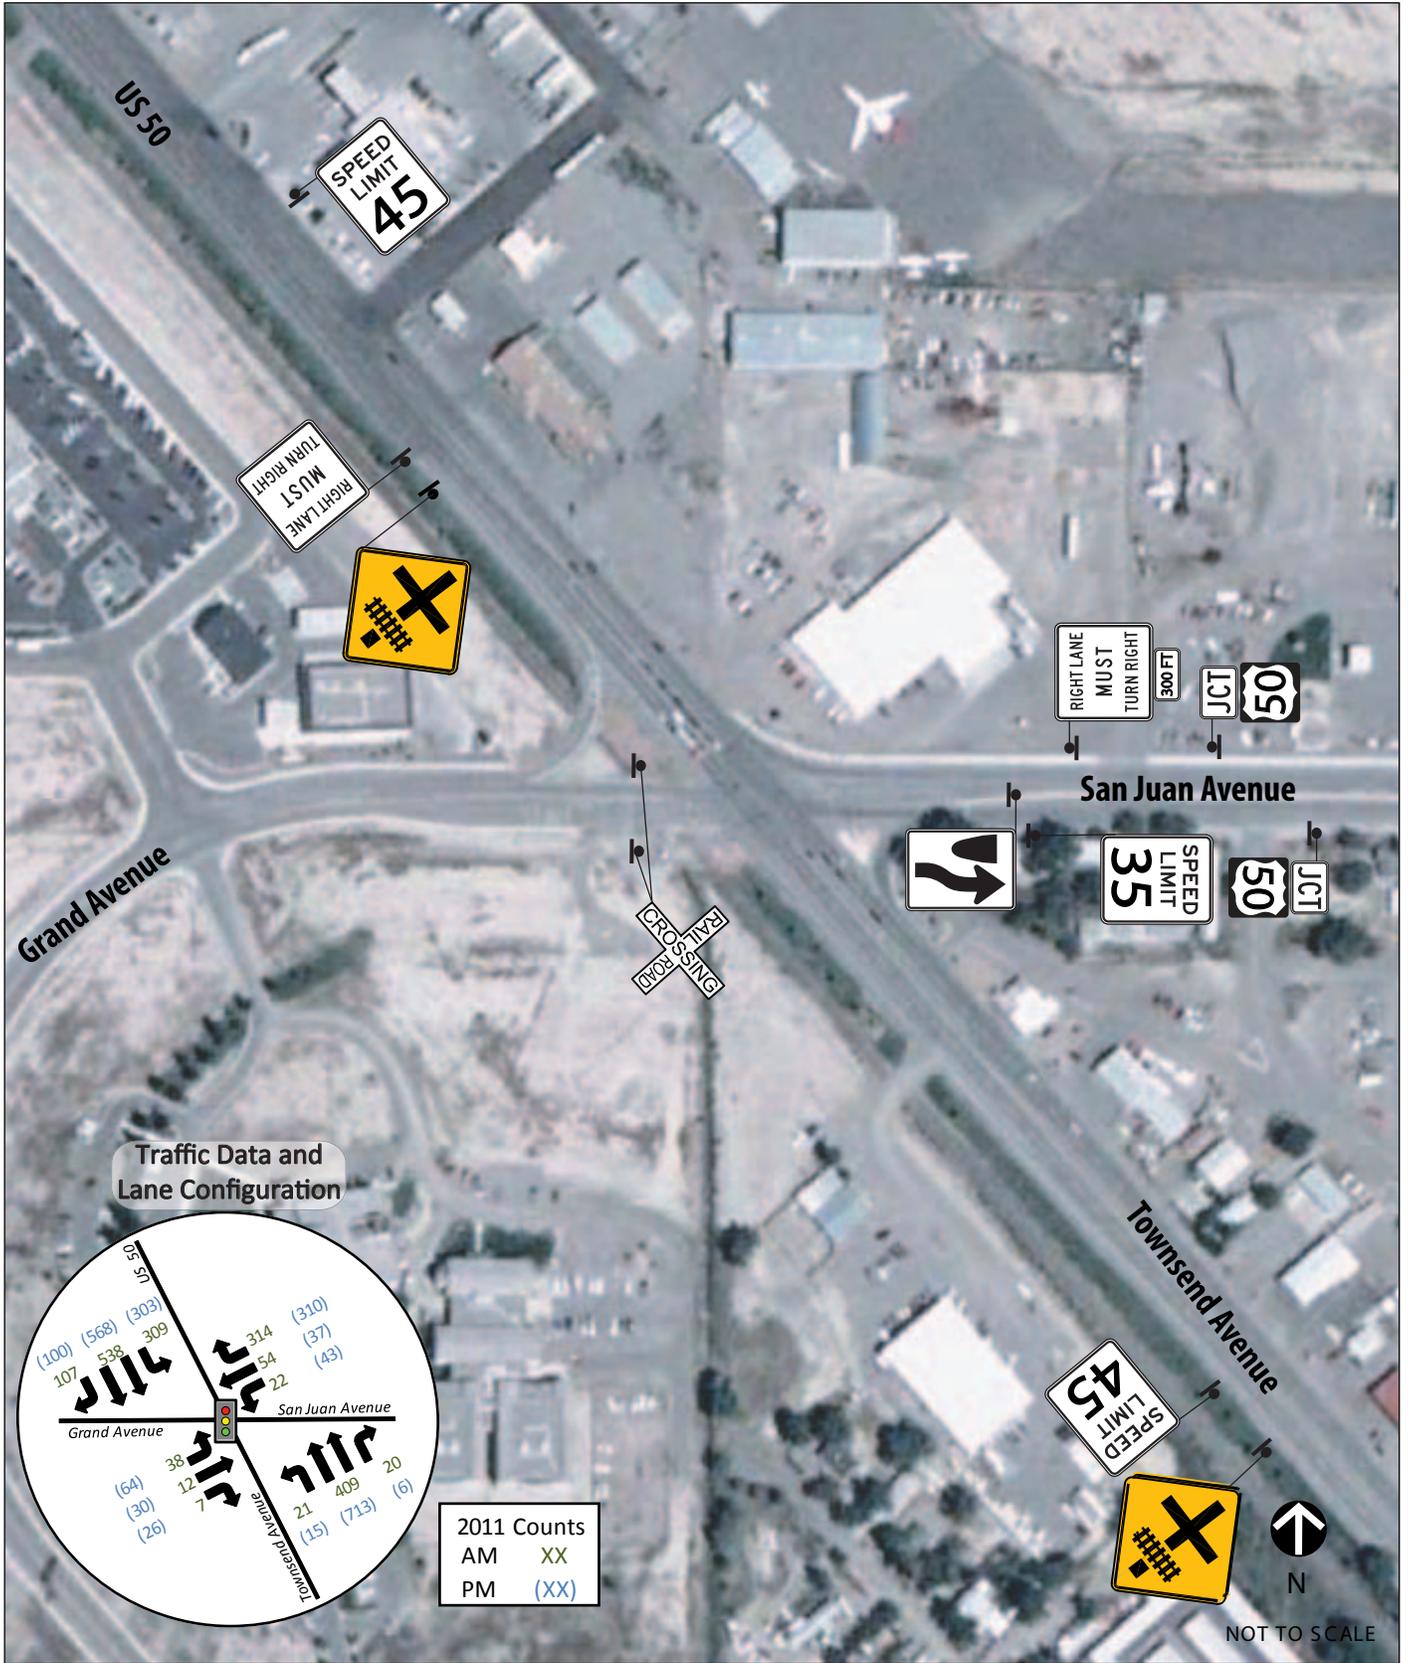
- Construct a northbound right-turn acceleration lane for vehicles turning right from San Juan Avenue.
  - Allow westbound right-turns to be free flowing.
- The skew does not appear to be causing any issues currently, however if operational or safety issues develop in the future due to the skew, the intersection should be realigned to address the geometric deficiencies. Realign of San Juan Avenue and Grand Avenue to be perpendicular with US Highway 50. Consider redesigning the intersection as a traditional design or as an off-set T-intersection.

Estimated Cost = \$150,000

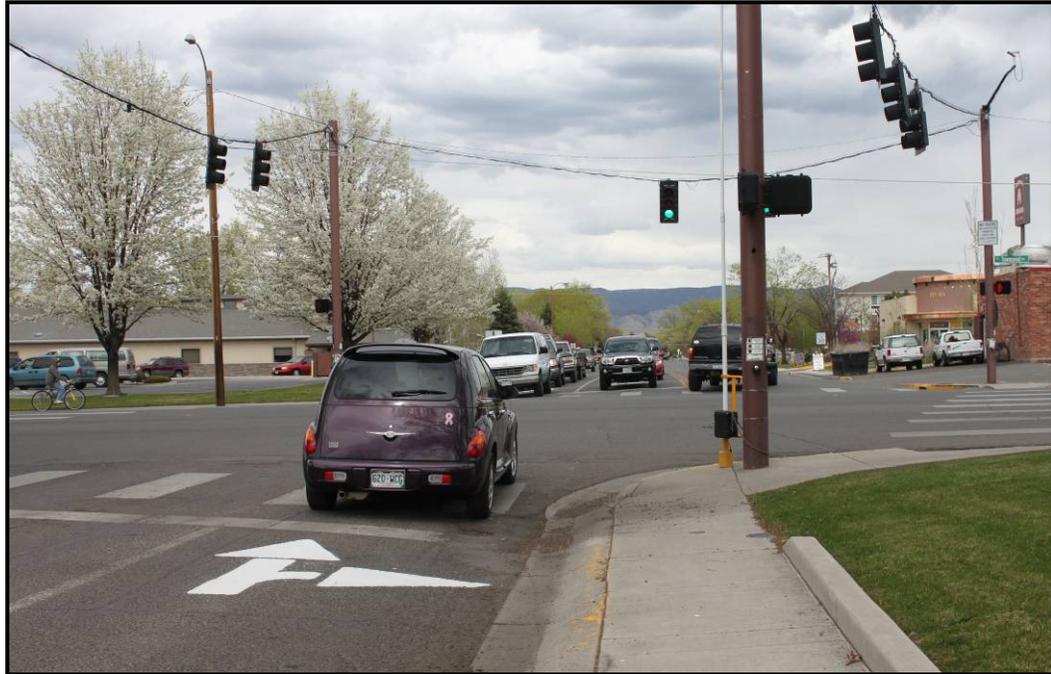
**Photo 5: US Highway 550 and 12th Street/Columbia Way**

- Pedestrian curb ramps do not meet the current design standards.
- The corner radii are small and it appears they are driven on frequently.
- Utility poles, lighting poles, and the southwest traffic signal pole are located within the sidewalk.
- All four corners have multiple commercial businesses with many driveways.

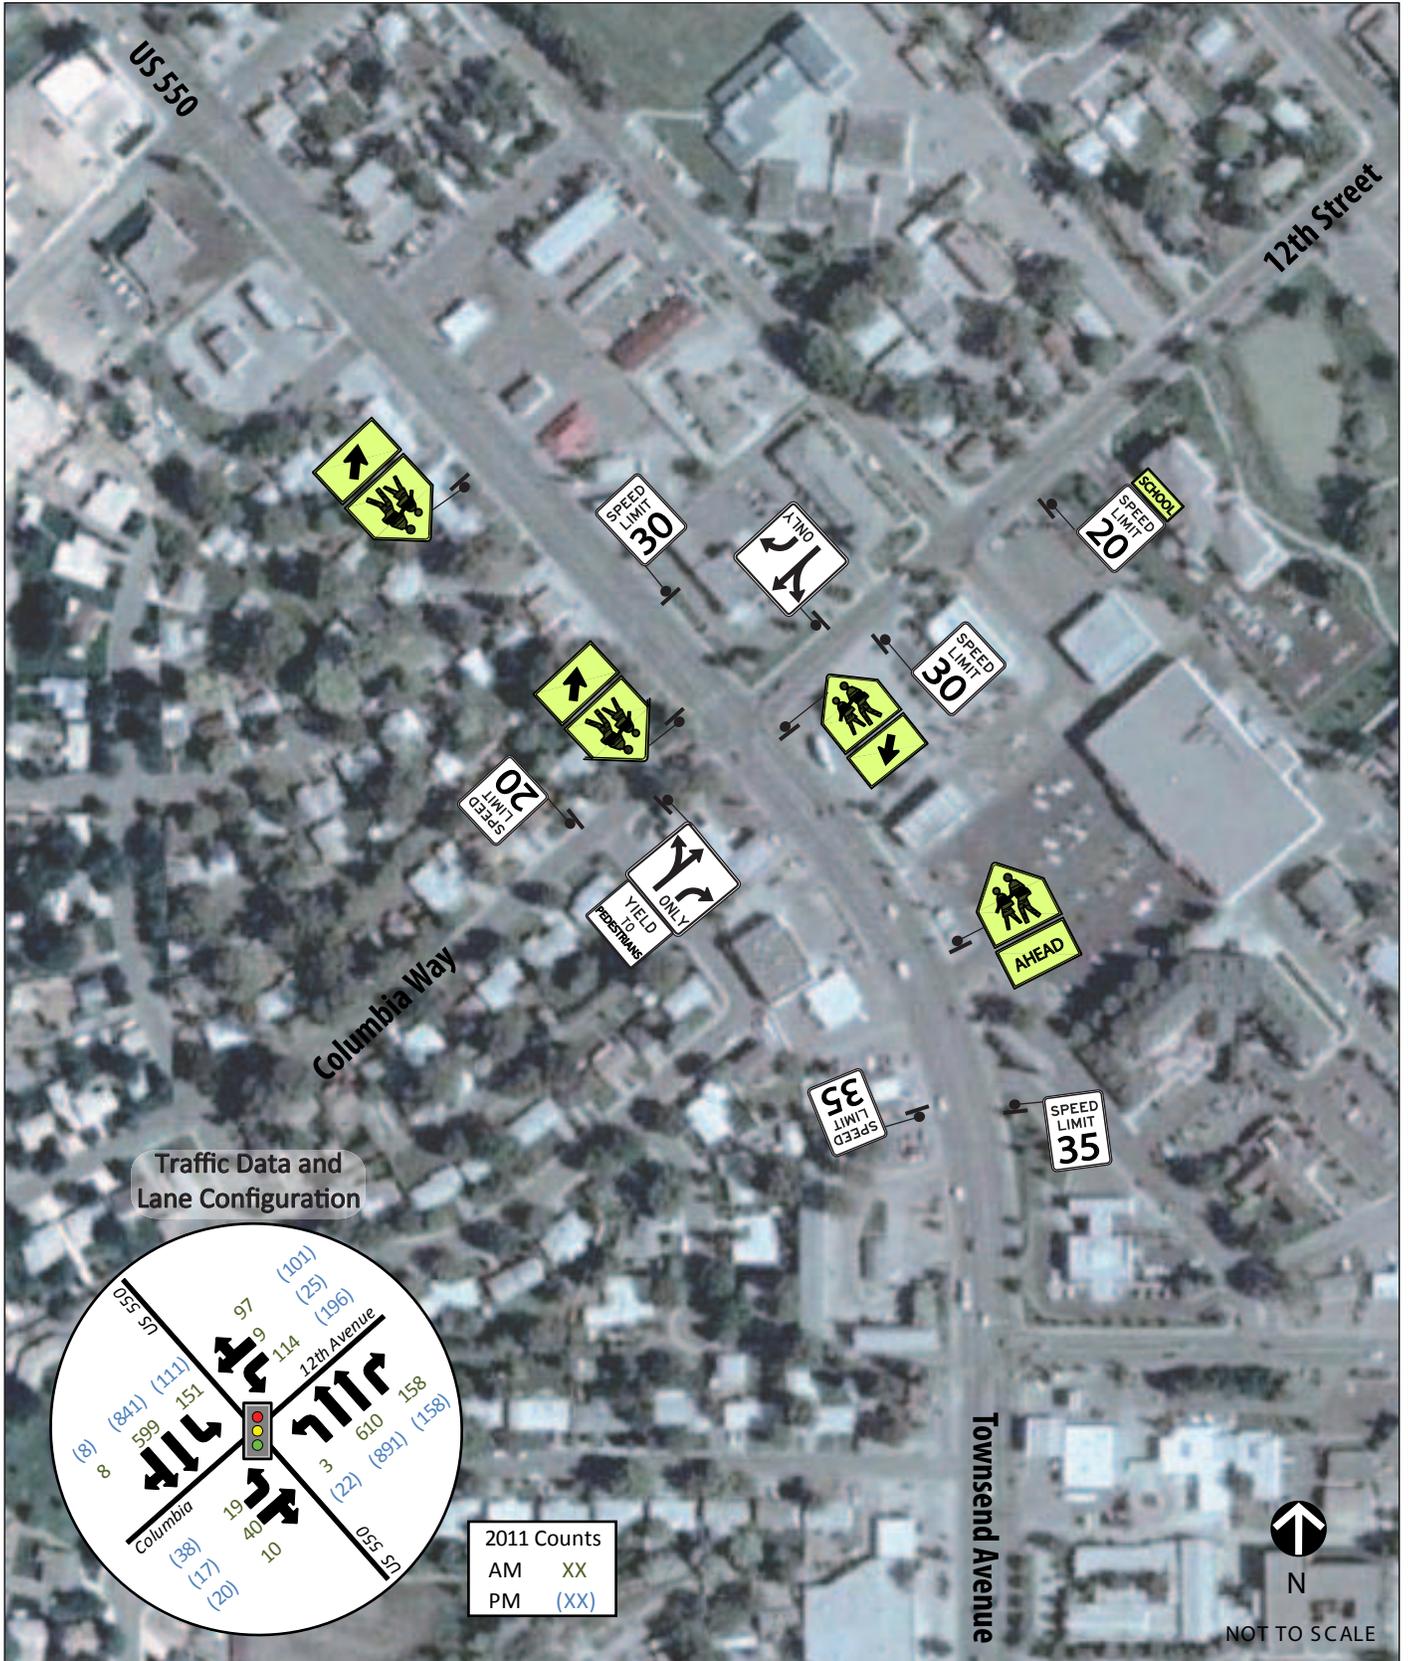
- Align the sidewalks on the north side of the minor streets.
  - Provide one left-turn lane, one through lane, and one right-turn lane for the westbound approach.
  - The extra pavement width from the realignment can be used by the City as they see fit based on the local needs.
- Increase the curb radii on all corners.

Estimated Cost = \$300,000 (signal) + \$400,000 (re-design, excluding right-of-way) = \$700,000

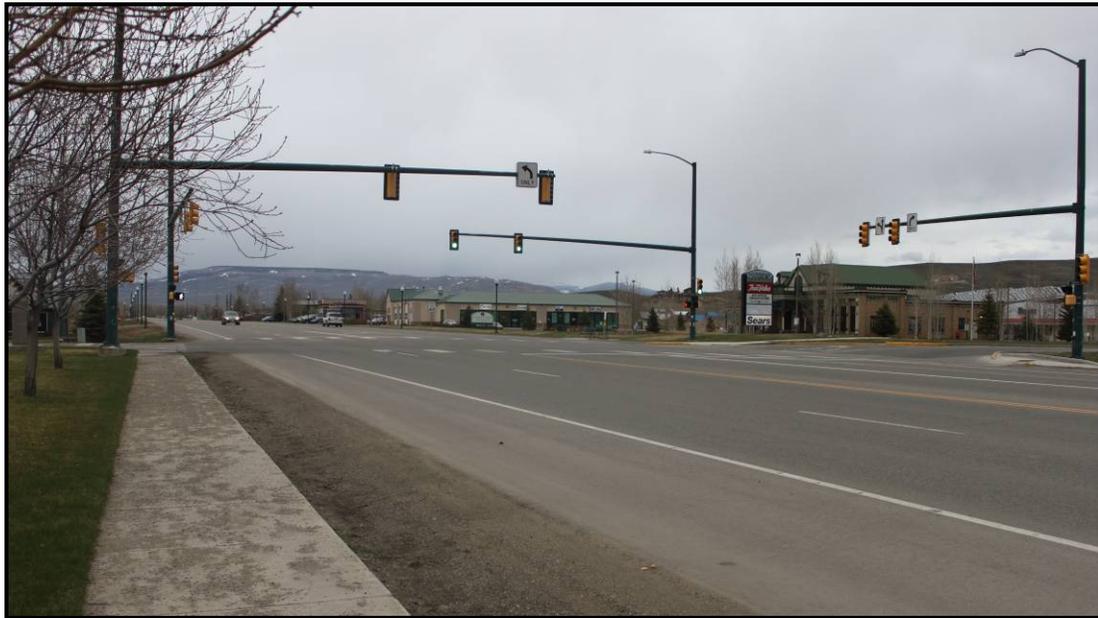
**Photo 6: US Highway 135 and Spencer Avenue**

- Drainage issues exist and are deteriorating the pavement on the west corners.
- There are a large amount of utilities located at the intersection.
- Crosswalk paint is faded.
- The northbound left-most signal head does not align properly with the left-turn and through lane.
- There is a R3-5L sign (left-turn only) on the backside of the southbound mast arm.
- The minor approaches are slightly skewed due to the different approach designs. Westbound has a center median; however, eastbound does not have a median.

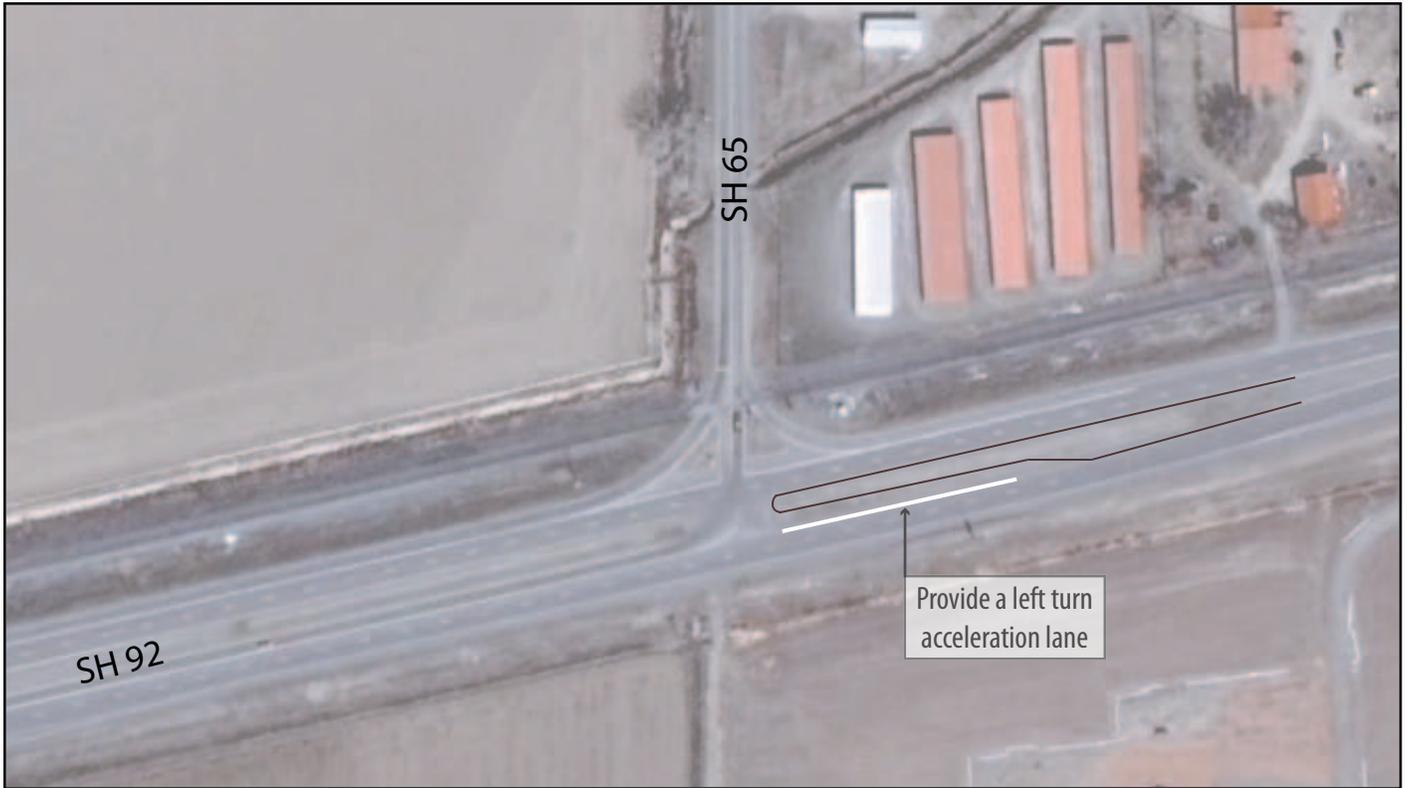
Option 1: Build In Median

Note: Median must continue to provide a minimum of four-foot separation between directions.

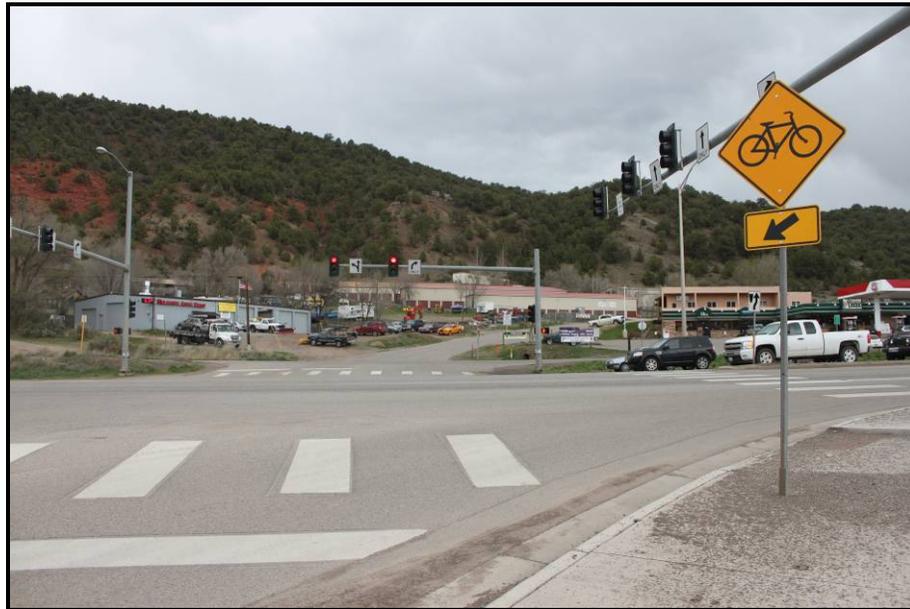
**Photo 7: State Highway 82 and County Road 154/County Road 114**

- Buses are allowed to use the shoulder.
- Lots of gravel collecting on the trail on State Highway 82.

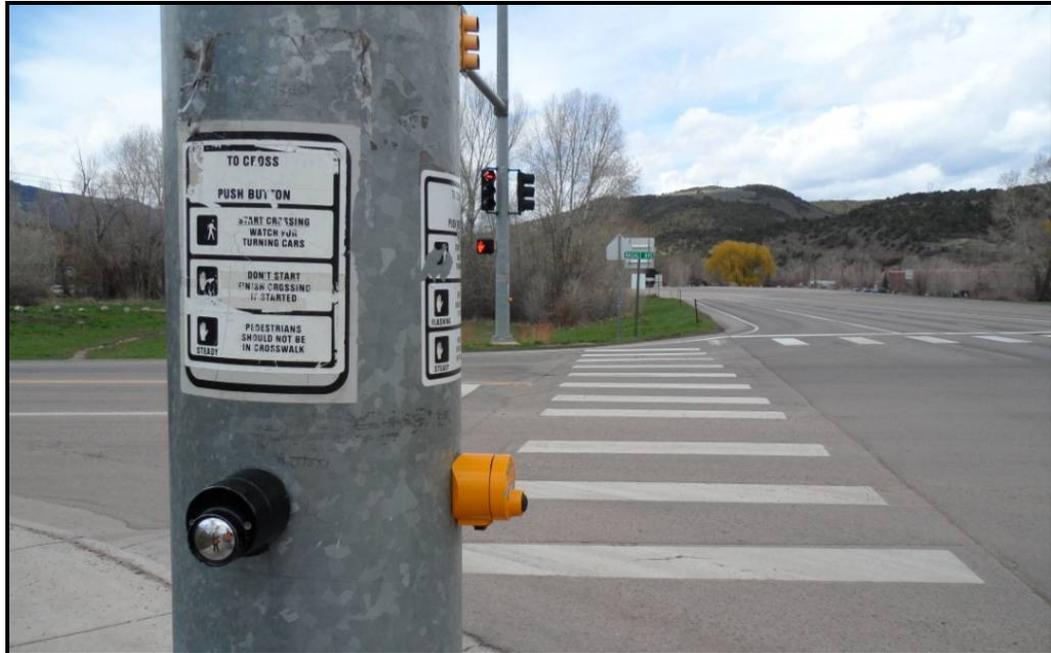
Photo 8: State Highway 82 and Basalt Avenue

- The pedestrian push button on the northeast corner is on the wrong side of the traffic signal pole.
- Pedestrians most likely cross this intersection to utilize the Rio Grande Trail on the south side of Basalt Avenue (observed trail marker leading to the Rio Grande Trail) and the Snowmass Trail to downtown Basalt on the north side.
- Signal heads are aligned properly and lane designation signs are installed on the mast arms.

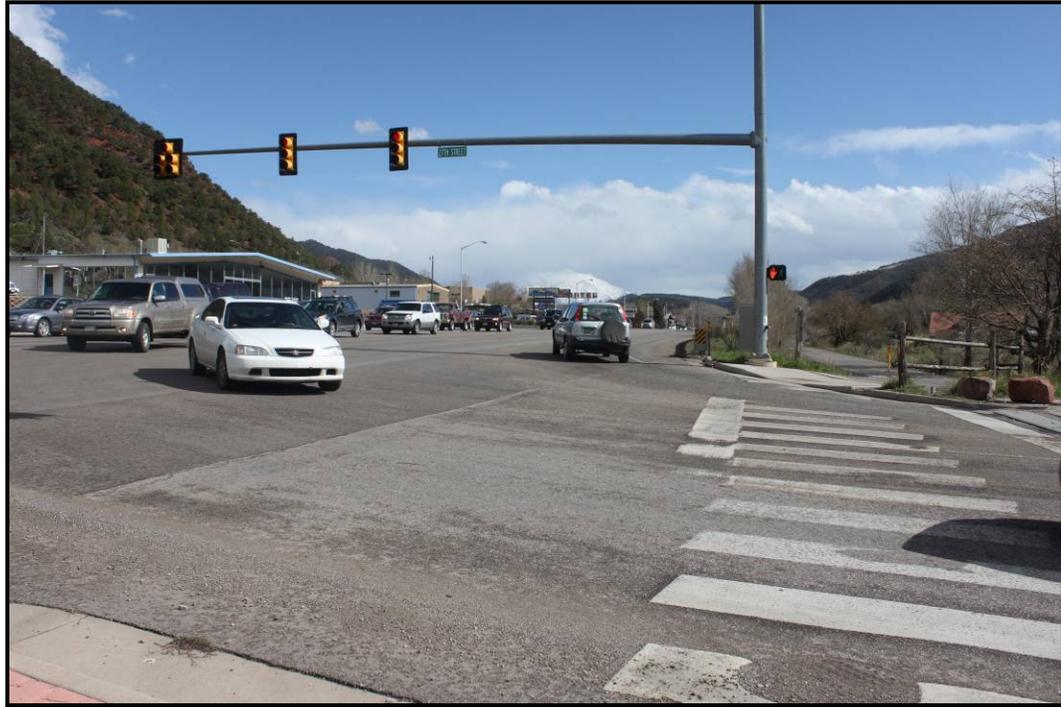
**Photo 9: State Highway 82 and 27<sup>th</sup> Street**

- Drainage elements (gutter pan and inlet) on the westbound approach are in poor condition.

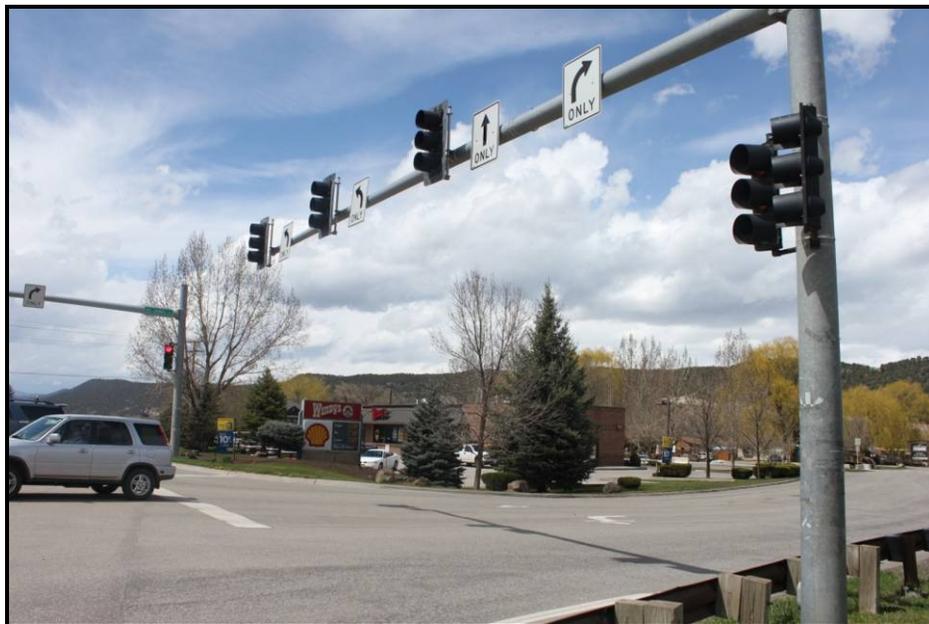
**Photo 10: State Highway 82 and El Jebel Road**

- The right-most signal head for the northbound left-turn has a red ball instead of a red arrow.
- A local resident and business woman stated that the tunnel is highly used and liked by the locals. It is well-lit and has CCTV cameras (provided by and monitored by the local business).
- There are drainage issues on the minor streets with pooling water and collected gravel.
- The median on the northbound approach is beneficial to direct southbound vehicles from impeding on northbound vehicles.
- There are potential plans to develop the area in the southwest quadrant for a recreation center and park-n-ride.
- The bus stop island on the north side of El Jebel Road seems to be more of an obstacle than a helpful element. With worn pavement markings, this island looks as though it is in the middle of the through lane.

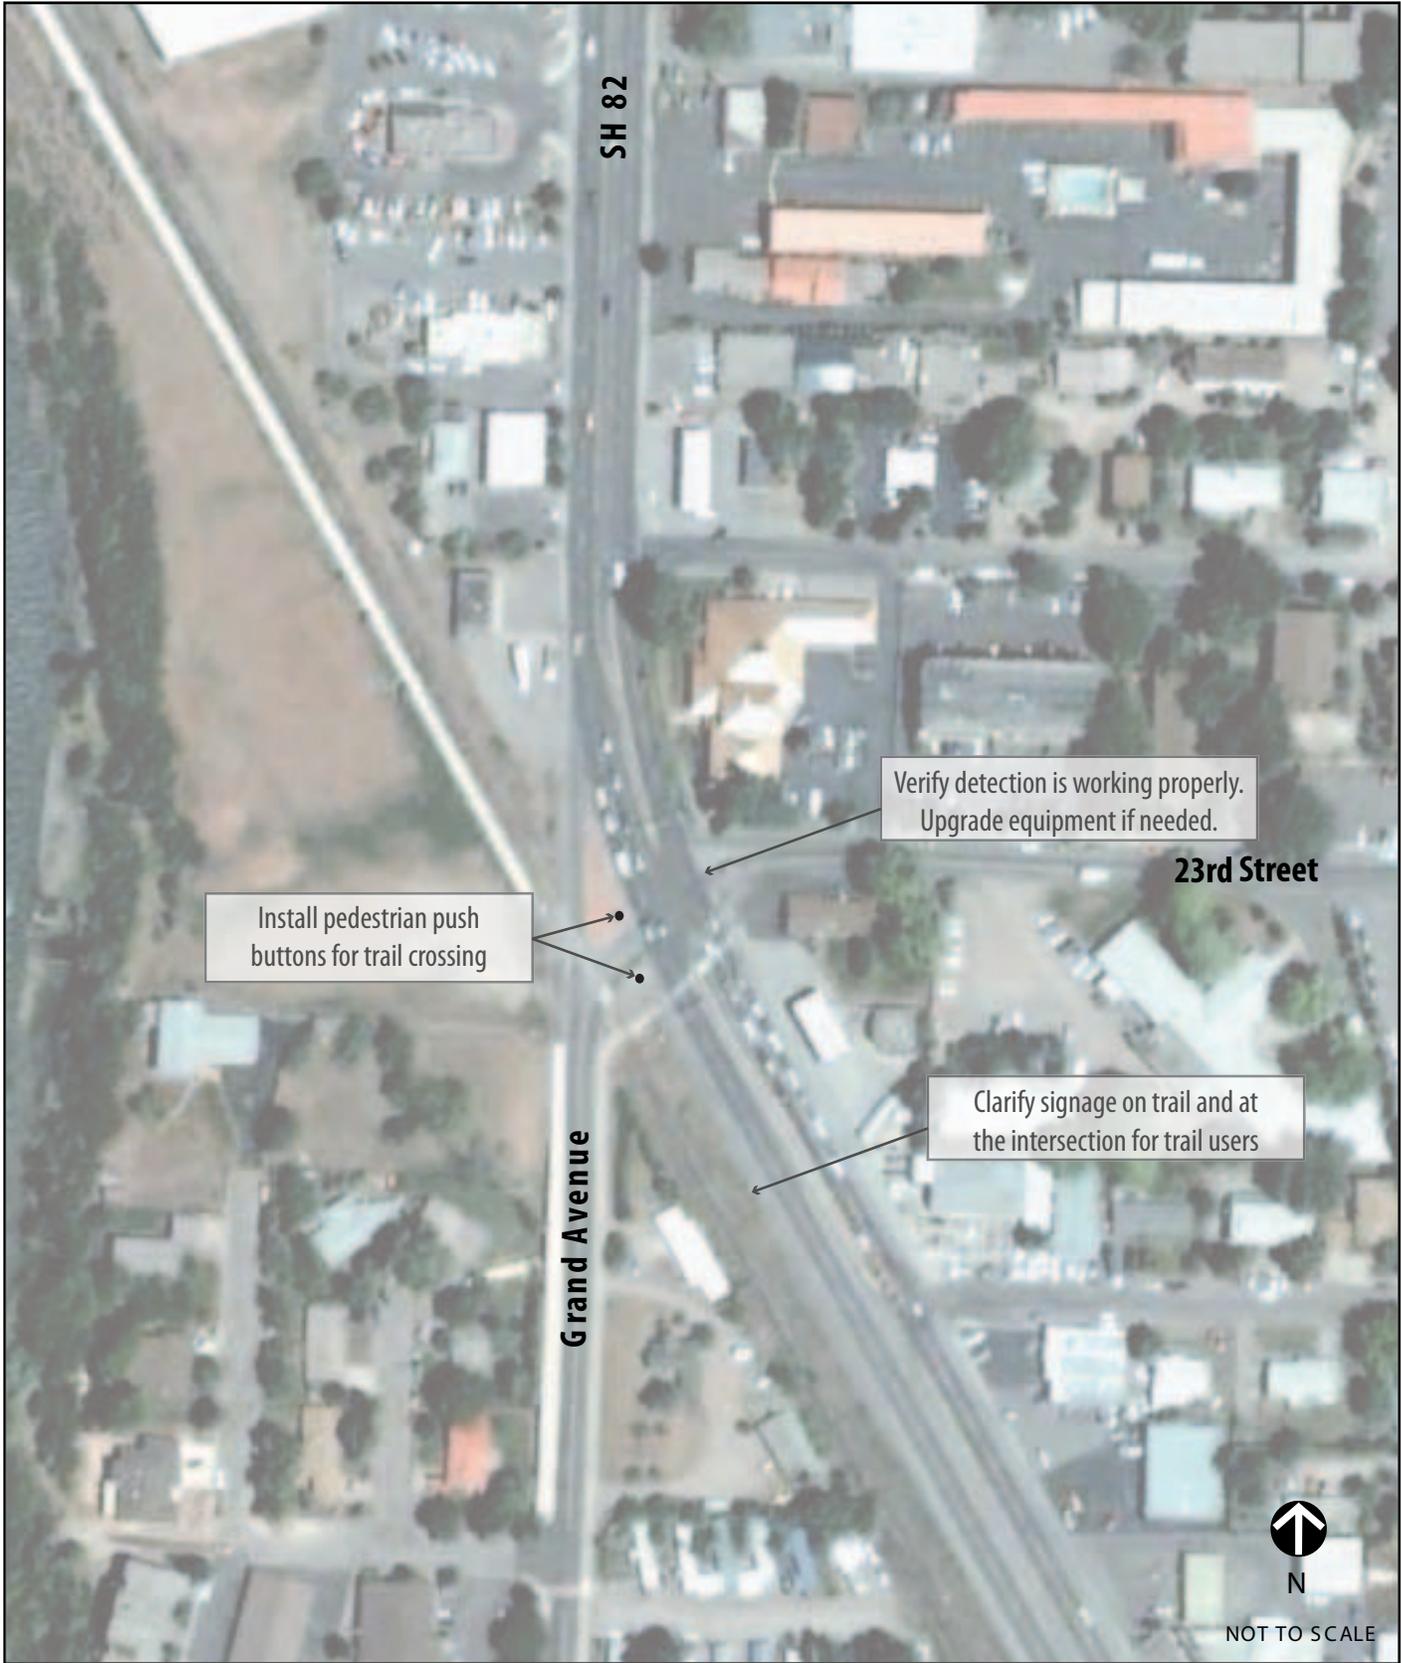
Note: This figure aerial does not reflect recent improvements to the southbound right-turn movement

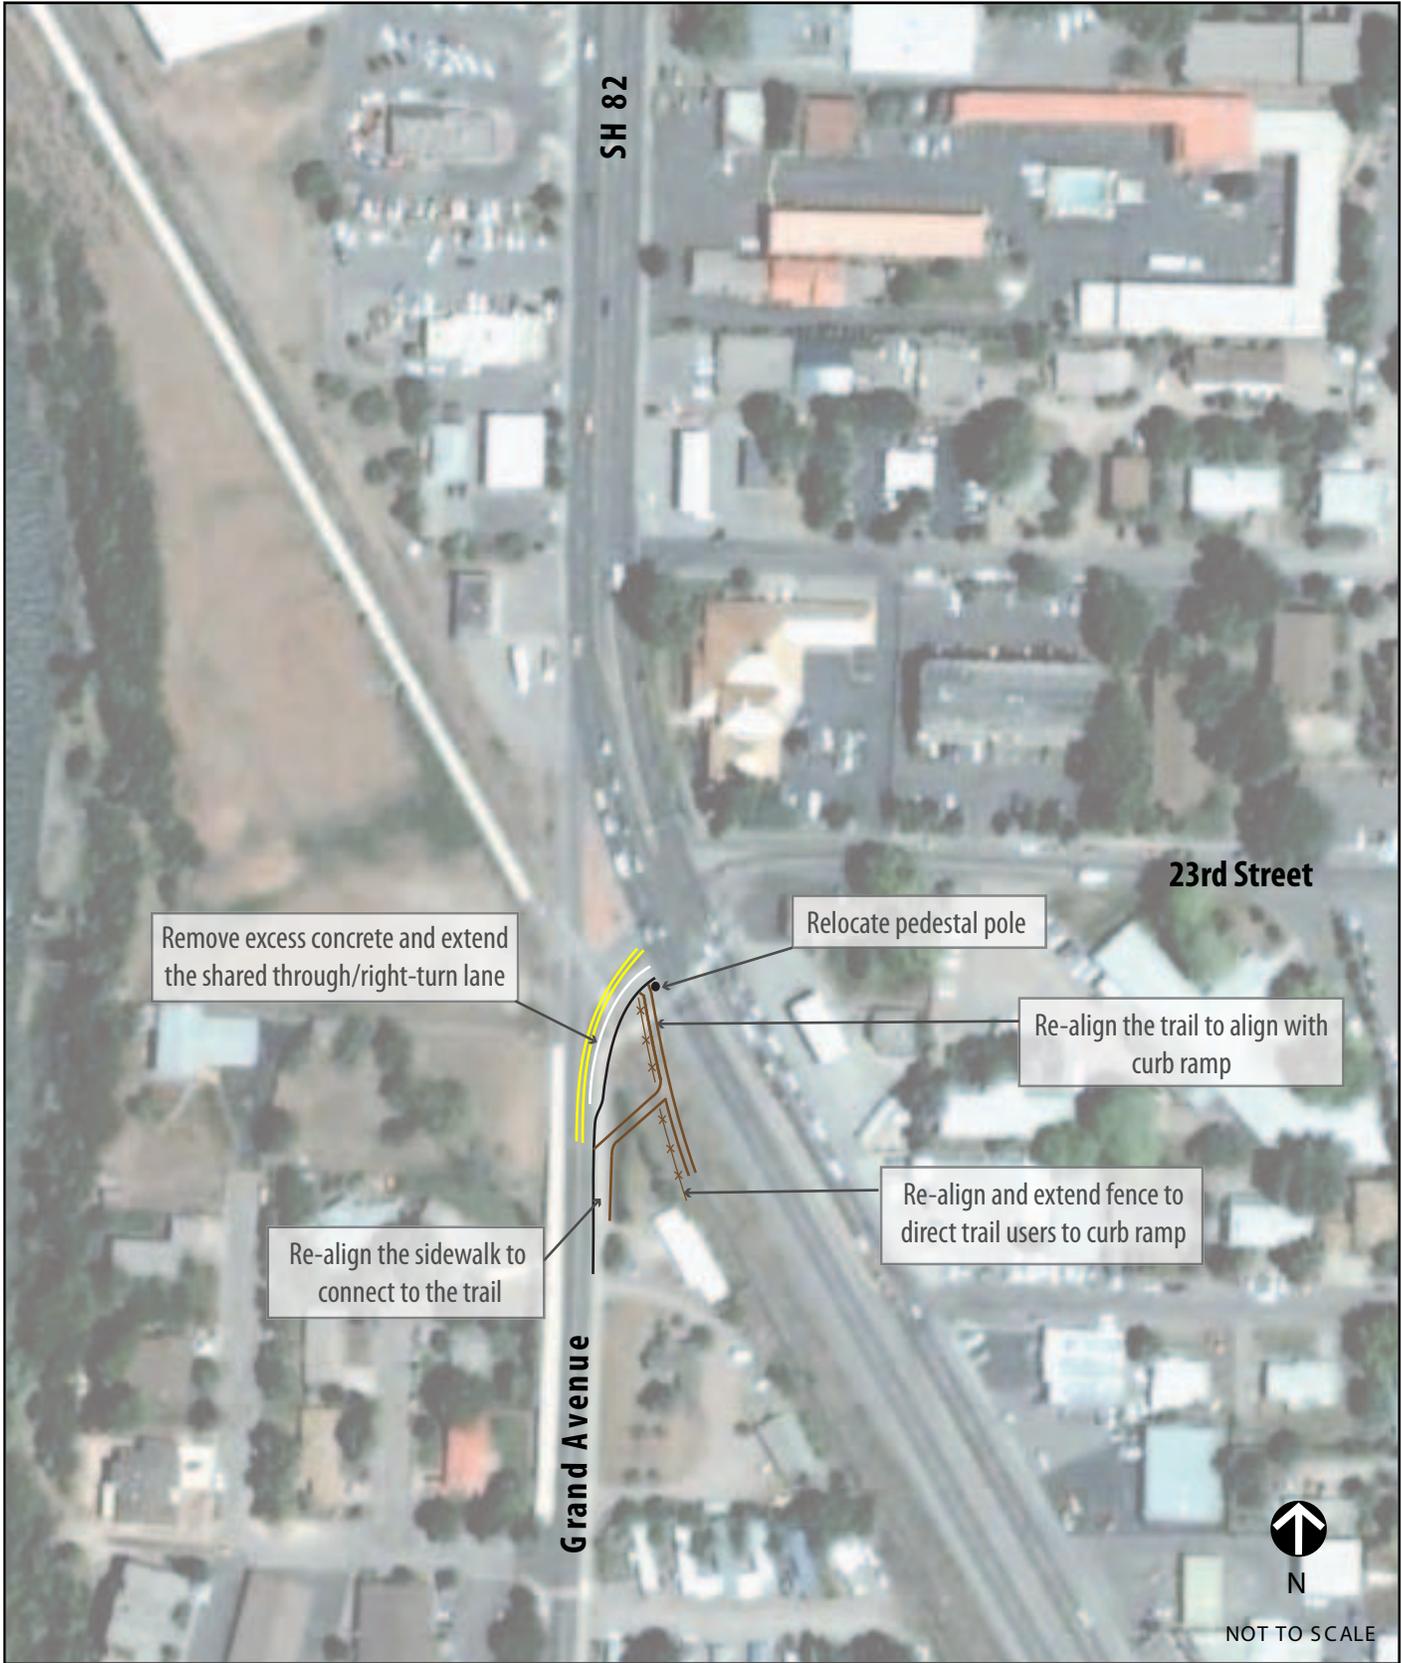
Note: This figure aerial does not reflect recent improvements to the southbound right-turn movement

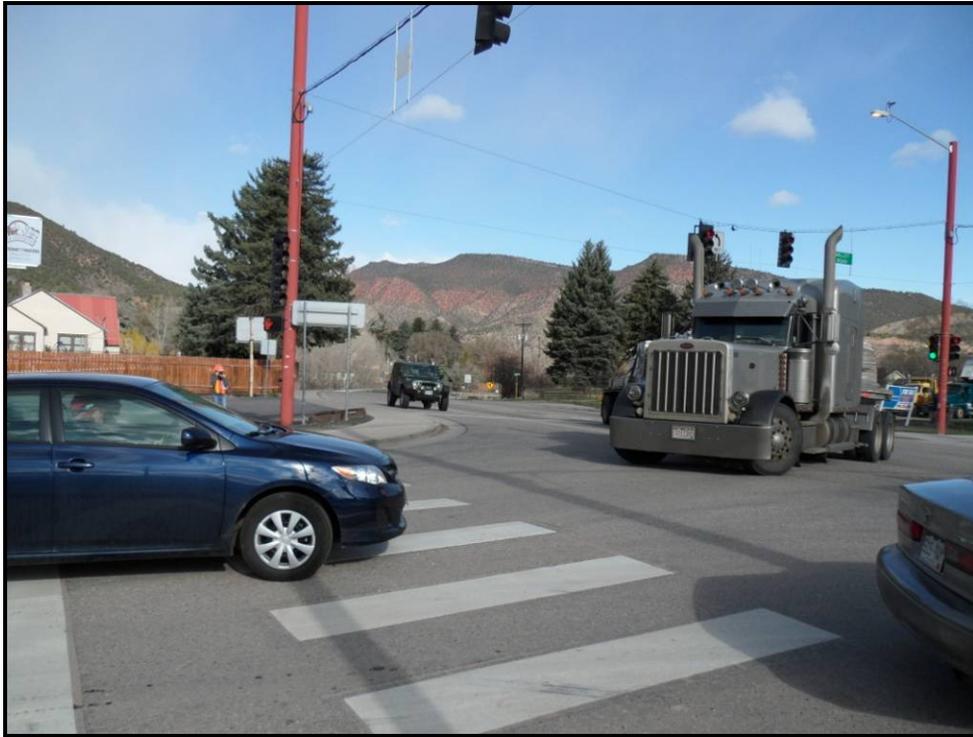
**Photo 12: US Highway 6 and Valley Road**

- There are four luminaires at the intersection, one per traffic signal pole.
- Pedestrian walk and clearance time is shorter than required.
- There are a few driveways close to the intersection on the south side of US Highway 6, just west of the intersection.
