# CDOT Region 3 Intersection Priority Study

June 2011

**Fehr & Peers**  
621 17th Street Suite #2301  
Denver, CO 80293  
303.296.4300

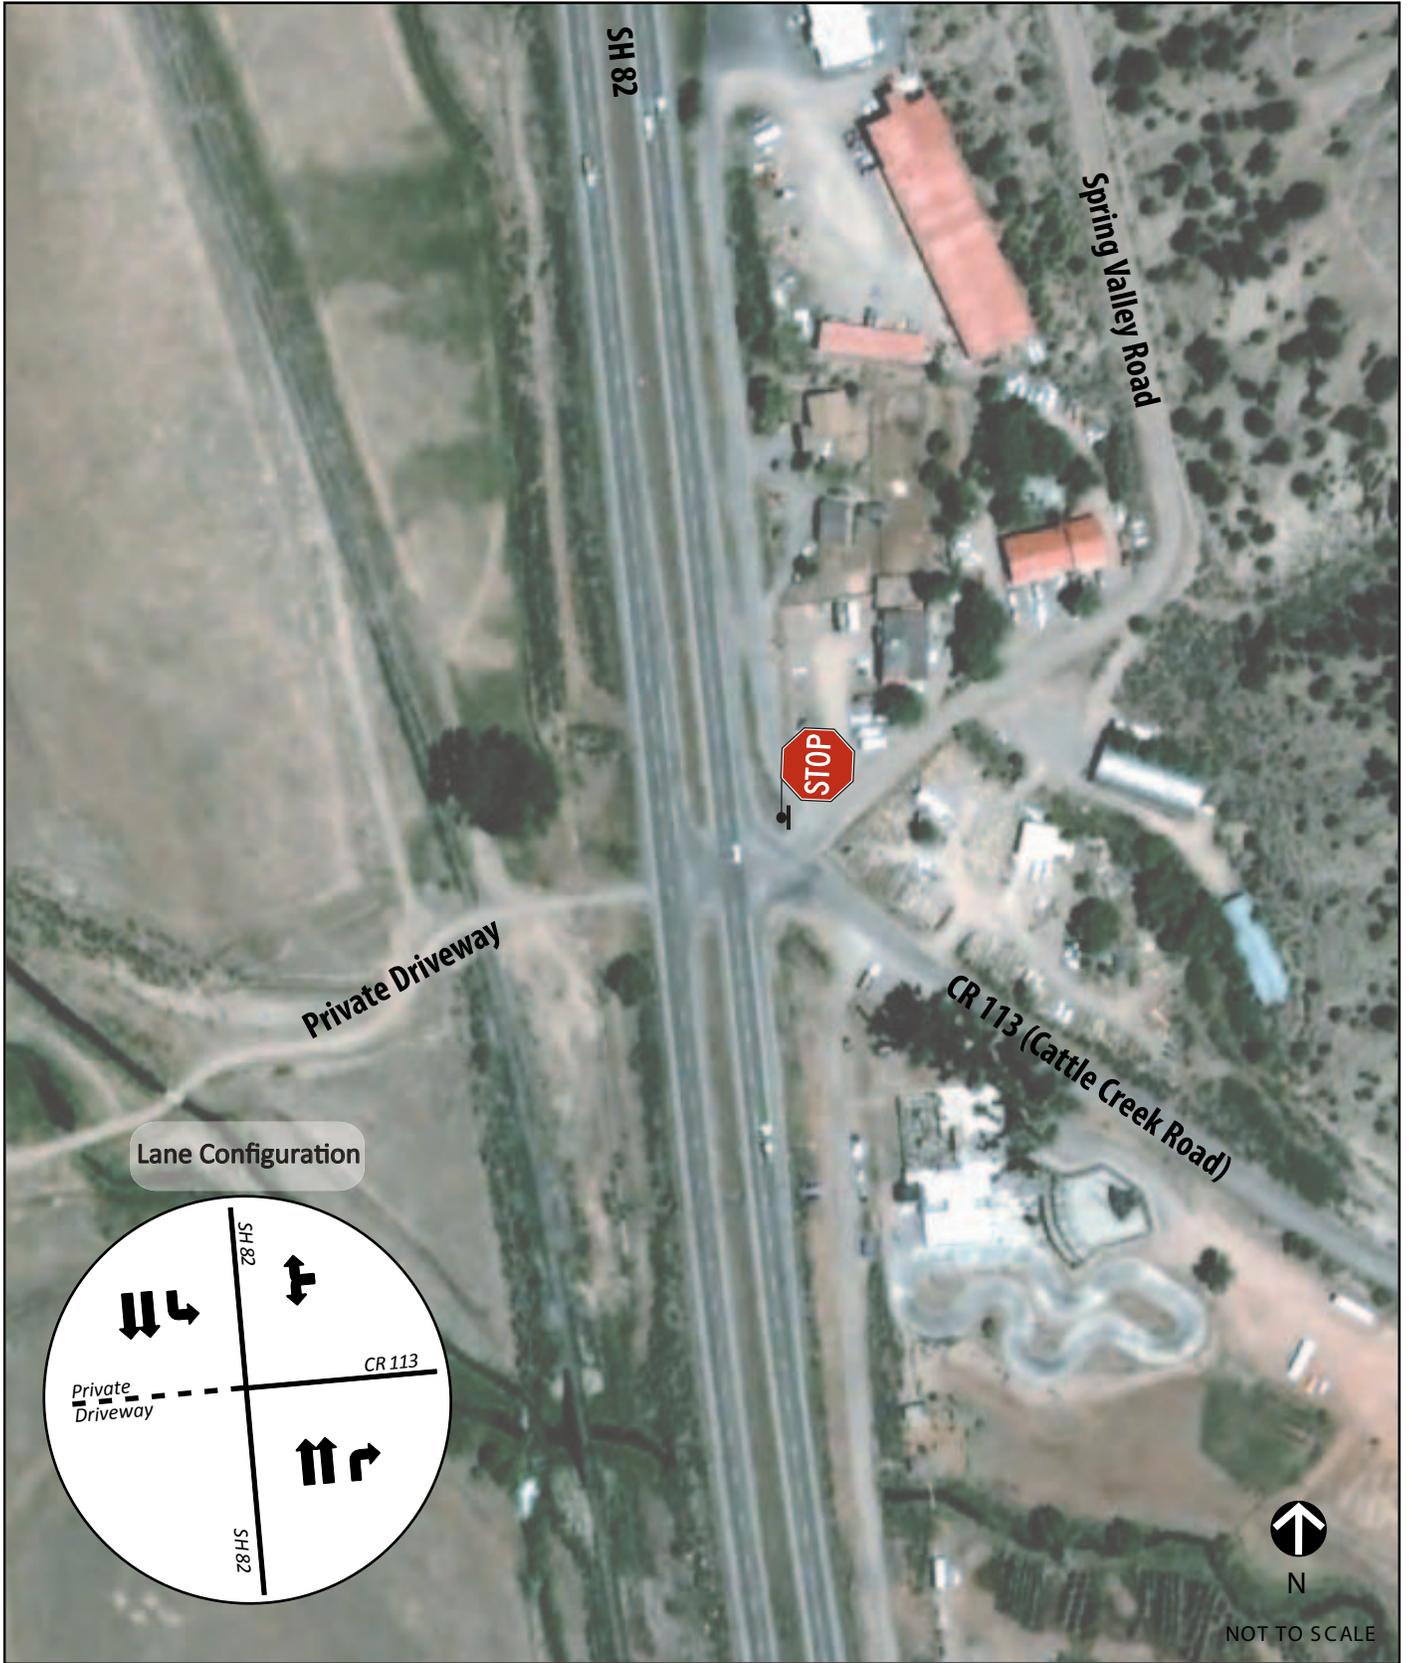
This intersection is unsignalized with the minor approaches stop-controlled. There are many closely spaced driveways and adjacent intersection on the east side. The frontage road and County Road 110 connect to Cattle Creek Road within 50 feet of the intersection and are stop-controlled as well. Refer to Figure 63 for existing conditions.

- Lengthen the acceleration and deceleration lanes to conform to the *CDOT Access Code*.
- Obtain recent traffic counts (turning movement and hourly directional) to verify signal warrants per the MUTCD.
  - If warrants are met, then install a new traffic signal.
- Implement access management techniques.
- Redesign the frontage road and local streets to improve spacing.

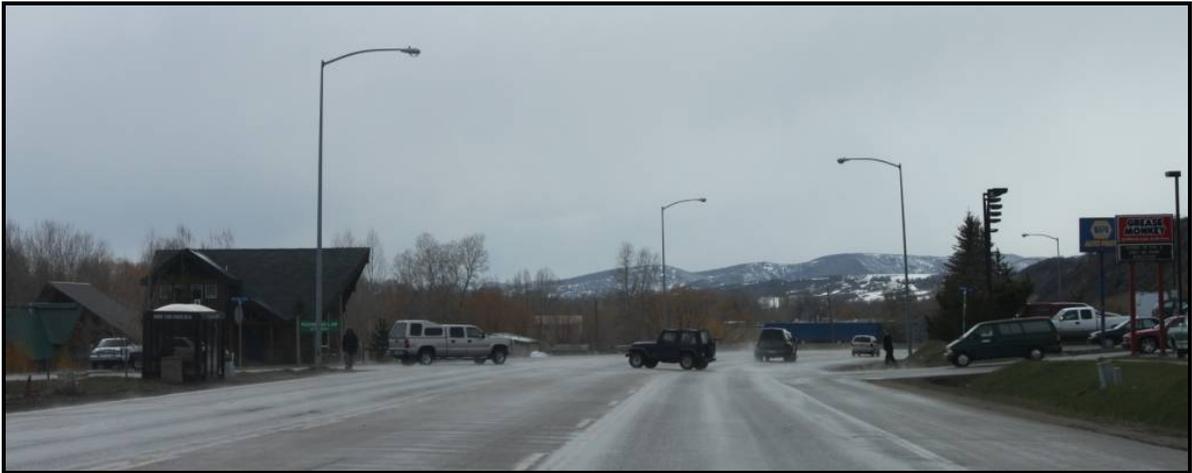
**Photo 13: US Highway 40 at Downhill Drive**

- Minor approaches are skewed.
- There is no westbound right-turn lane.
- There are many commercial driveways on Downhill Drive near the intersection.

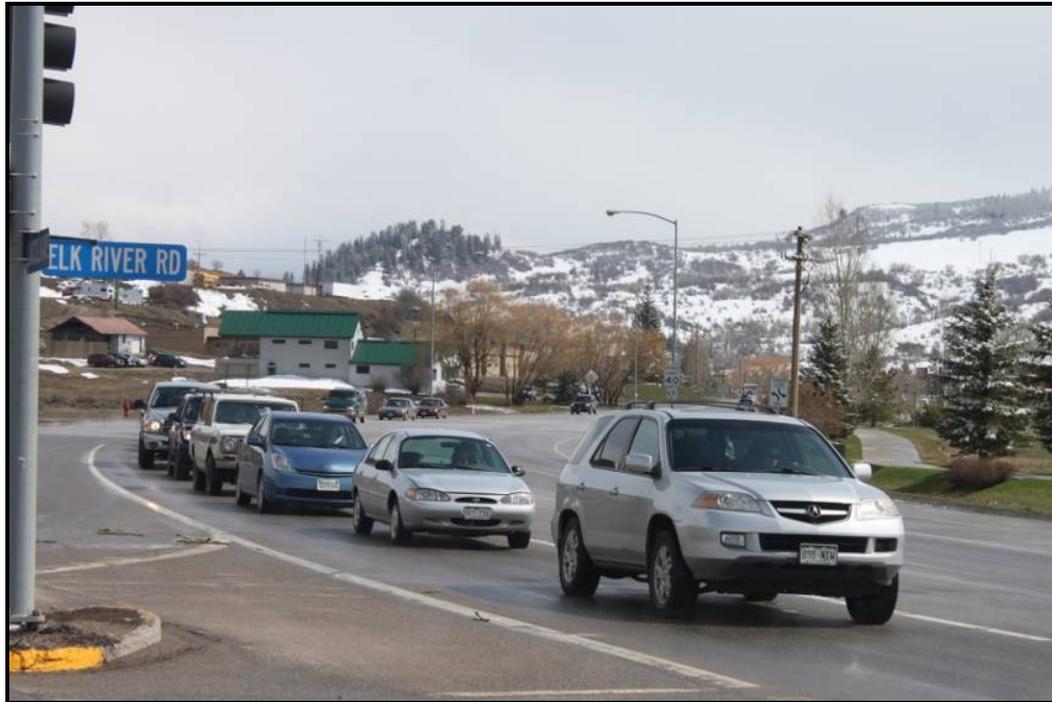
Photo 14: US Highway 40 and Elk River Road

- The westbound right-turn lane is a yielded movement; however, it acts as a free movement by most drivers.

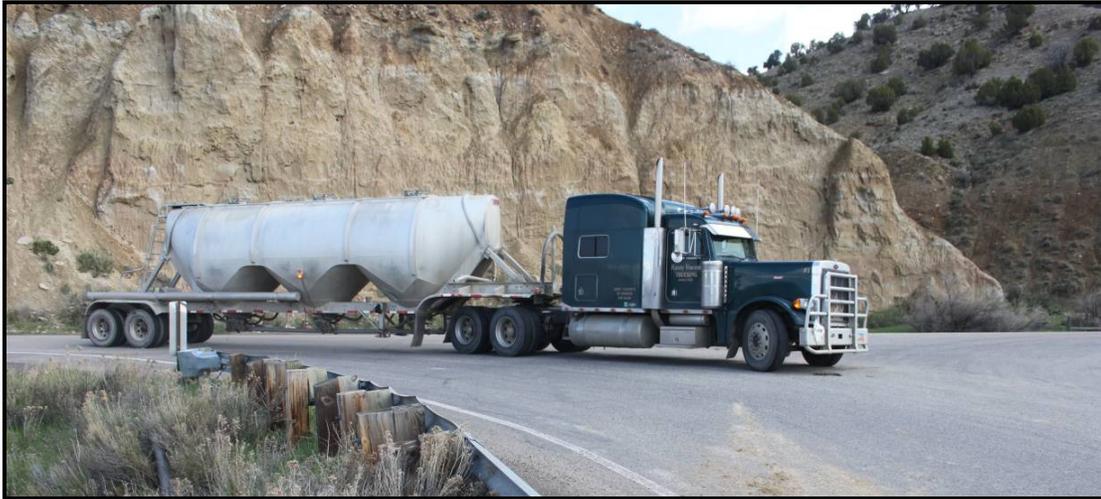
**Photo 15: State Highway 64 and County Road 5**

- The pavement is in fair condition for all approaches.
- The striping is in poor condition on County Road 5.
- There is a set of mail boxes located on the north side of State Highway 64 directly across from County Road 5.
- There was lots of gravel sitting on the edges of the bridge and building up on the guardrail.
- When a wide-load was traveling eastbound, a semi-truck traveling westbound drove on the edge of the pavement to have enough room to pass.

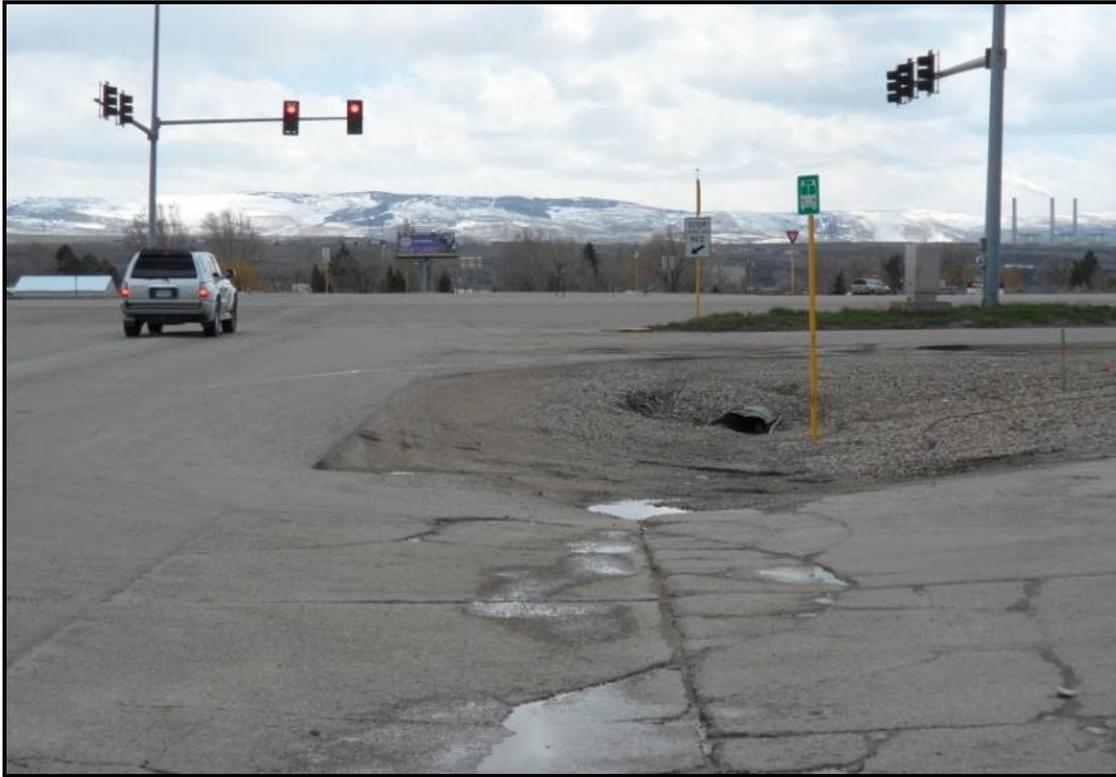
**Photo 16: US Highway 40 and State Highway 13/County Road 7 (Great Divide Road)**

- There is a pedestrian signal located approximately 525 feet north on County Road 7 that is at a trailhead, but is non-operational. The signal heads were off and the push buttons do not engage the pedestrian signal.
- There is a bus stop located at the gas station driveway.
- The northbound signal heads are not aligned above the centerline of the lanes.
- Drainage issues exist on County Road 7 along the driveways.
- The signal does not have any lane designation signs, which could better define the southbound approach.
