**Report No. CDOT-DTD-R-99-2**  
**Quick Study**

# **EFFECT OF MAGNESIUM CHLORIDE ON ASPHALT PAVEMENTS**

**COLORADO DEPARTMENT OF TRANSPORTATION  
RESEARCH BRANCH**

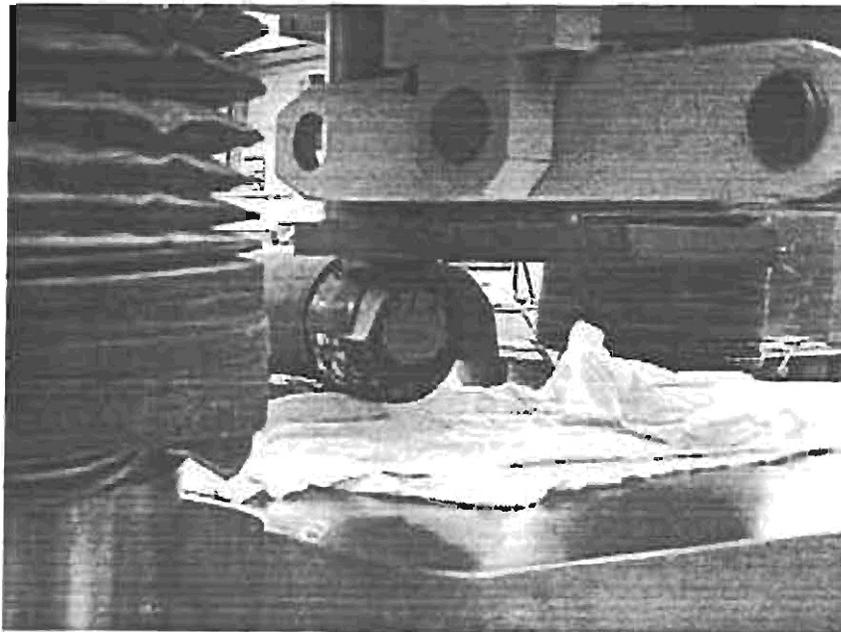
**Photo 1: Shear test setup**

The following photo shows the test setup on the Instron press, where the samples were loaded to failure.

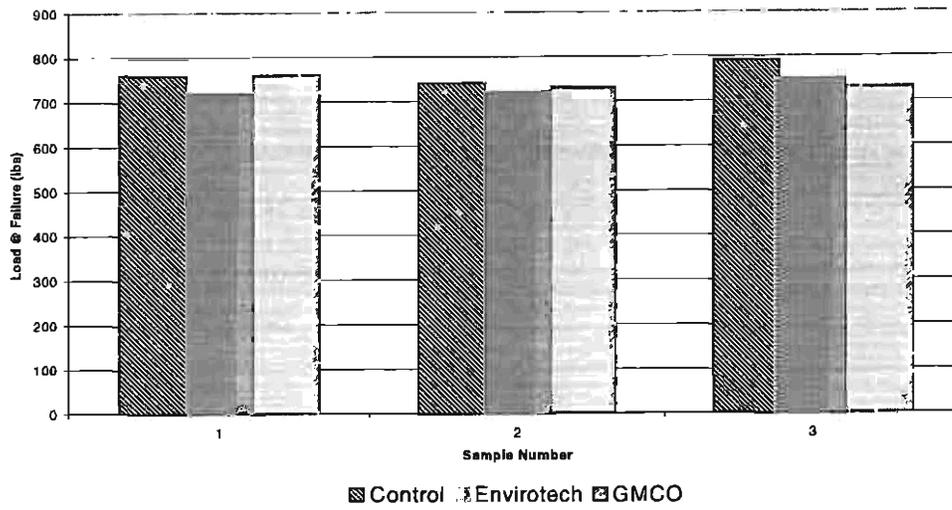
Figure 1

Table 5 below shows the result of the shear tests in tabular form, and figures 1, and 2 give a pictorial representation of these tests.

Shear Test for Mix No 1 (334)

Table 7 above shows the average, maximum, minimum, and range of loads resulting in failure of the samples. Although the control samples indicate somewhat higher values, the magnitudes of the failure loads do not support the hypothesis that magnesium chloride has a deleterious effect on bond strength of an HBP overlay.

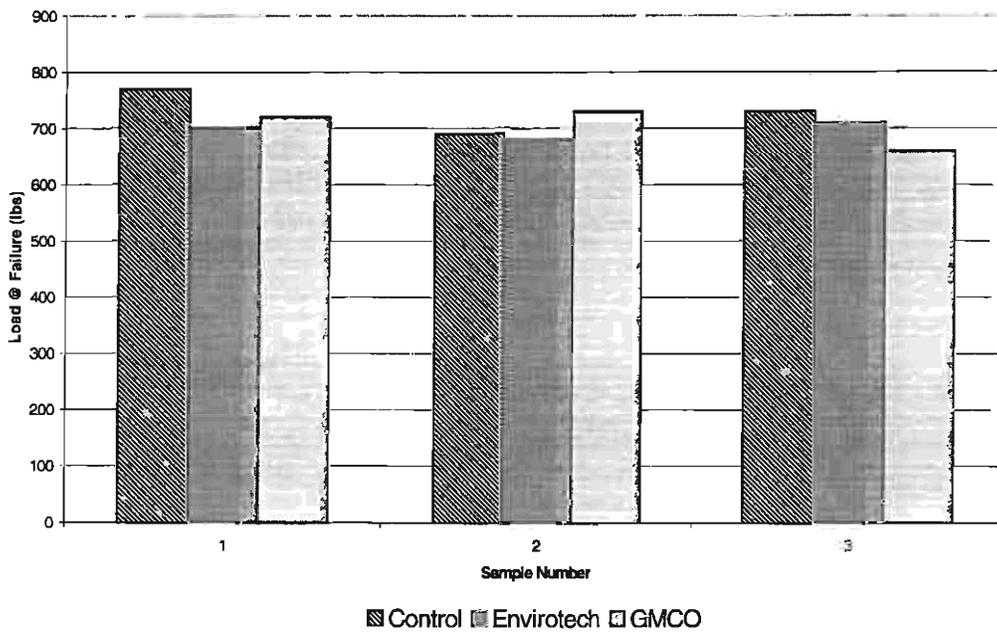
Figure 2

Shear Test for Mix No 2 (326)

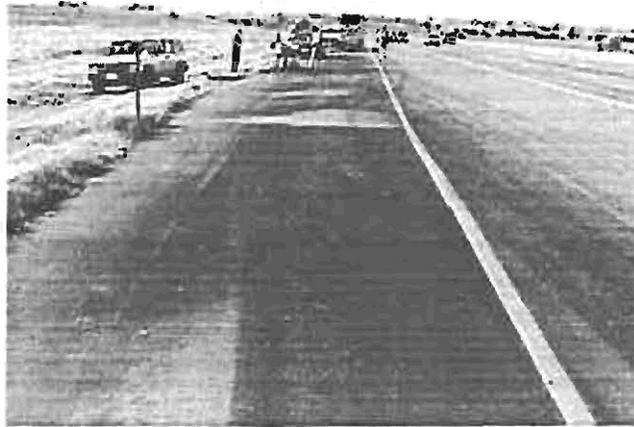
A test section on I-225 was selected for this experiment. A widened roadway section which serves a temporary truck weighing station was pretreated with magnesium chloride at application rates of 20 and 60 gallons per lane-mile. These application rates represent the typical low and high application rates that are used by CDOT maintenance. The chemical was applied one week prior to the testing.

The photo above shows the magnesium chloride treated section. Minimal amount of water was used to wash several areas to achieve a dilution. Excess water was broomed off and dried before installing the PREMARK 20/20 marking tape, which is used in Colorado.

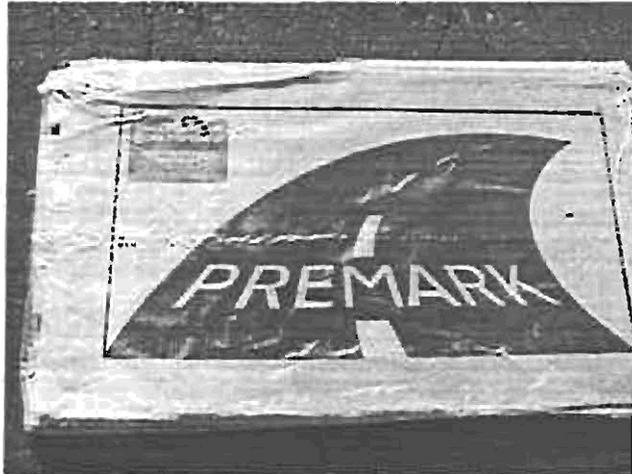
PREMARK 20/20 marking tape is being tested for bonding property

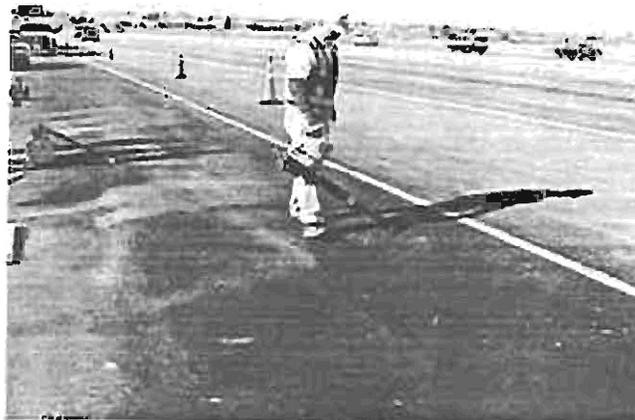
Surface debris is removed with a blower

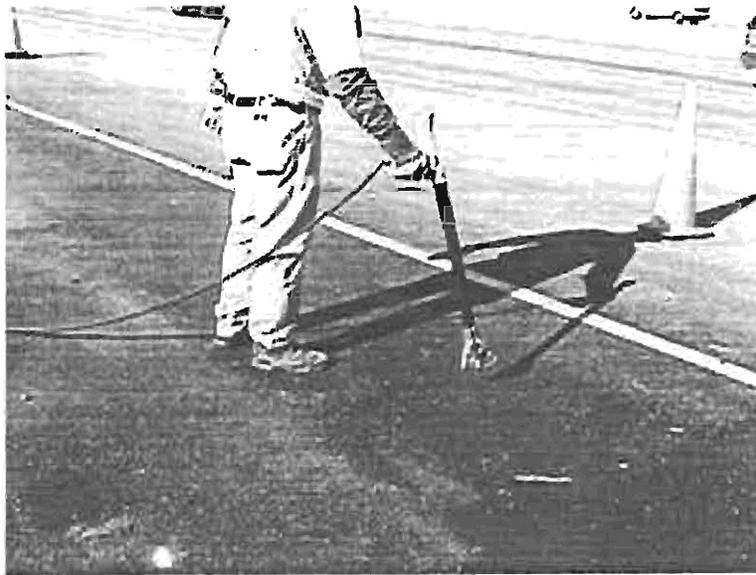
A heat lance is used to remove excess moisture from pavement surface

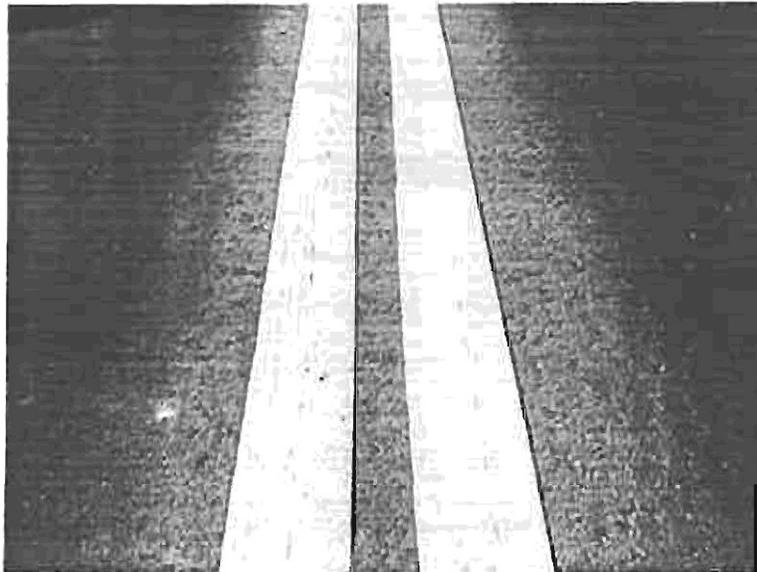
Two types of tape are being installed: PREMARK 20/20 at right  
And a new (not approved) metric version of PREMARK

In the photo the “heat indicators” (indentations) are shown which tell the installer when sufficient temperatures are reached. Also the residual magnesium chloride (light area surrounding the tape) is clearly visible, after all moisture has been removed.

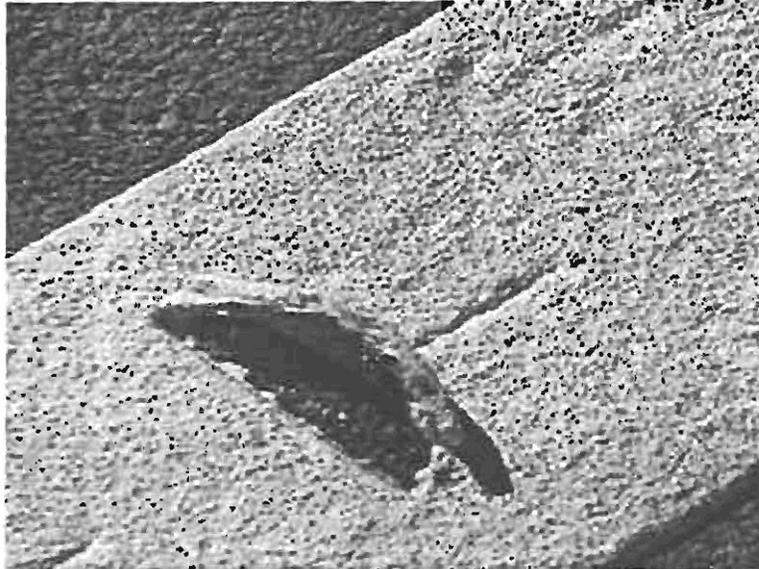
**Undiluted 60 gal/lane-mile magnesium chloride test section**

The "Chisel Test" shows a bond failure for the non-approved Metric version of the marking tape.

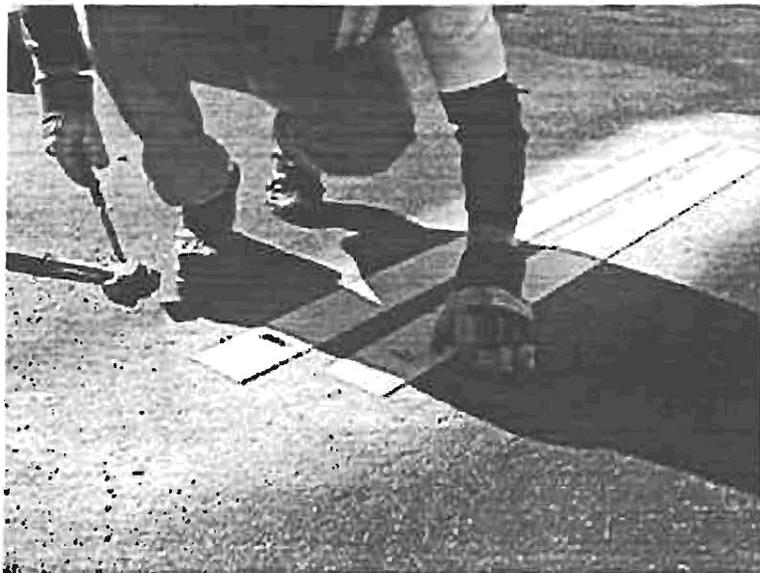
Marginal bond strength for the PREMARK 20/20 (some asphalt aggregate is adhering to the tape)  
On the 60 gal/lane-mile application rate section

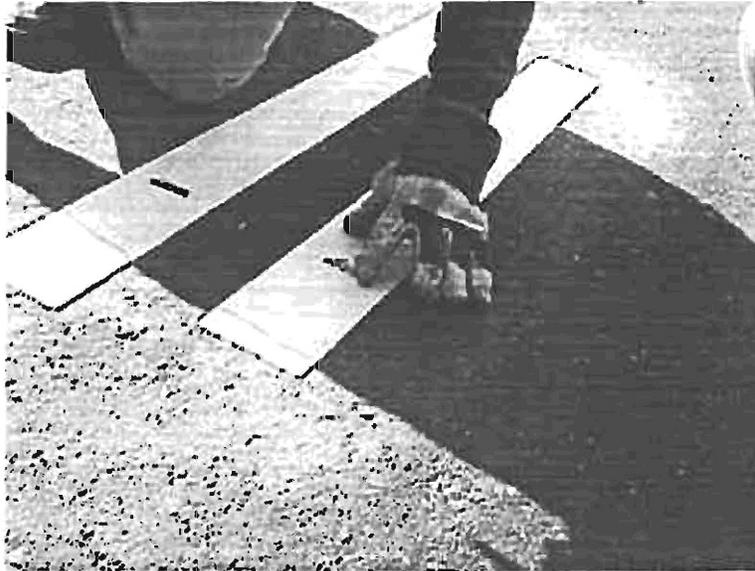
The results of the chisel test for PREMARK 20/20 on the right shows good bonding on the 20 gal/lane-mile undiluted test location. Failure is clear on the metric tape, which has no embedded aggregate on the tape. Note the residual magnesium chloride left after cleaning and drying.

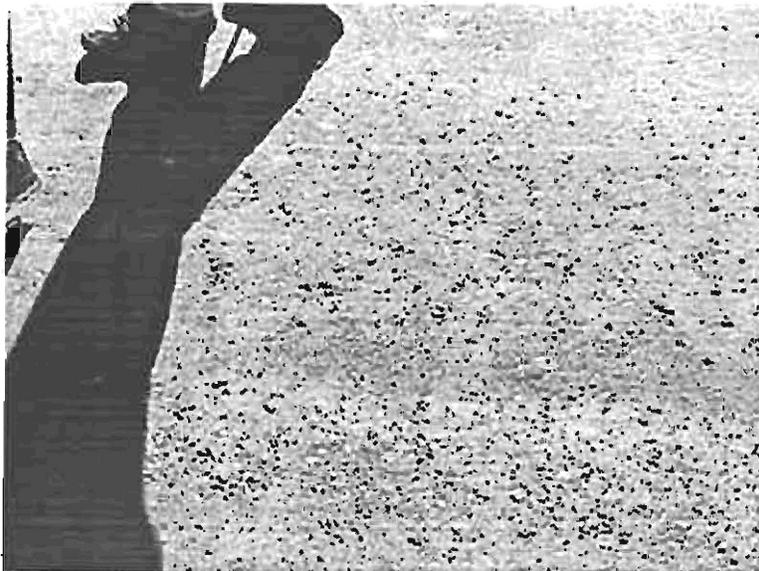
**20 gal/lane-mile Test Section (diluted by washing and drying)**

“Washed” segment of pavement still shows traces of magnesium chloride  
Marking tape is placed between the residual mag chloride area

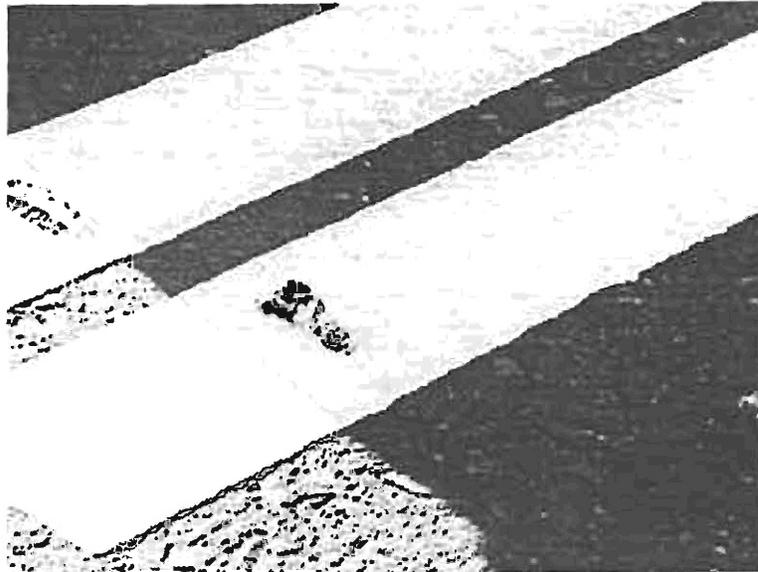
The washed section shows equally good bond properties

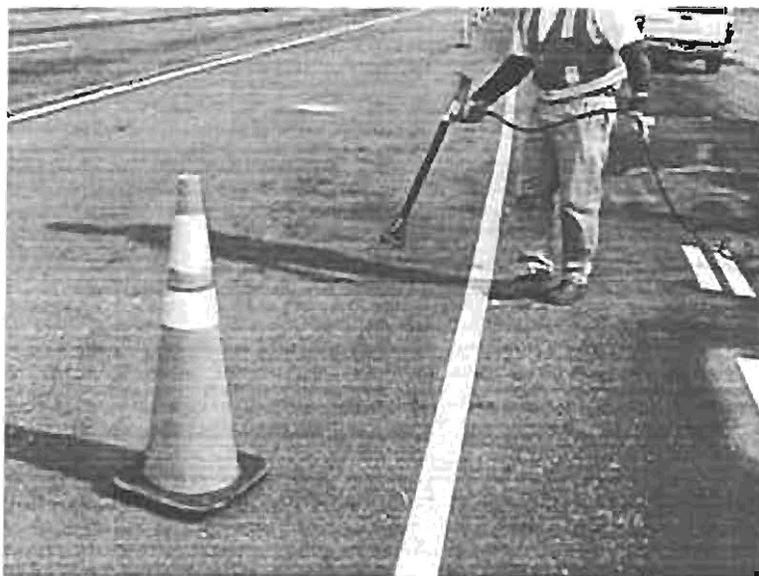
**Test Section without magnesium chloride**

Heat lance is used to remove any potential moisture

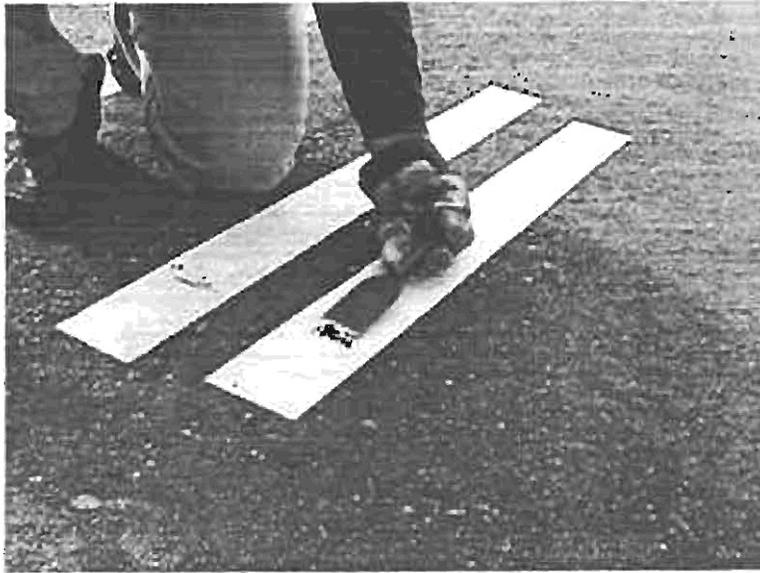
The resulting chisel test indicates good bond strength for the PREMARK 20/20. The metric tape shows marginal results. Although relative good bond strength is achieved. The tape itself seems to be brittle, and tends to crack.

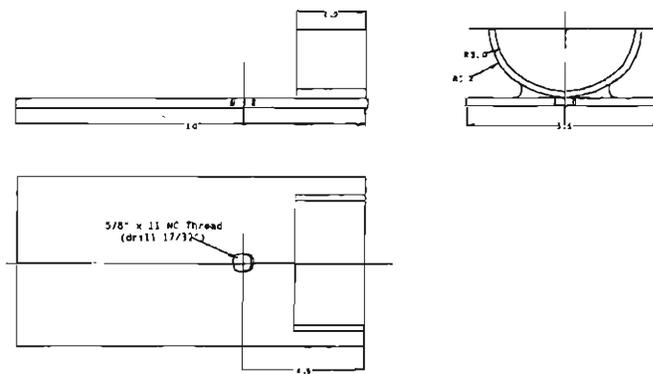
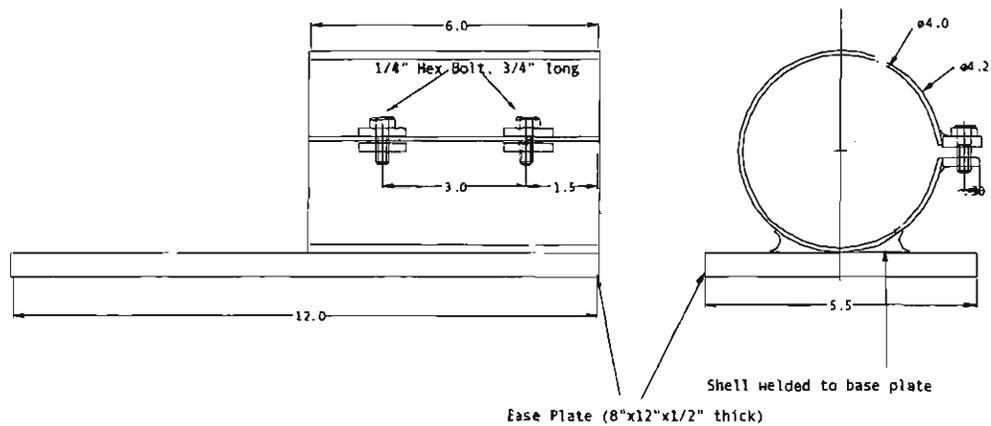
## Shear Test Apparatus

Top Plate

Shear Test Jig for Magnesium Chloride Quick Study  
Bottom Plate

Since no testing device was readily available, a fairly inexpensive apparatus was designed and built by Research personnel and Geology, using a discarded core drill barrel and scrap metal. A sketch of the design can be found in Appendix A.
