Report No. CDOT-DTD-R-2005-01

**EVALUATION OF THE FRP-RETROFITTED ARCHES IN THE
CASTLEWOOD CANYON BRIDGE**

December 2004

**COLORADO DEPARTMENT OF TRANSPORTATION
RESEARCH BRANCH**

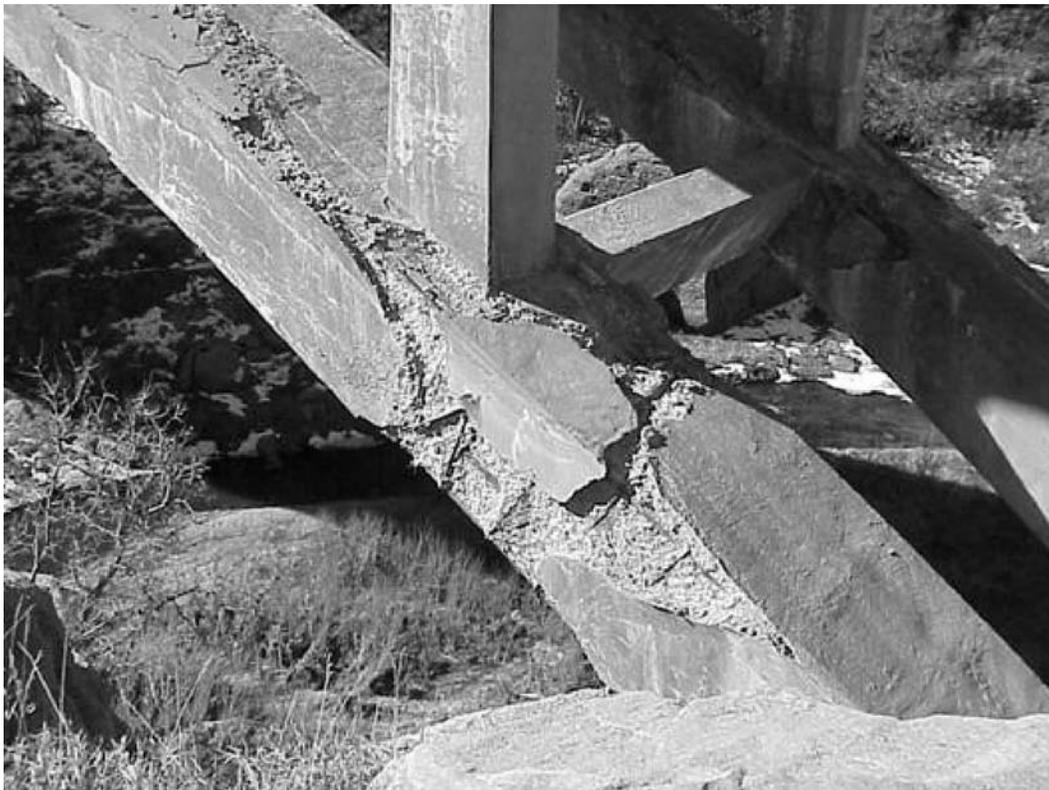
Figure 1-3 Spalling concrete and exposed steel before repair

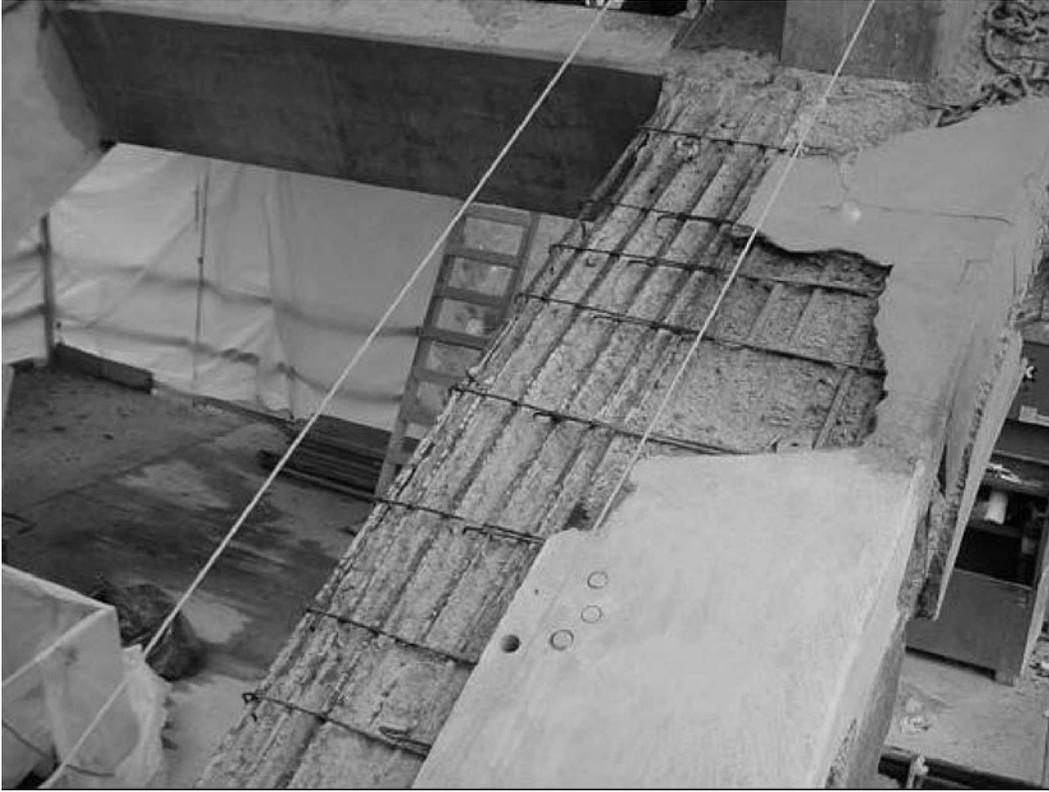
Figure 1-4 Spalling concrete and exposed steel during construction

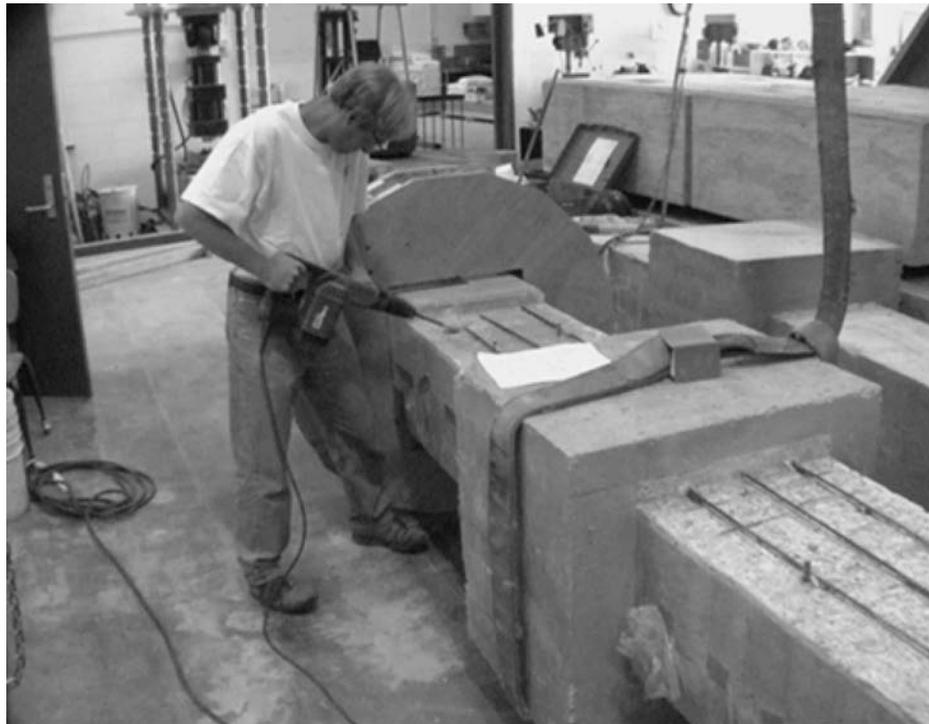
After the forms were removed, the concrete in the blockouts of the FR specimen had to be roughened and cleaned to prepare the surfaces for the application of the shotcrete. The surfaces were chipped with a power chisel, care being taken to avoid striking the rebar, until the surface was rough and all loose concrete had been removed. (see Figure 1-37). The surface was thoroughly cleaned and then soaked with wet rags and sealed with plastic for at least 24 hours prior to placing the shotcrete.

Figure 1-37 The surface of the FR specimen was roughened and prepared for shotcrete. The specimen was turned upside-down by rolling on large plywood wheels, like the one supporting the far end of the specimen, to avoid disturbing the shotcrete before it had fully cured.

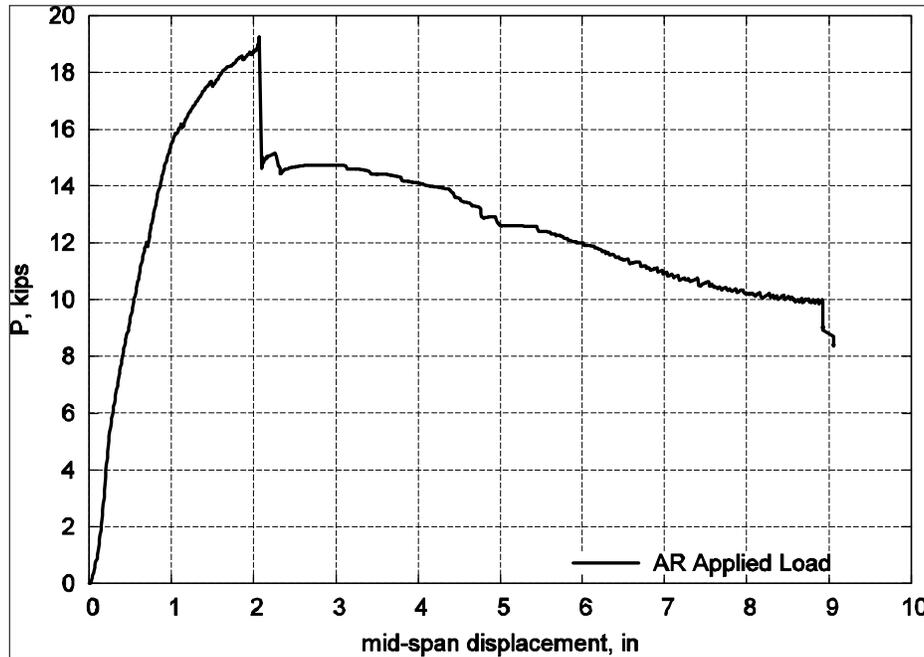
spalling in the compressed concrete at the top, though the spalling could not be observed at that time. P began to rise less quickly at $\Delta = 0.84$ inch and reached a peak of 61.9 kips at $\Delta = 1.46$ inch. P decreased slowly until $\Delta = 5.2$ inches, when crushing of the concrete caused a more rapid loss of strength.

Figure 1-57 Plot of P vs. mid-span deflection for FC specimen

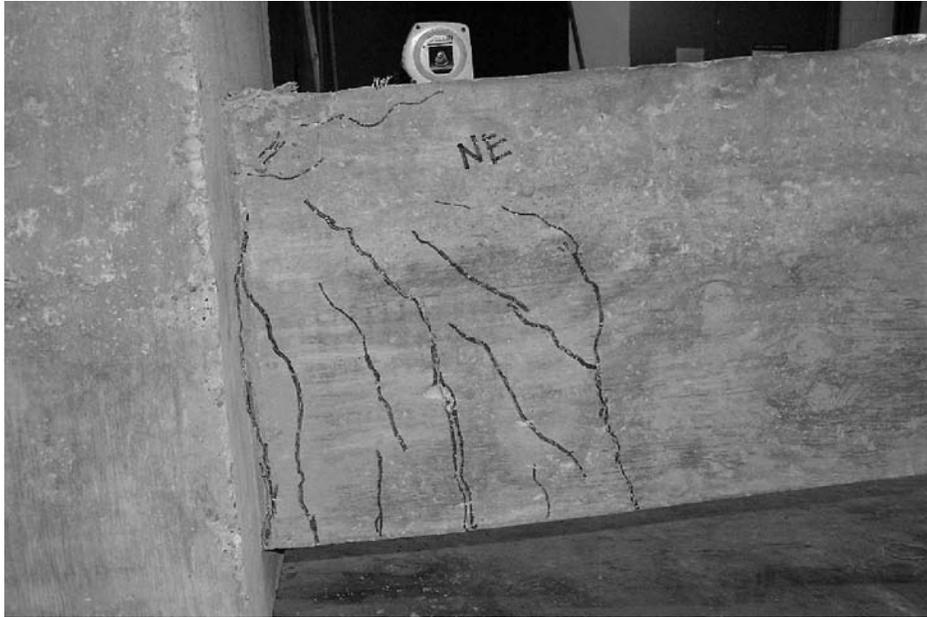
Figure 1-59 Final crack pattern at non-critical side of specimen (FC specimen)

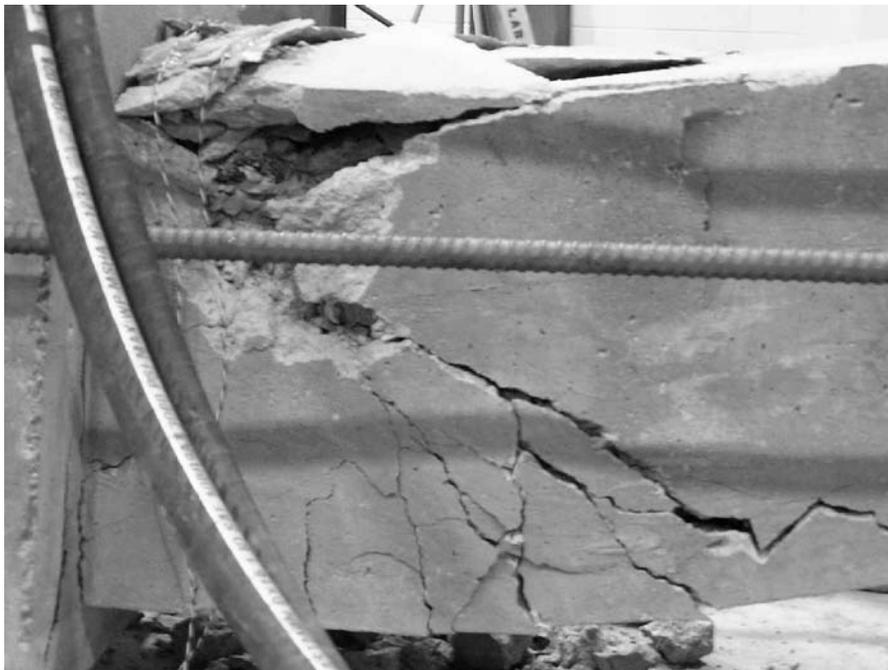
Figure 1-60 Final crack pattern at critical side of specimen (FC specimen)

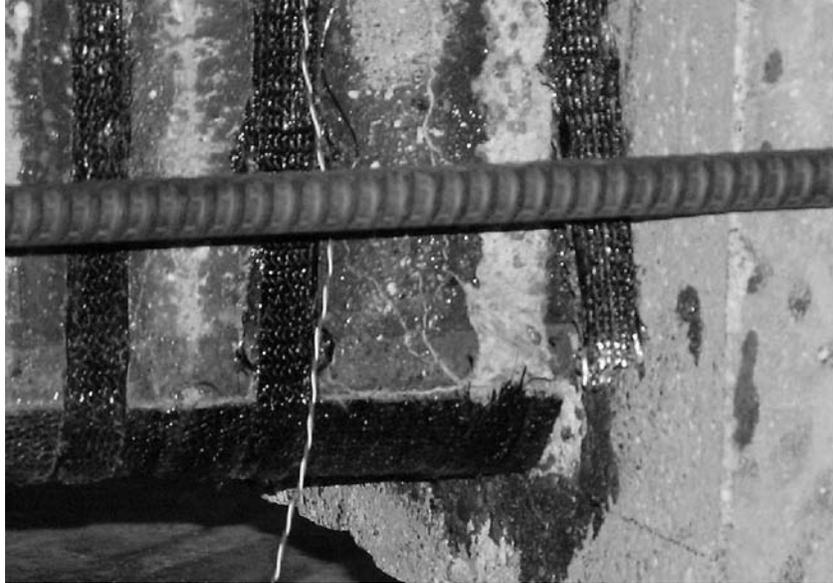
Figure 1-64 Ruptured transverse Fibrewrap where shotcrete pulled away from FR specimen

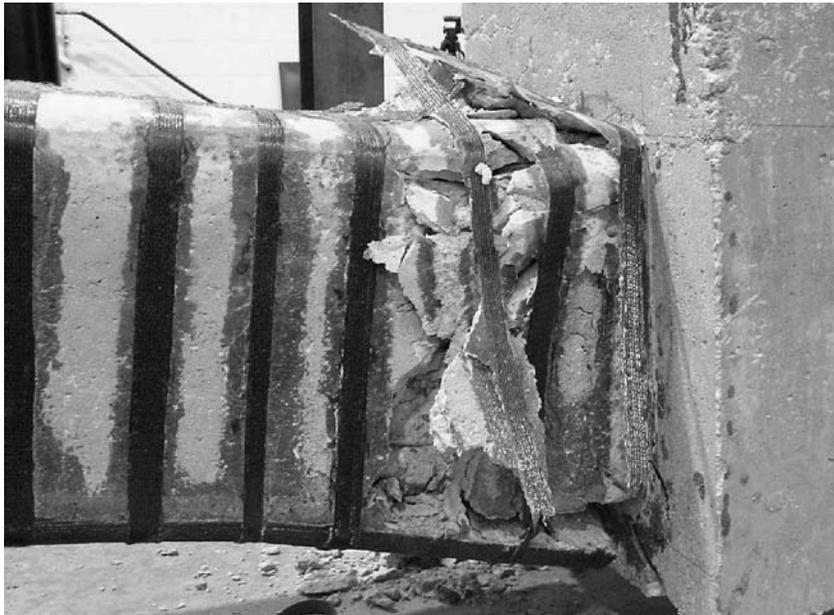
Figure 1-65 Critical section of FR specimen

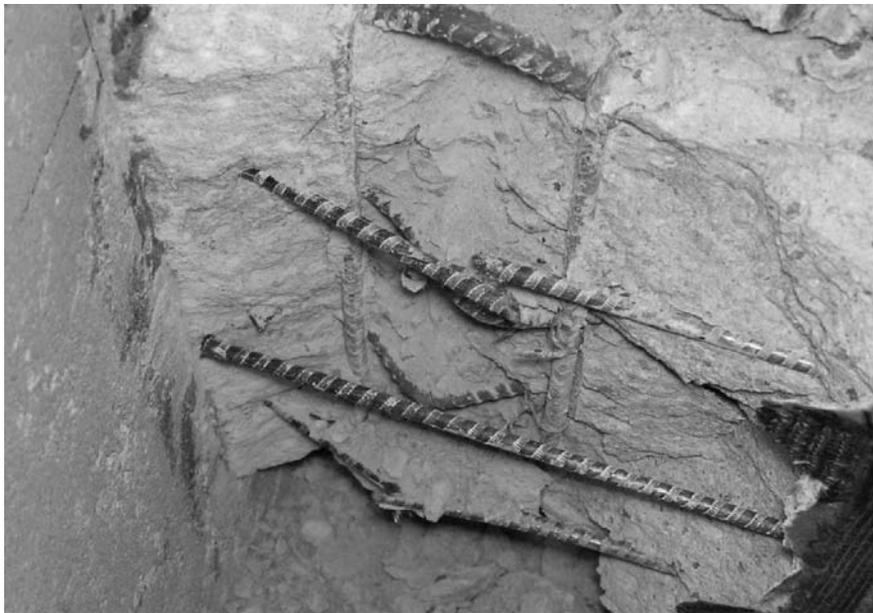
**Figure 1-67 Buckled rebars and ruptured Leadline at the top of the FR critical section
(Note: specimen is lying on its side and loose debris has been cleared away.)**

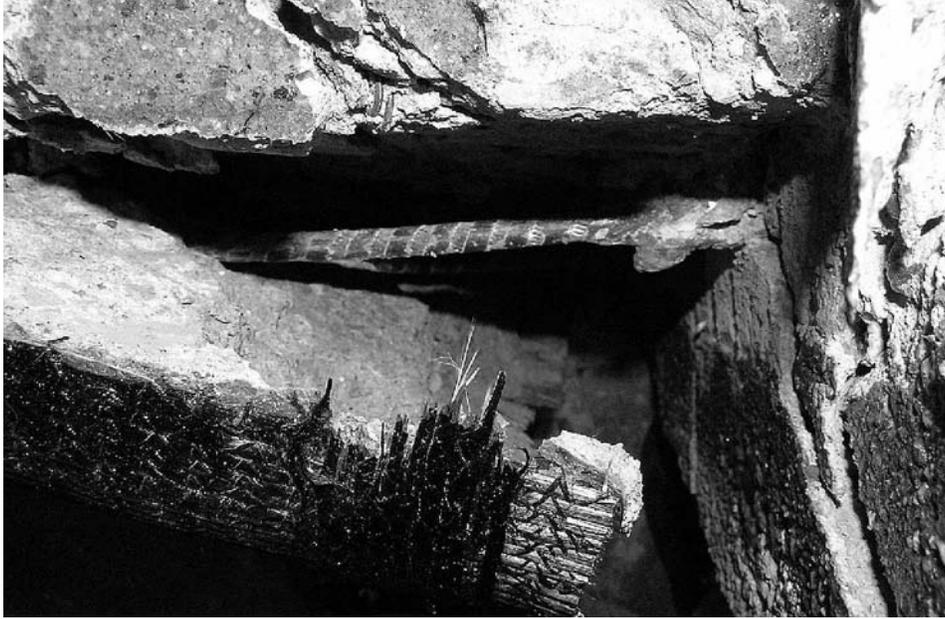
Figure 1-68 FR specimen tension Leadline between concrete and shotcrete

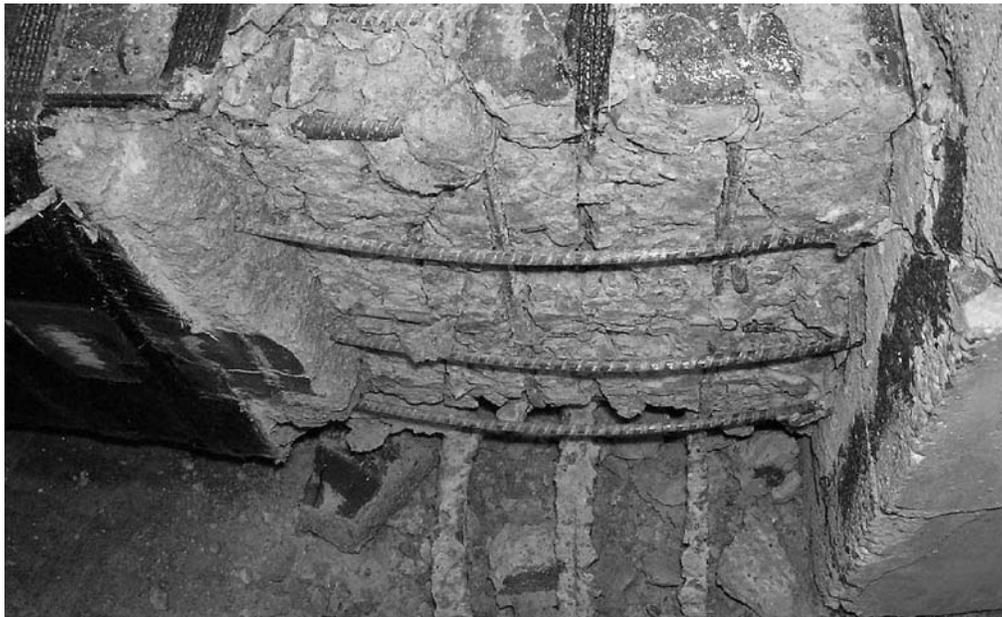
Figure 1-69 FR specimen tension Leadline with loose shotcrete patch removed

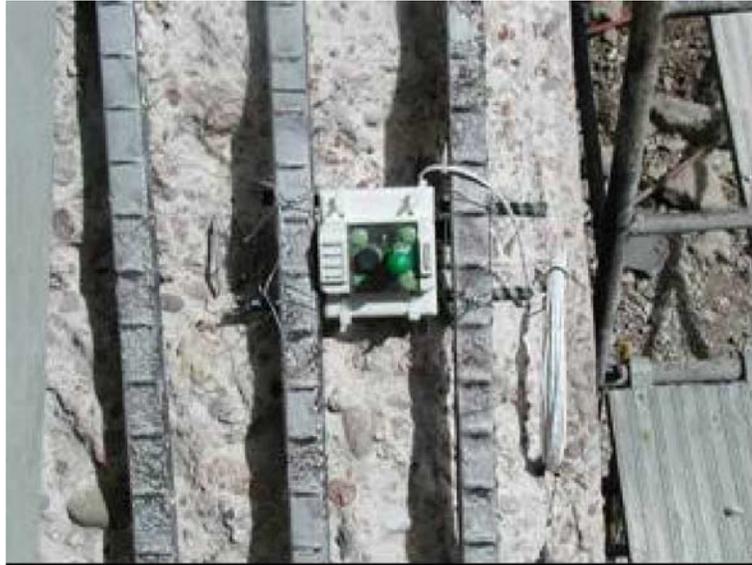
Figure 3-10 An installed corrosion sensor (ECI-1)

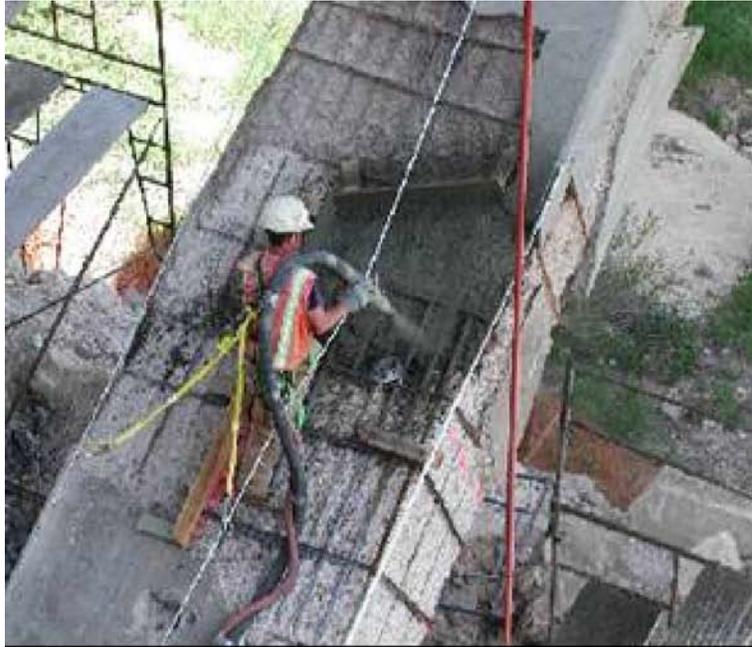
Figure 3-12 Shotcreting over corrosion instrument

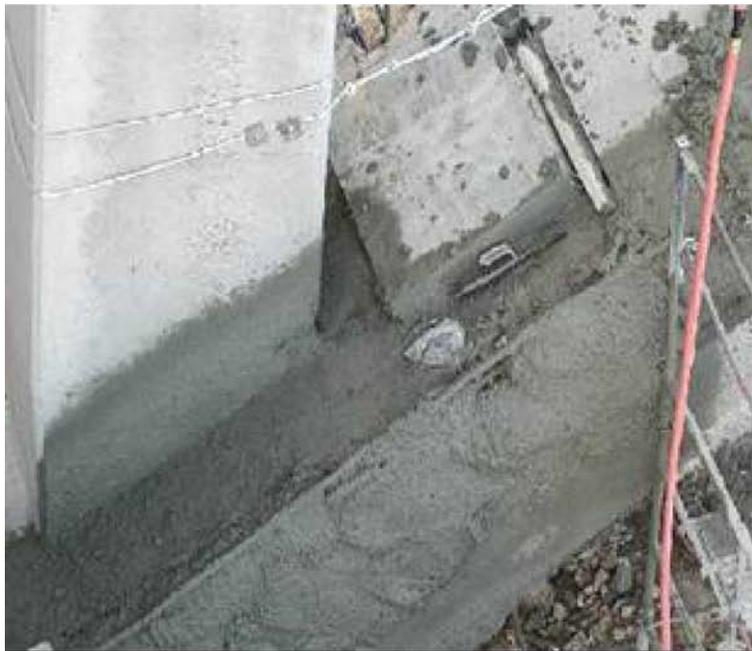
Figure 3-13 The embedded corrosion instrument (ECI-1)
