MONITORING OF NONDURABLE SHALE FILLS IN SEMI-ARID CLIMATES

Majid Derakhshandeh

Colorado Department of Highways
4201 East Arkansas Avenue
Denver, Colorado 80222

Final Report
December, 1989

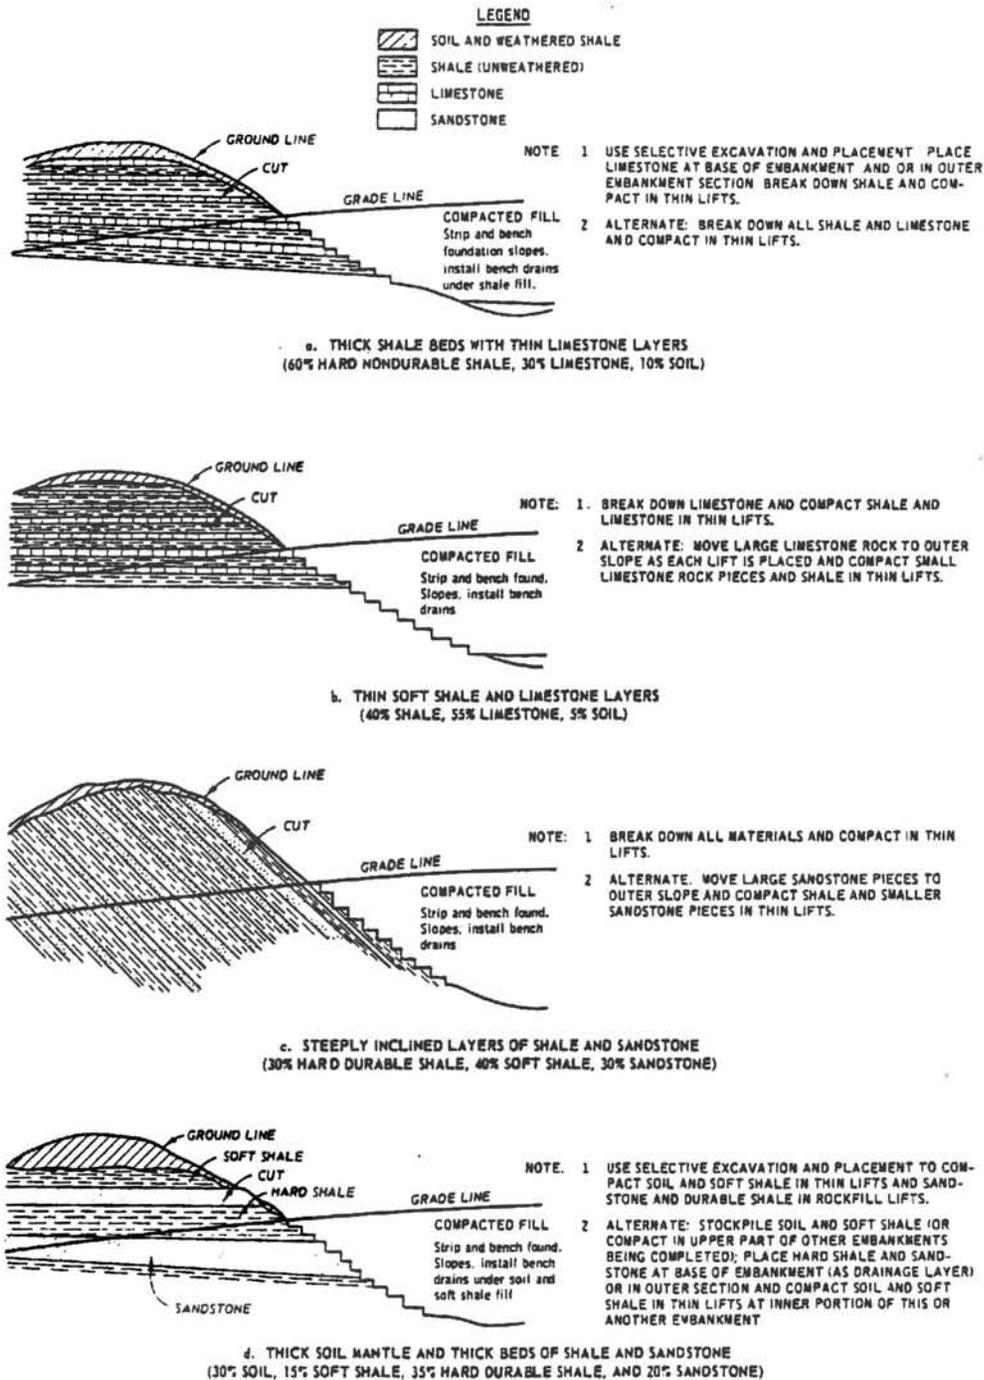
Figure 1. Examples of difficult shale and stratigraphic features and possible solutions

embankment. On the other hand, if the 10 ft. thick section contained 60 percent or more of durable shale, then the material could be used as rockfill. But, in this case, an excessive amount of fine-ground material could prevent adequate compaction between durable rocks, as illustrated in Figure 2b. In the upper drawing of Figure 2b, the loose soil between rocks would soften and deform under infiltrating water, resulting in large settlements. Therefore, the following specifications, as outlined in Reference No. 5, should be considered to prevent post-construction problems in shale embankments.

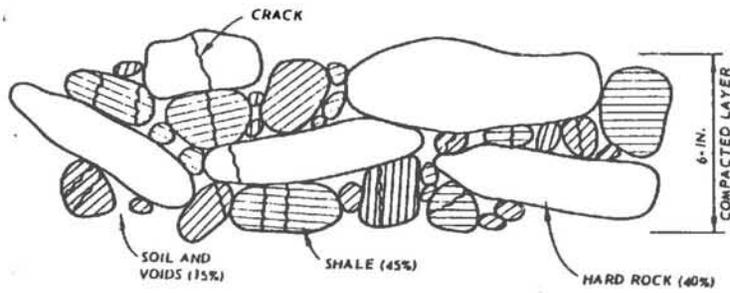
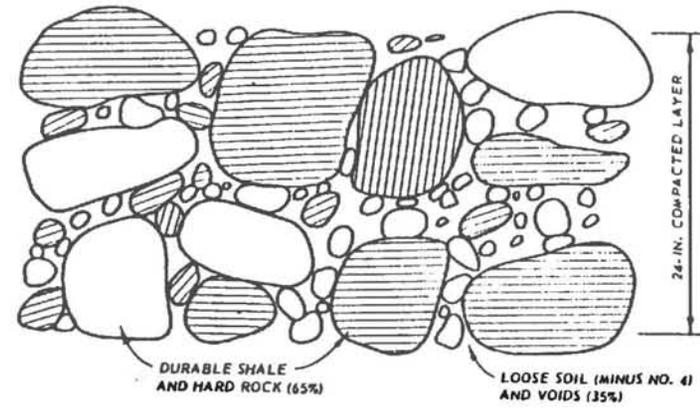
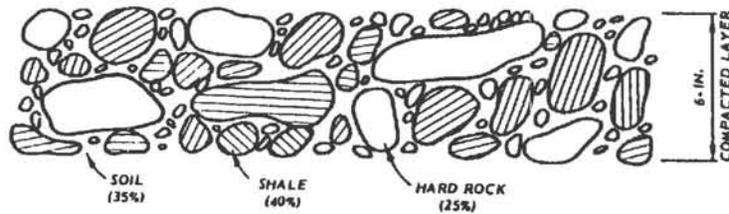
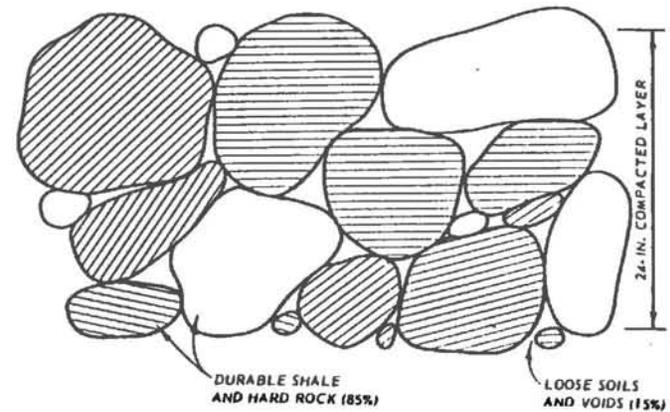
Figure 2. Effects of rock size on nondurable shale and of soil (minus No. 4) on durable shale

INADEQUATE COMPACTION, EXCESSIVE AMOUNT OF LARGE ROCK

POOR ROCK CONTACT

GOOD COMPACTION, SMALL ROCK SIZE AND ADEQUATE FINES

a. Nondurable shale in soilfill

GOOD ROCK CONTACT

b. Durable shale in rockfill

The use of heavy compaction equipment on a rocky mixture of nondurable shale and hard rock shown in upper drawing of Figure 2a would not produce adequate density because hard rock such as limestone would not break down. Conversely, small rock sizes and soil can be well compacted in thin lifts using conventional compaction equipment.

Durable shales and rock used as rockfill require good contact to achieve a stable mass that will not deform or settle. As illustrated in the upper drawing in Figure 2b, the large shale and rock are floating in loose soil. It would be practically impossible to obtain good

compaction of the soil even with very heavy equipment. Thus, the loose soil structure would compress and deform with time under infiltrating water and result in large settlements. A much more stable mass of rock and shale is obtained when large pieces are pushed together to form a large number of contacts, as shown in lower picture in Figure 2b. To achieve the desired clean rock, the amount of soil (minus No. 4) should be limited to not more than 20 percent for lifts as thick as 24 inches.

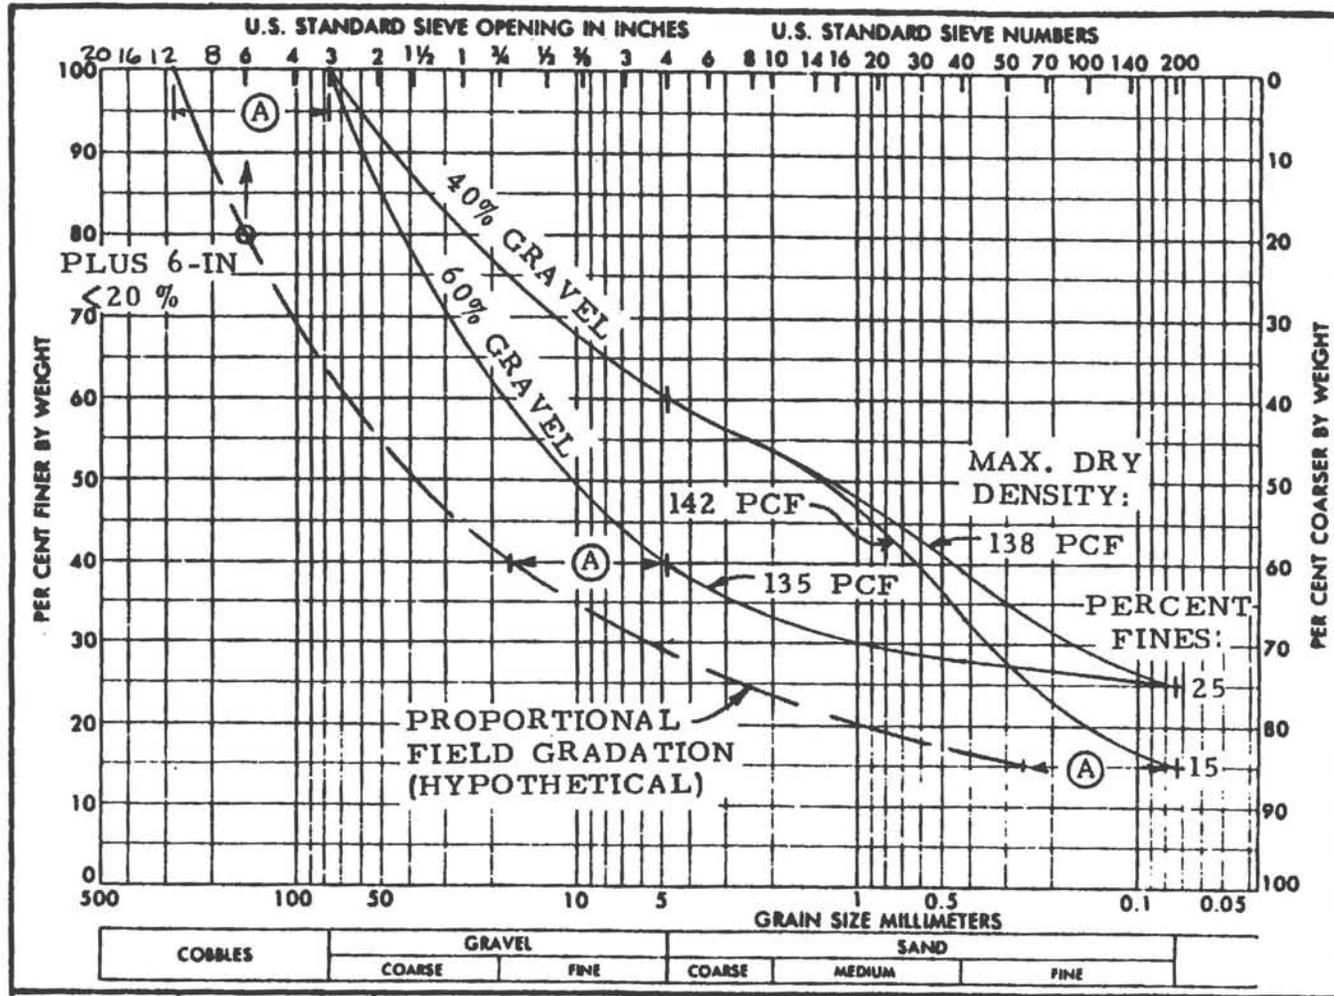
Figure 3, Basis of gradation requirements for nondurable shales used as soilfill

Using the gradation curves from the earth rock mixture, and assuming a maximum rock size of 12 in. for an 8-in. lift, a proportional gradation curve is constructed (using the offset distance A, based on the

difference between the maximum size of 12 in. to 3 in. as shown in Figure 3, for the dashed curve). This proportional curve indicates a well graded material with 20 percent of plus 6-in. size rock. Since a 6-in. size is easily recognized in the field and rocks larger than 12 in. should be prohibited or limited to a smaller percentage, criteria limiting plus 6-in. rock size to less than 20 percent should be used as a minimum. Hard nondurable shales that do not contain sufficient fines may require an additional limitation of about 60 percent on the plus 1-in. size (or a requirements for about 40 percent, minus 1-in. material).

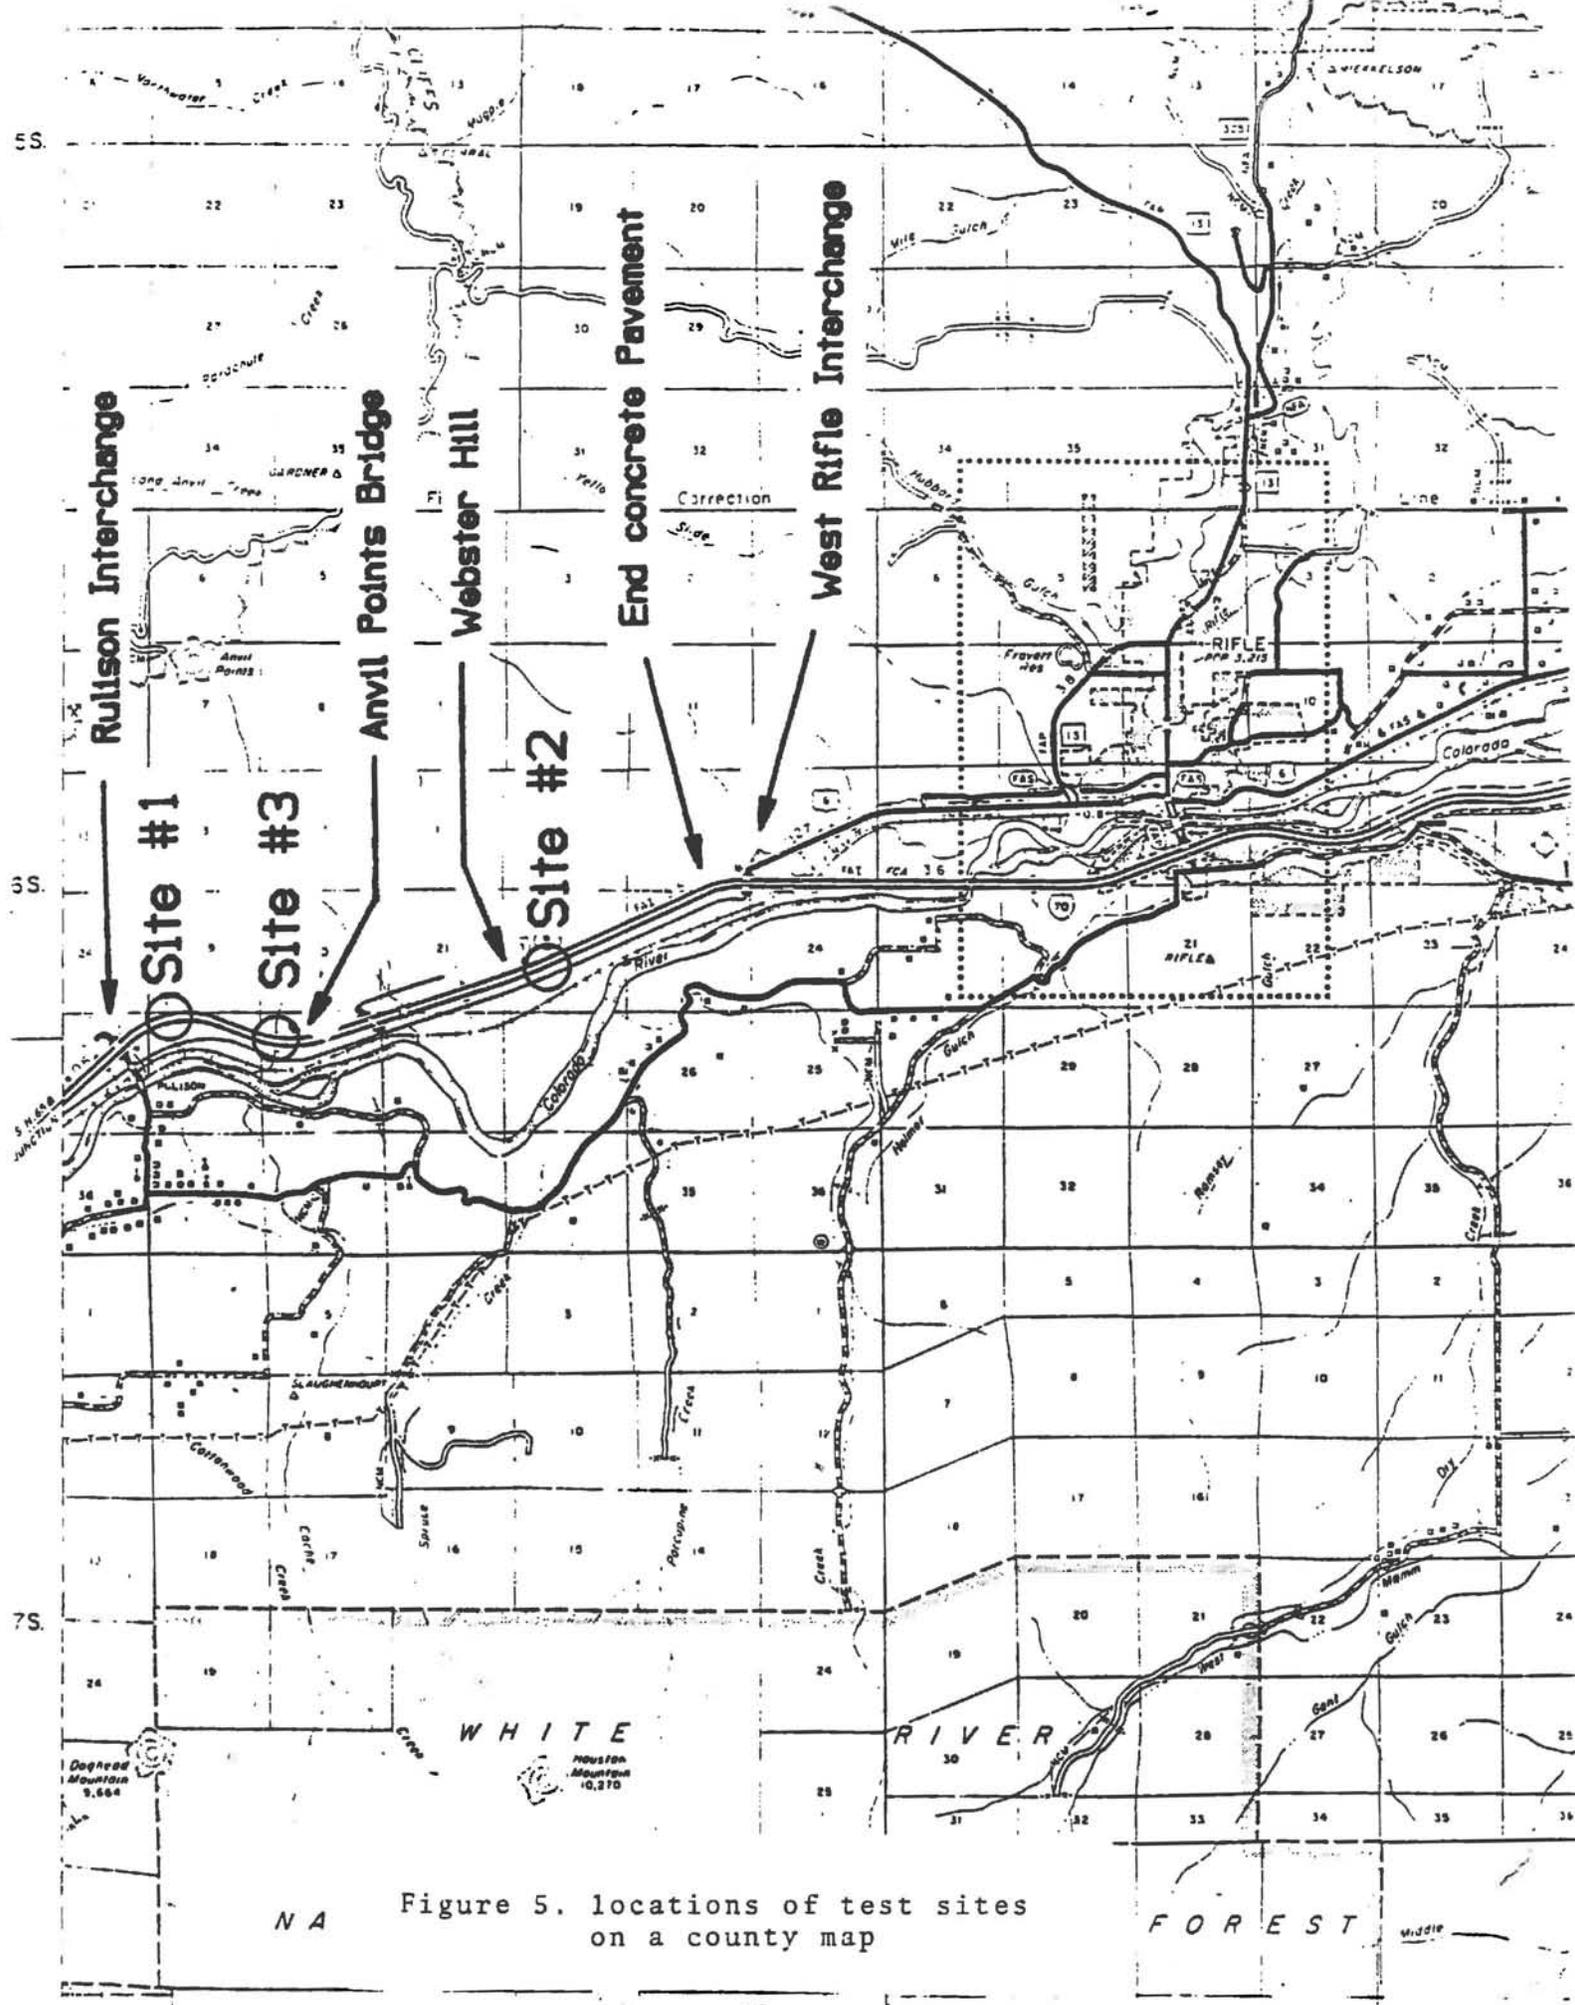
Figure 5. locations of test sites on a county map

Three embankments along I-70 in Western Colorado were selected to be instrumented and monitored during this study. Location of these three sites are marked and they are illustrated in Figures 4 and 5.

Site No. 1 was an embankment 50 foot high with a 2 to 1 slope about 1/4 mile east of the Rulison Interchange as shown in Figure 5. The exposed shale on this site is mostly nondurable and it could easily be detected visually. Figure 6 shows the shale formation that was used during the 1980 construction of the "Rulison cut". Note the small monads, especially the one in the lower left quadrant of the photo. These began as hard, dense silty shale rocks (shaley siltstone), but due to weathering and moisture absorption during many years, they have disintegrated into much finer and softer material.

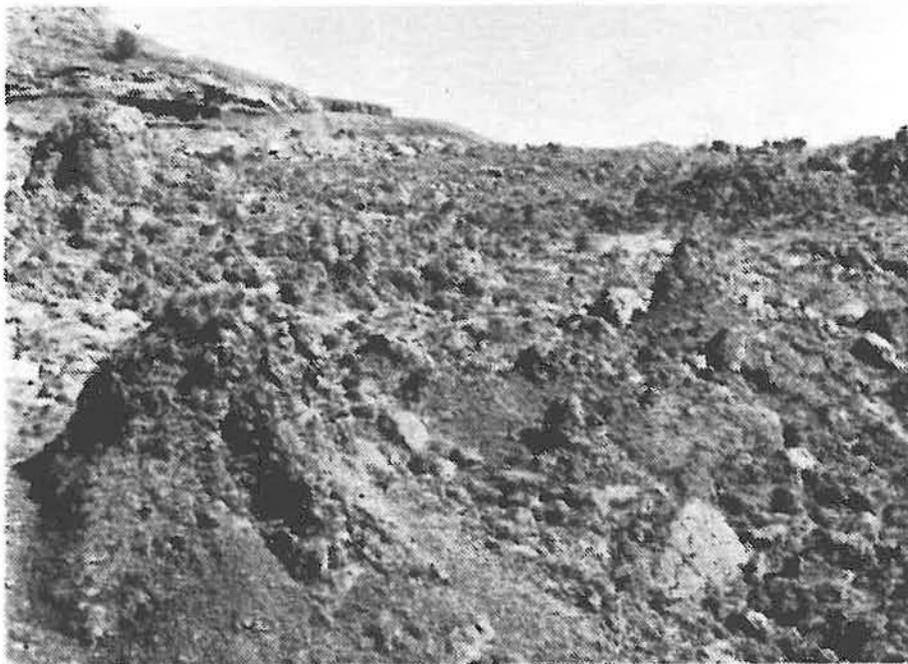
Figure 6. Shale formations near site no.1

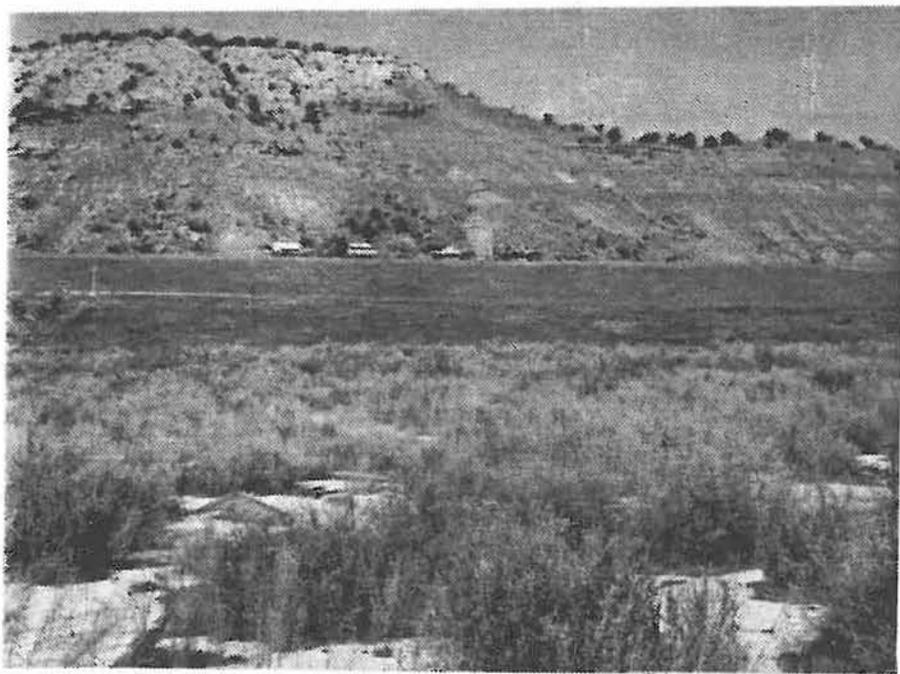
Figure 7.
View of the embankment
located on site no. 2

Site No. 2 was selected east of the Webster Hill cut, as shown in Figure 7. The embankment on the east side of this hill stretches for more than 2 miles, and its height descends from 100 to 10 feet from the top to the bottom of the hill, as shown in Figure 8. The shales on this site were weathered and had rocklike appearance as shown in Figure 9.

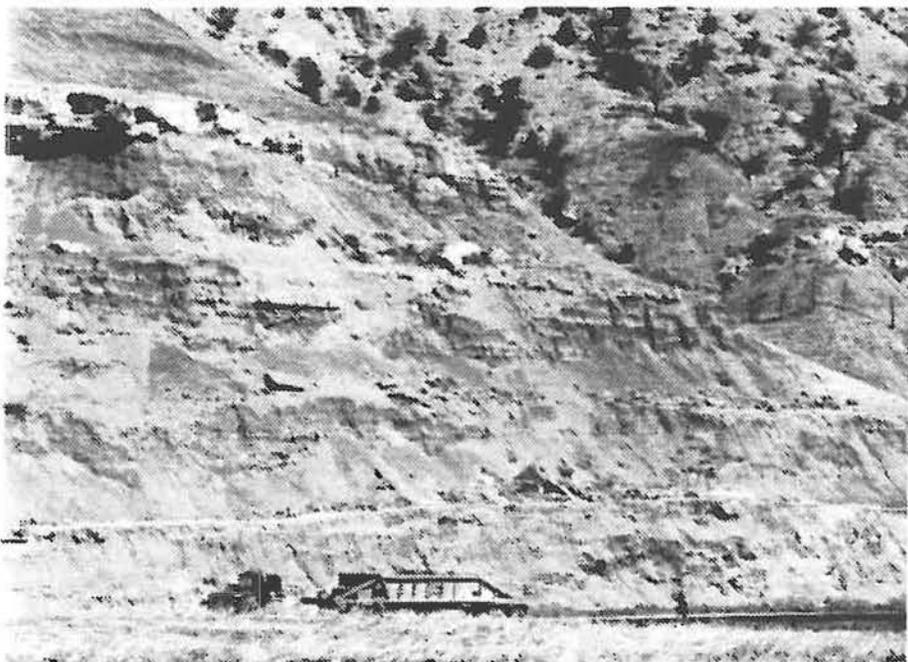
Figure 9.
Shale formations near
site no. 2

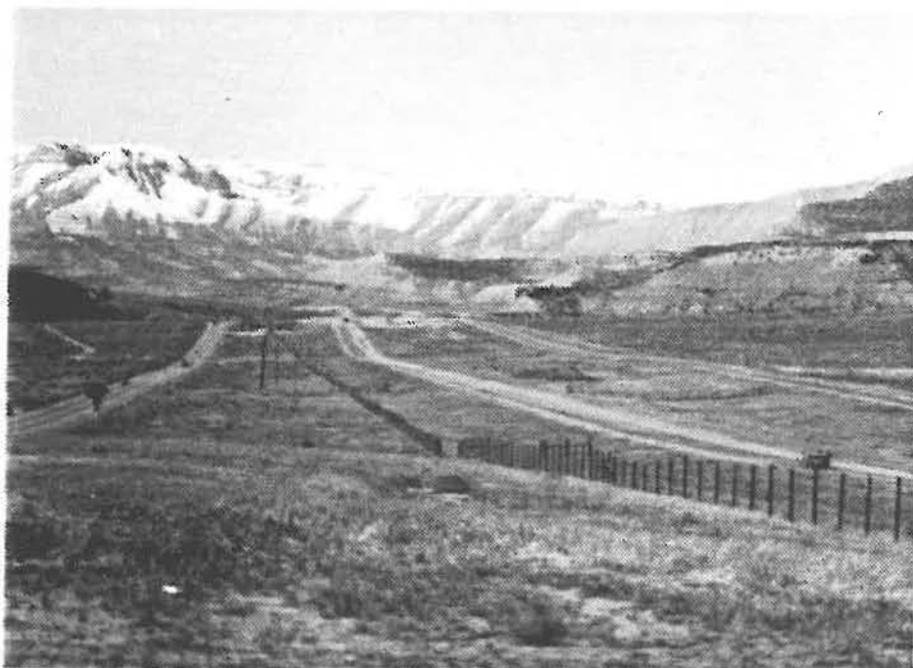
Figure 10. View of site no. 3

Site No. 3 was selected westbound just west of the Anvil Point Bridges, See Figure 10. The embankment on this location was less than a mile in length and its height varied from 30 to 5 feet from the top to the bottom of the slope. The shales on this location were very similar in appearance and durability to the shales on Site No. 2.

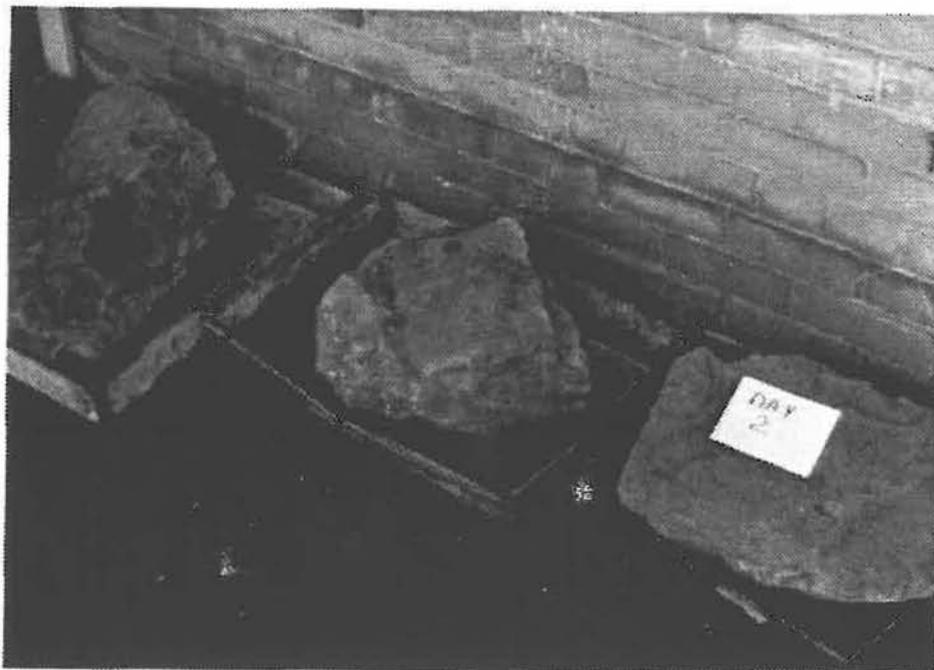
Figure 11. Selected shales from the construction site two days after excavation

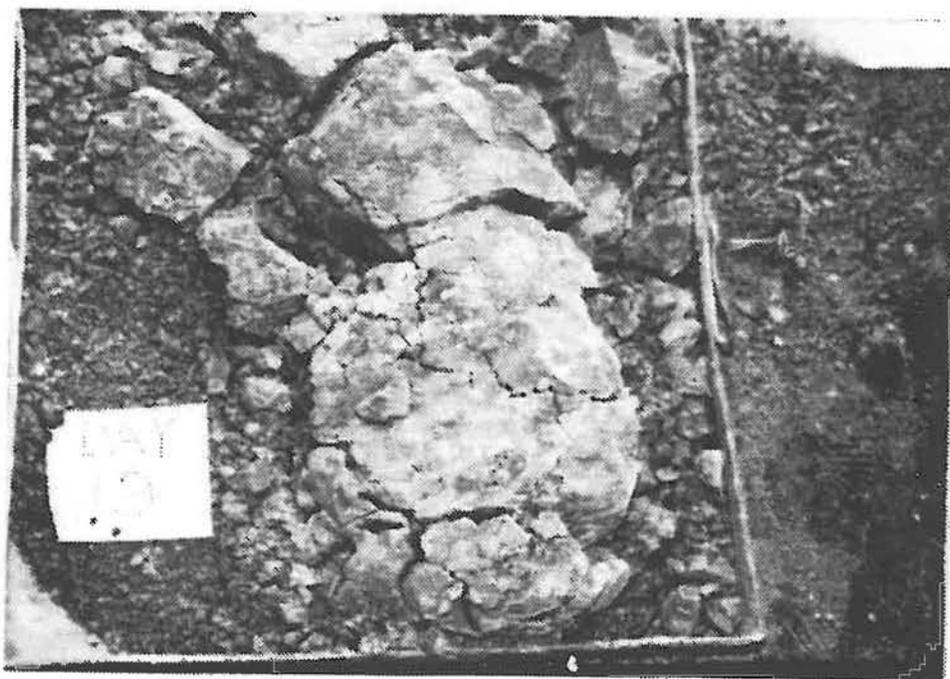
Figure 12. Disintegration of the above selected shales nineteen days after excavation

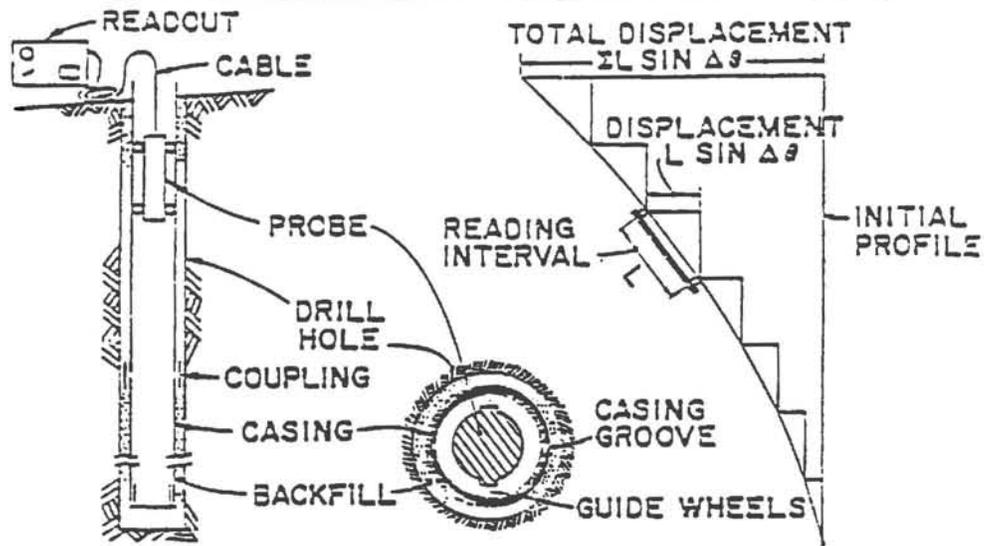
INCLINOMETER PRINCIPLE

Figure 13a. COMPONENTS OF INCLINOMETER EQUIPMENT AND A SKETCH OF ITS MEASURING PRINCIPAL

A total of 3 slope indicators (inclinometers), one on each site, were used to measure the lateral movements of the selected highway embankments. In addition, each inclinometer was encased in a collapsible tubing (Sondex) with stainless steel rings set at an initial two-and-a-half foot spacing to measure the settlement and/or expansion of the fill material. Figure 13 shows sketches illustrating the mechanics of the inclinometer and Sondex systems. These two instruments are capable of measuring movements as small as a quarter of an inch in either the horizontal or vertical directions. In addition, standard surveying instruments were used to measure the change in surface profile in each site. Table 1 shows the distribution of instruments on each site.

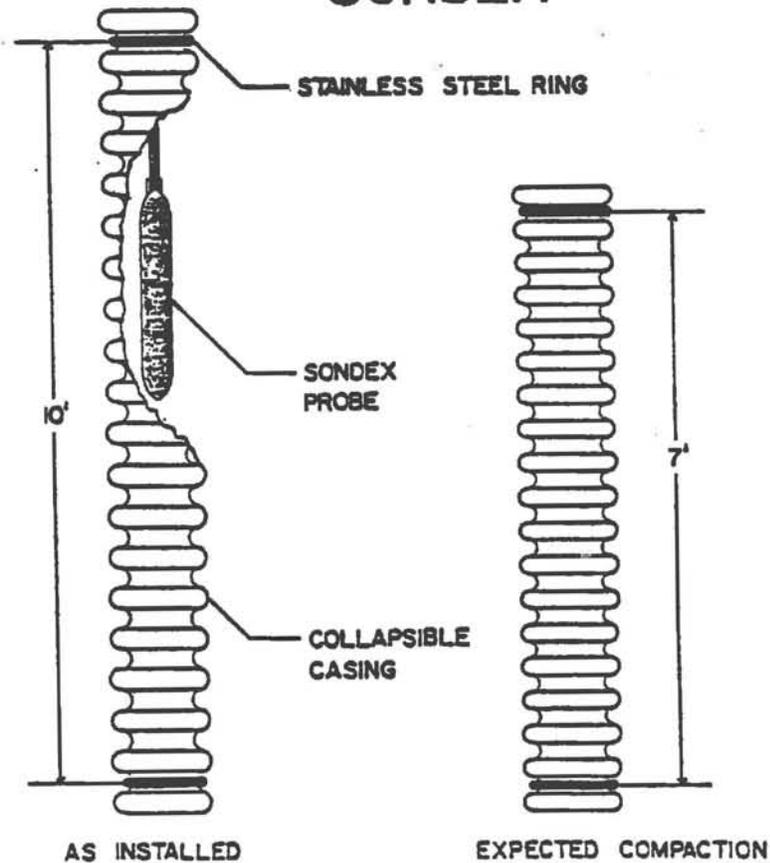
Figure 13b. SKETCH OF VARIOUS COMPONENTS OF A SONDEX SYSTEM

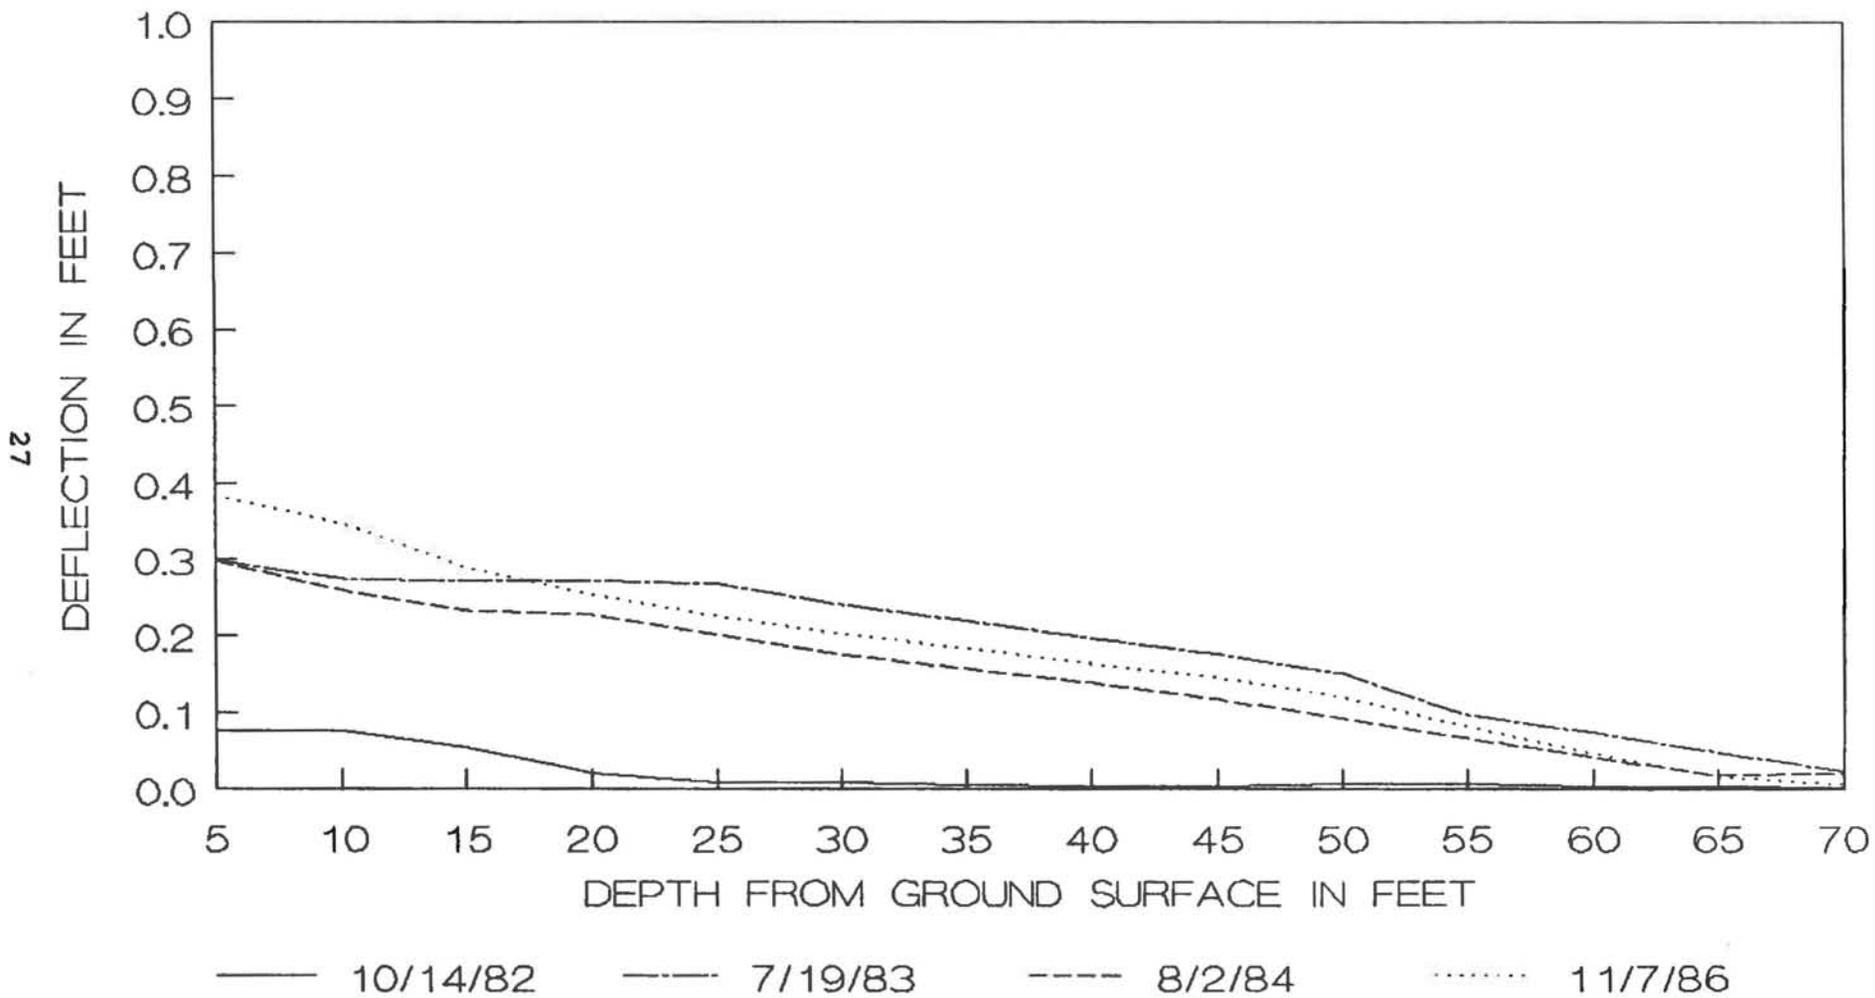
Figure 15

INCLINOMETER DATA FOR OBSERVATION WELL NO. 1

The inclinometer data was plotted, and they are shown in Figures 15 through 17. The test embankments No. 1 and 2 showed 0.386 and 0.348 ft. of lateral movements, respectively. The test embankment No. 3 showed 0.484 ft. of lateral movement which is higher than the lateral movements of the other two test embankments.

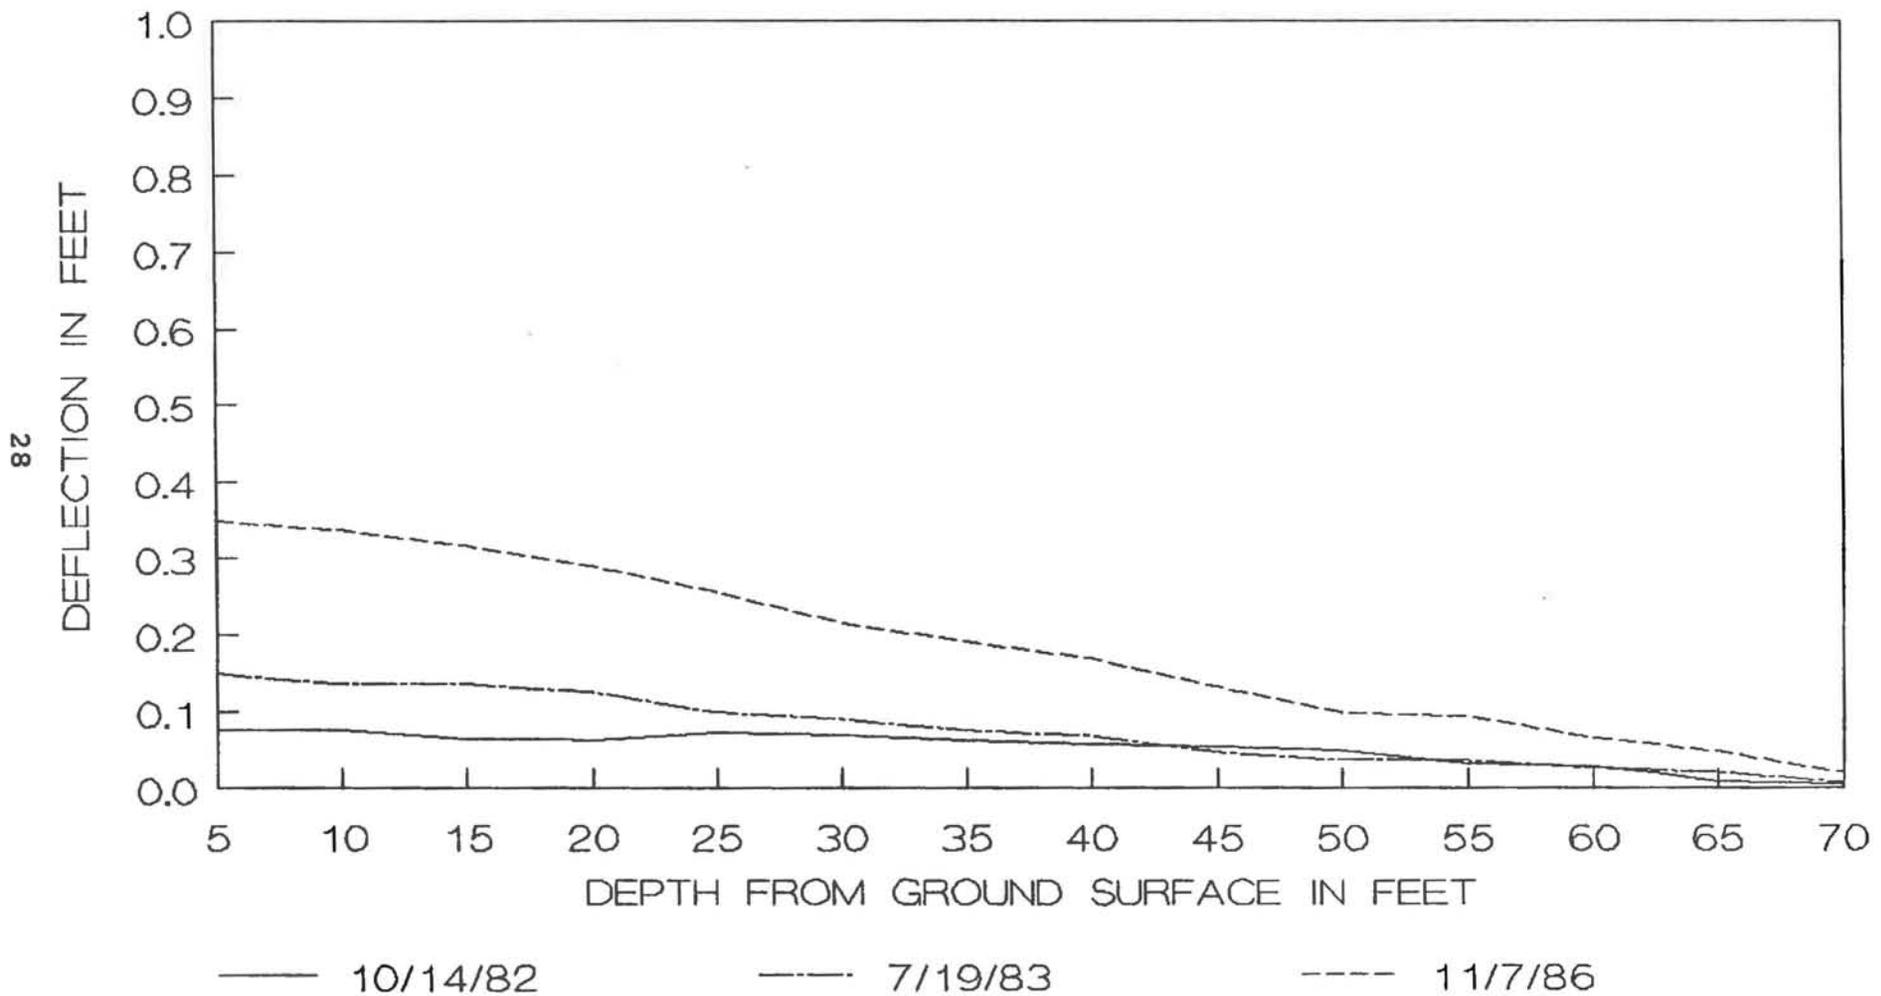
Figure 16

INCLINOMETER DATA FOR OBSERVATION WELL NO. 2

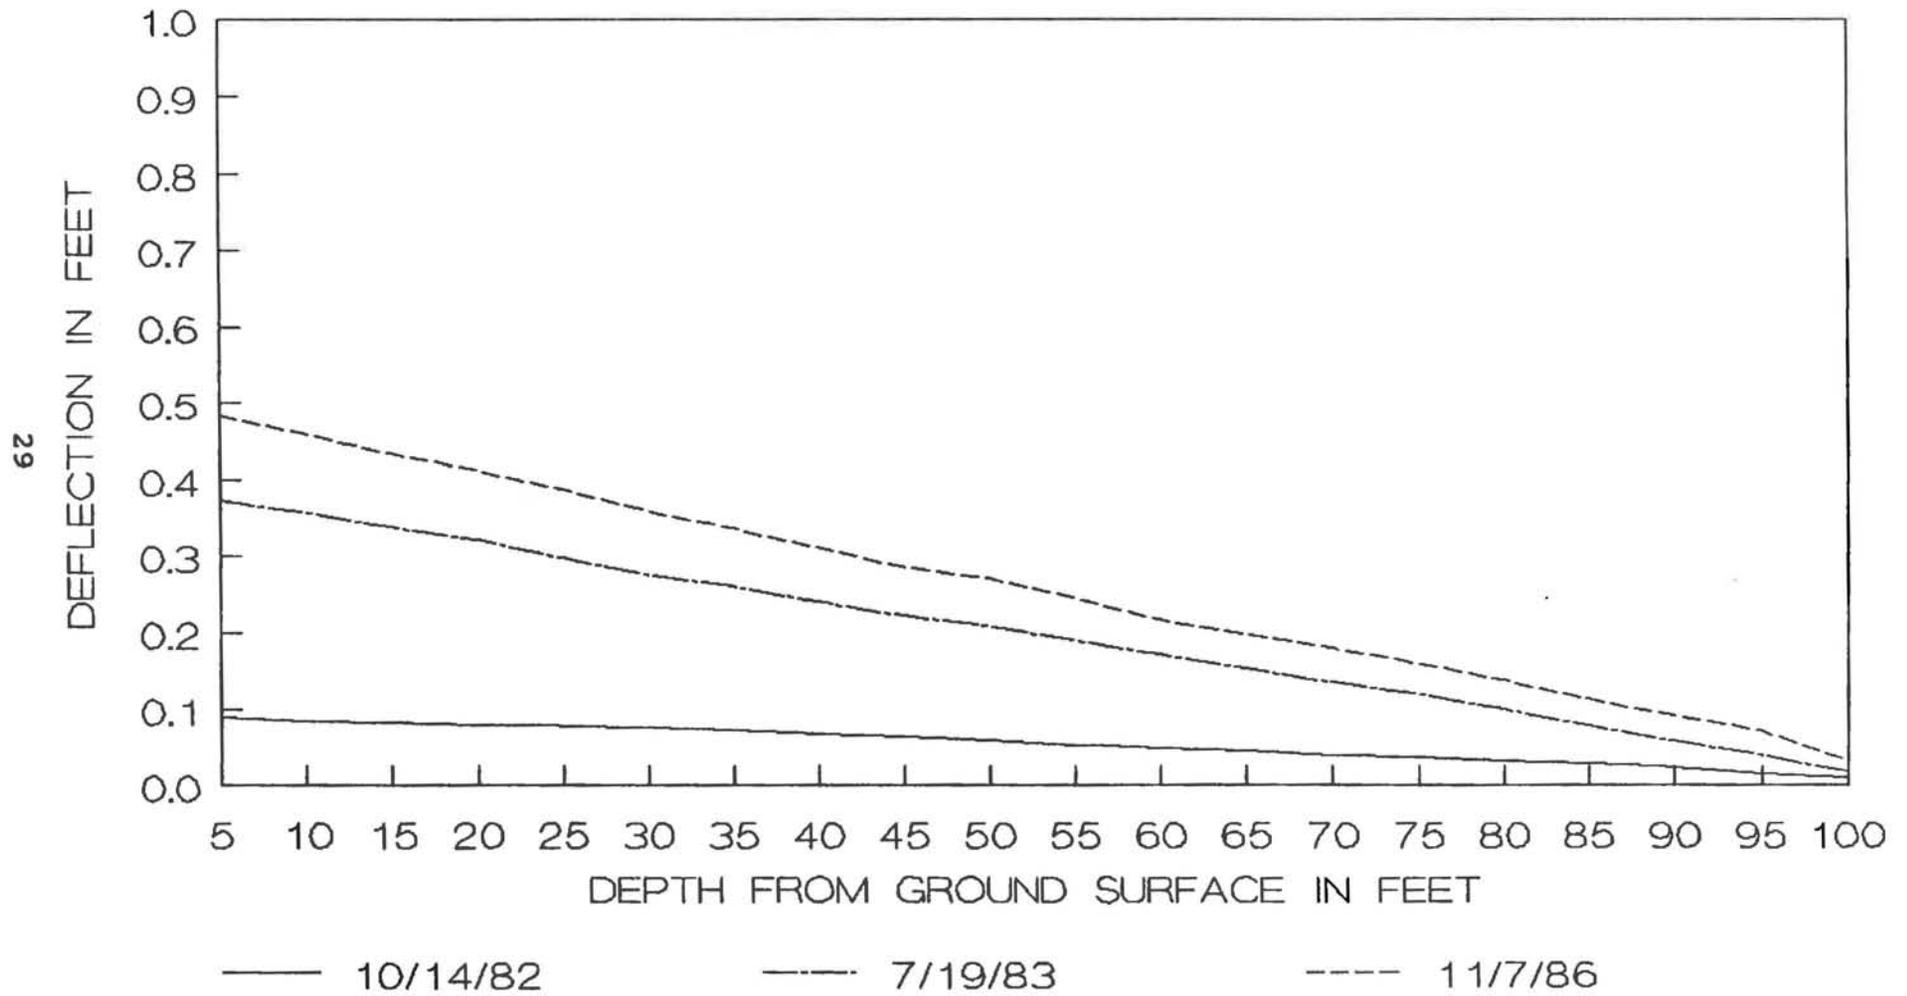
Figure 17

INCLINOMETER DATA FOR OBSERVATION WELL
NO. 3

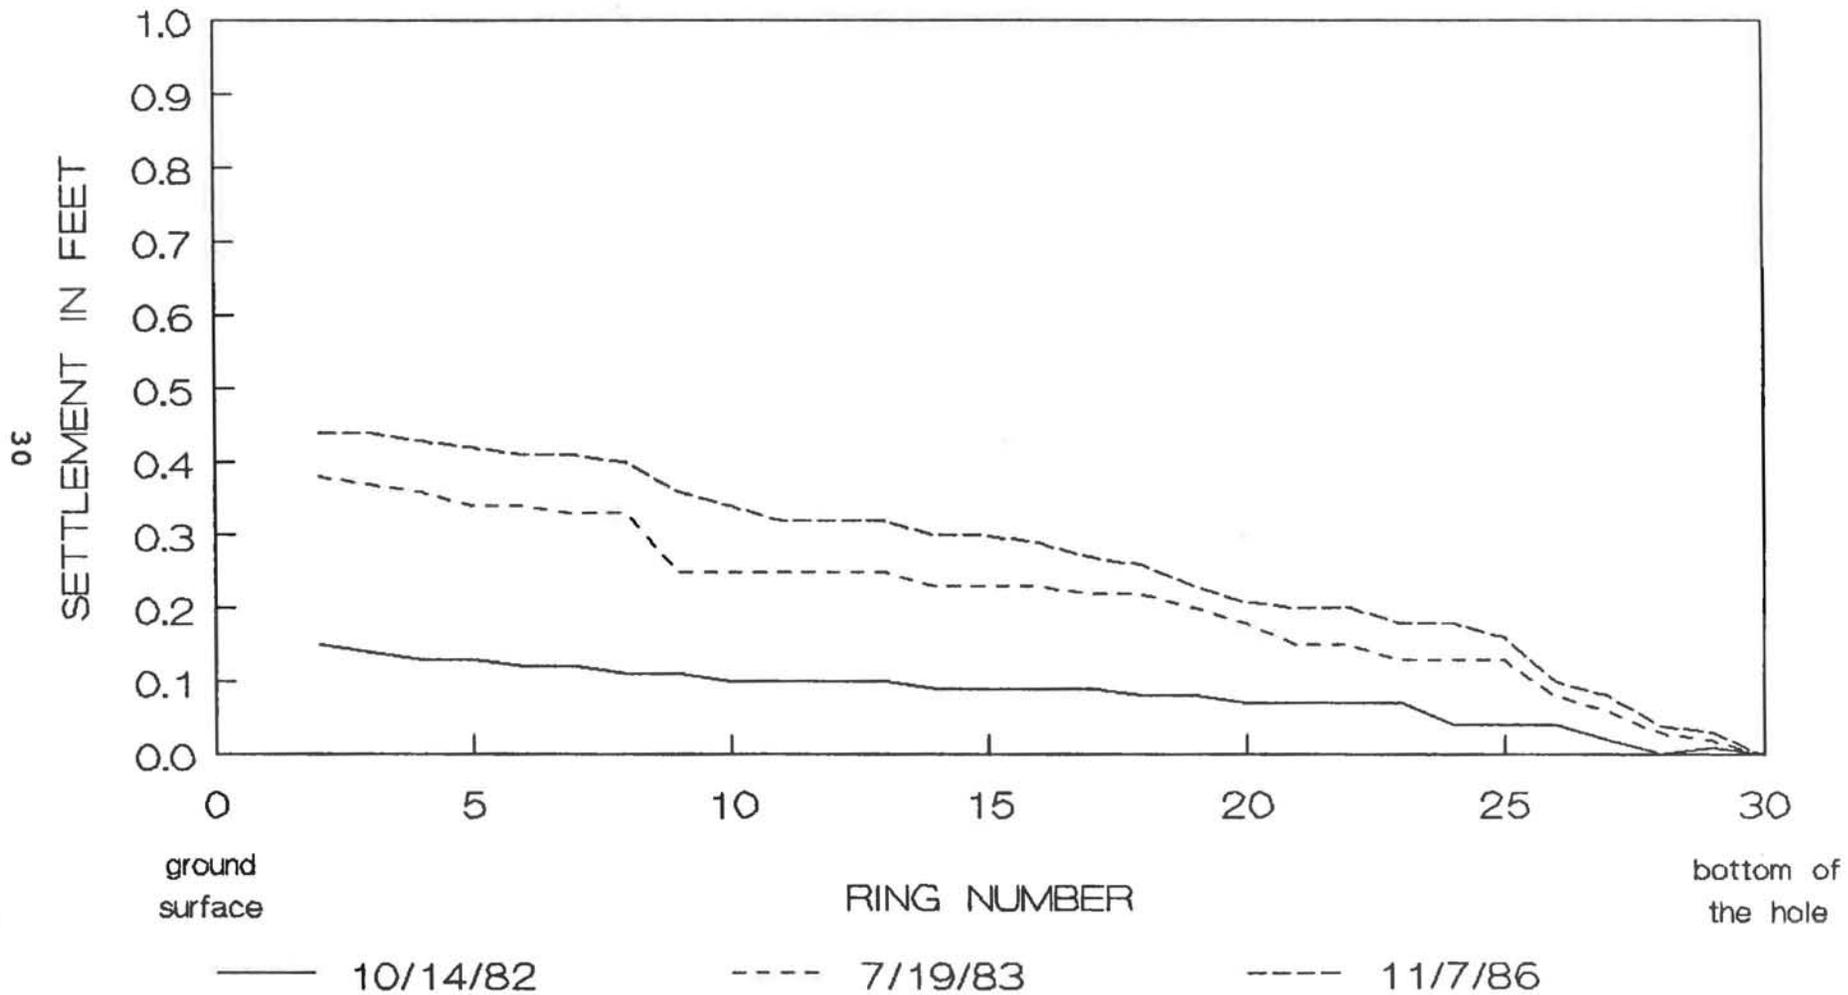
Figure 18

SONDEX DATA SITE NO. 1

The Sondex information was also plotted, and they are displayed in Figures 18 through 20. The maximum settlement of the top ring which is an indicator of the total overall settlements are .44, .32, and 0.99 ft. of settlement, respectively, on sites No. 1, 2, and 3. Site No. 3 shows the largest settlement corresponds well with the inclinometer data.

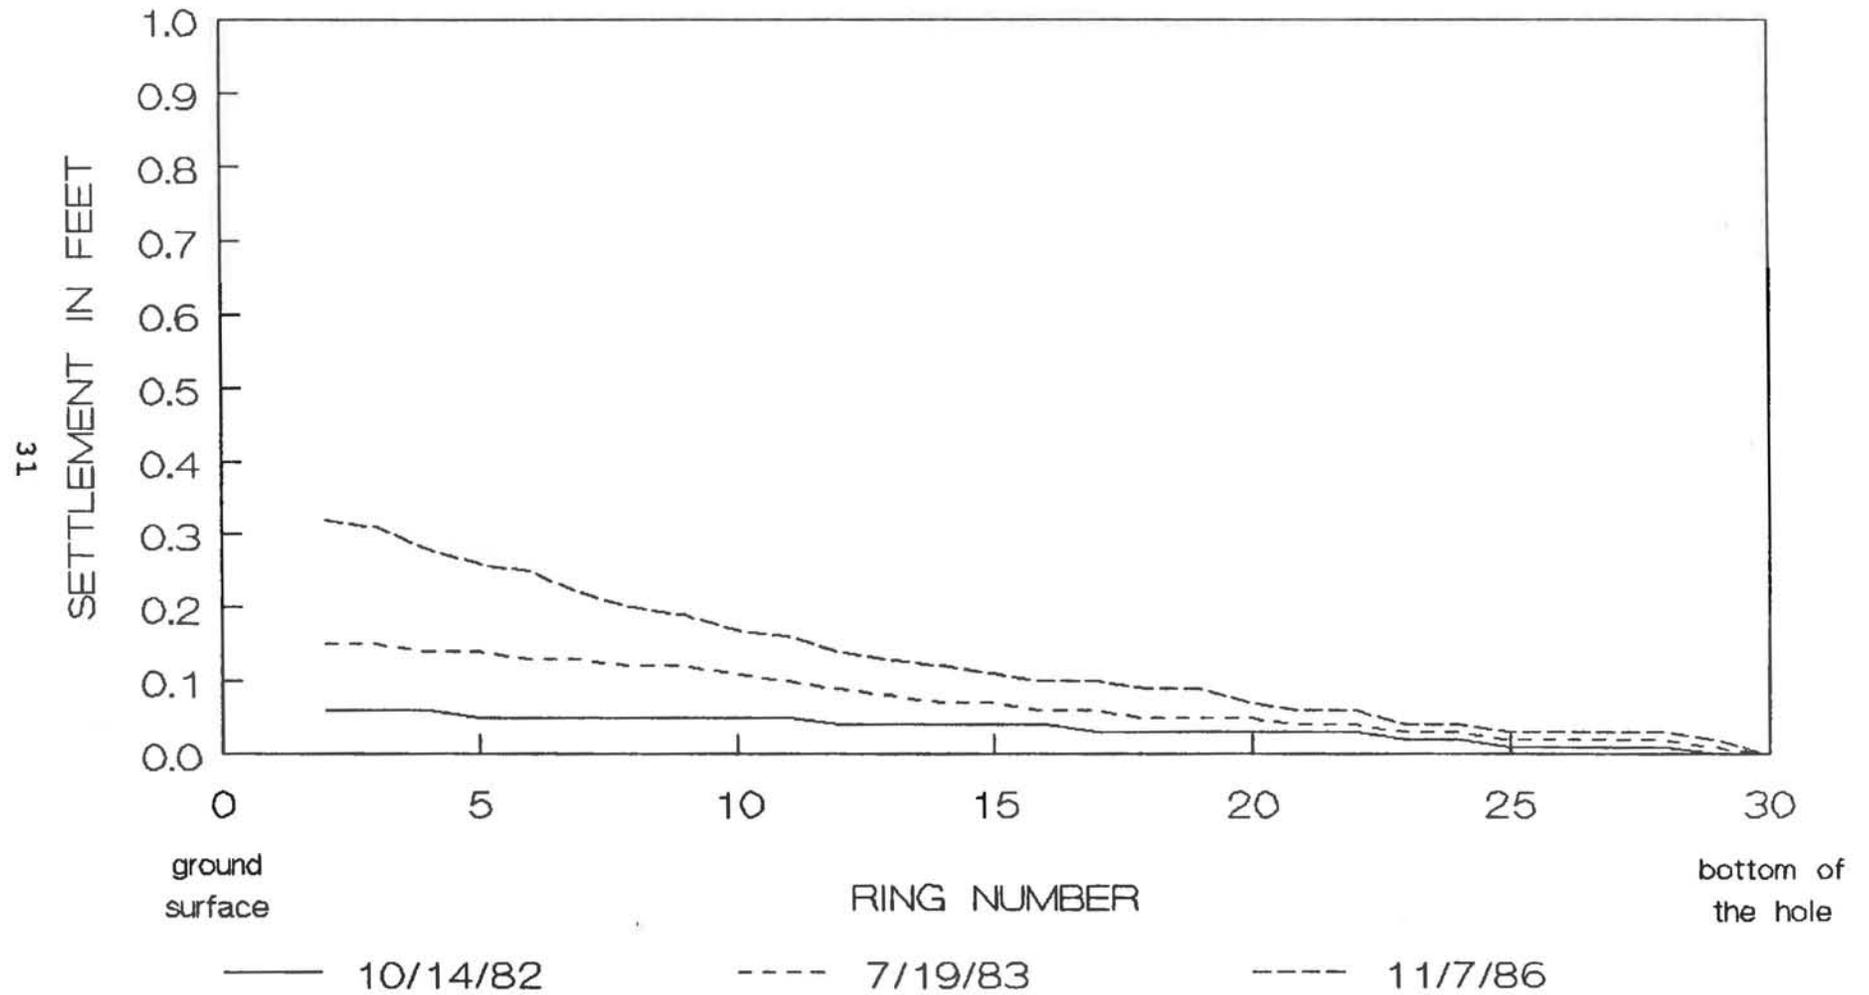
Figure 19

SONDEX DATA SITE NO. 2
