MONITORING OF NONDURABLE SHALE FILLS IN SEMI-ARID CLIMATES

Majid Derakhshandeh

Colorado Department of Highways
4201 East Arkansas Avenue
Denver, Colorado 80222

Final Report
December, 1989

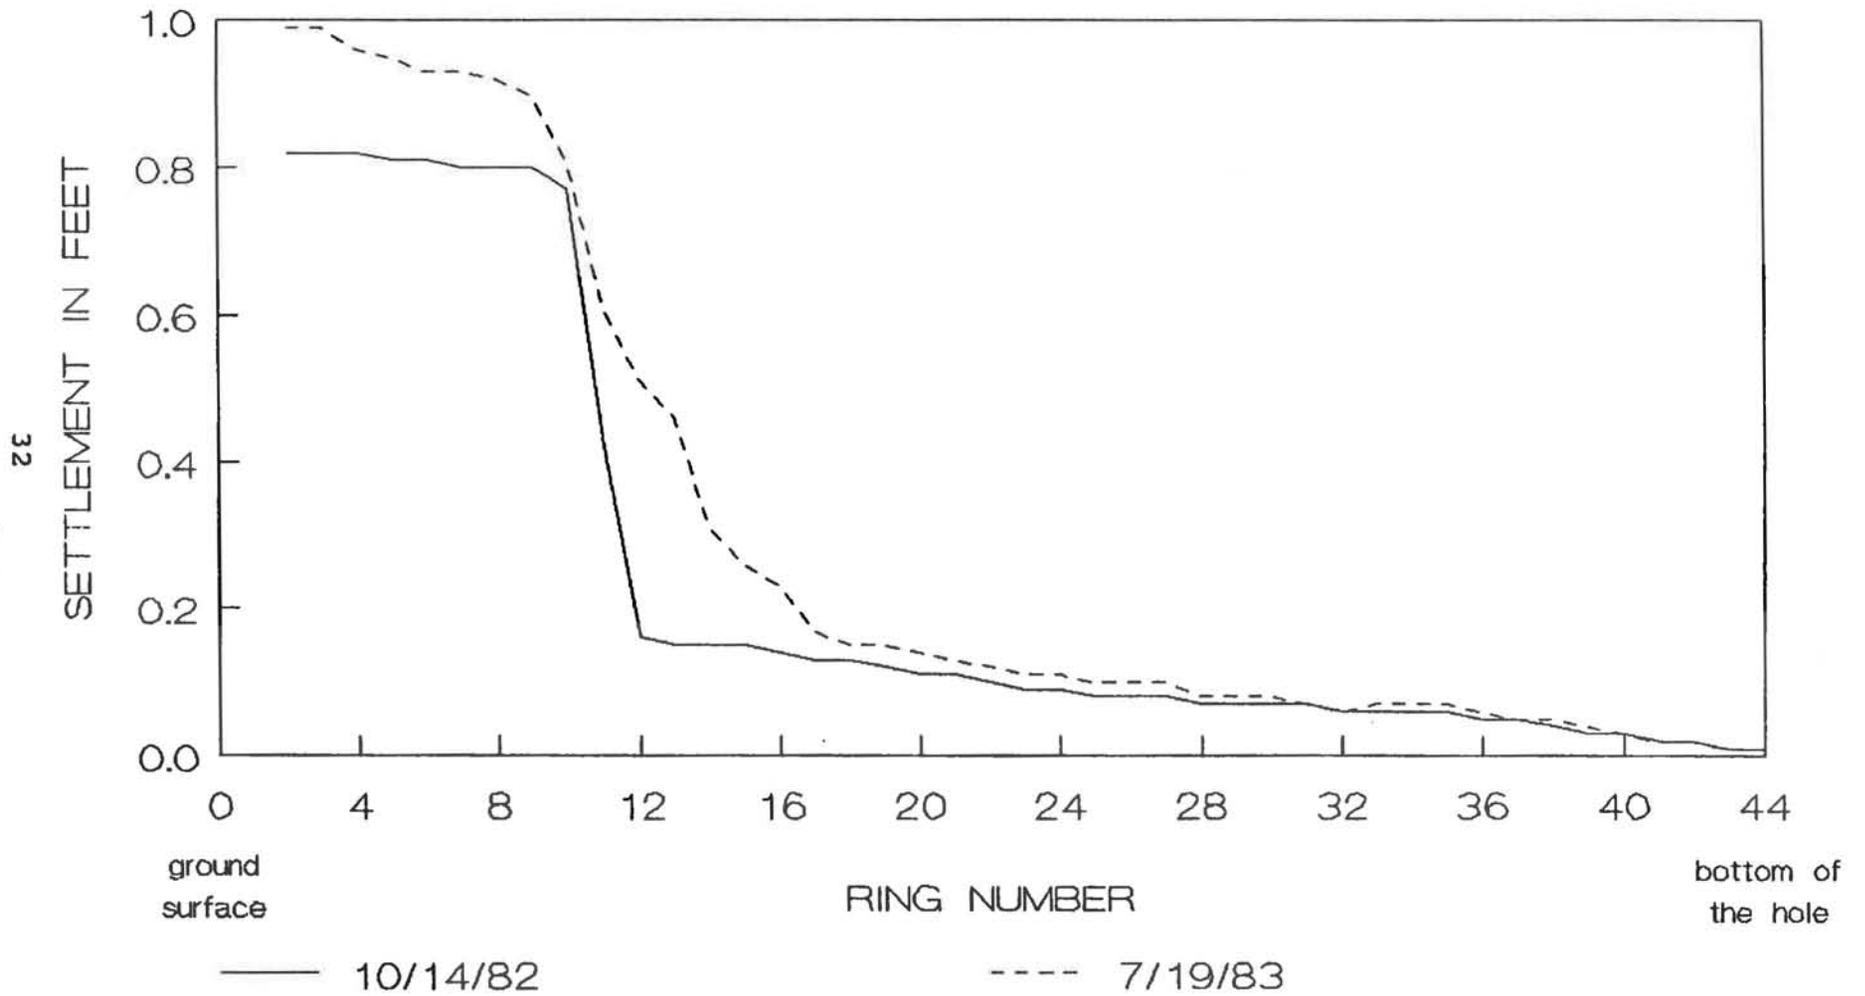
Figure 20

SONDEX DATA SITE NO. 3

The Sondex information was also plotted, and they are displayed in Figures 18 through 20. The maximum settlement of the top ring which is an indicator of the total overall settlements are .44, .32, and 0.99 ft. of settlement, respectively, on sites No. 1, 2, and 3. Site No. 3 shows the largest settlement corresponds well with the inclinometer data.

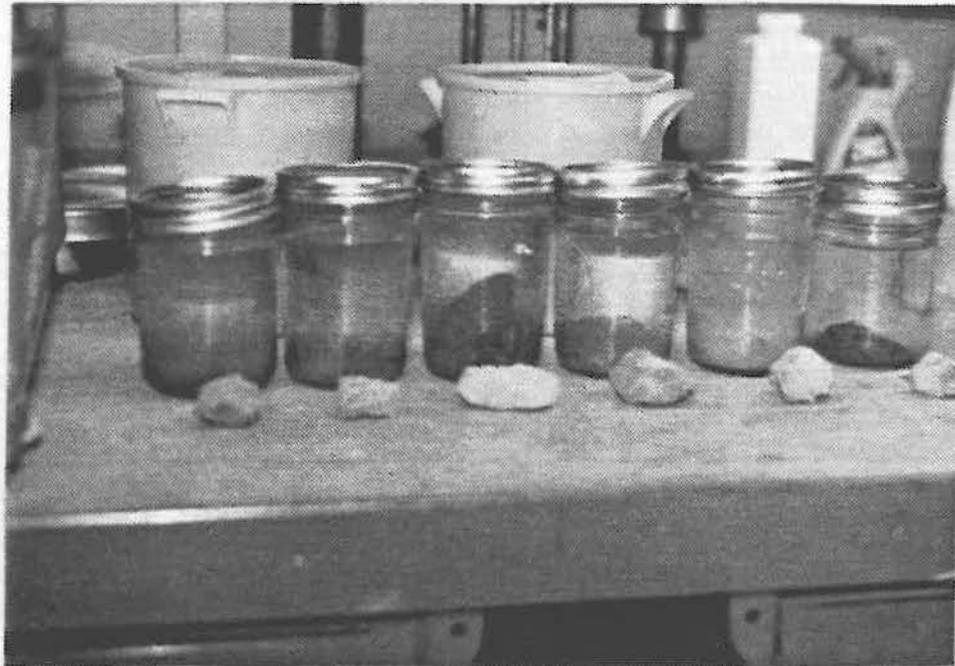
Figure 21. Jar-Slake durability test in progress

shales as being weak and nondurable when exposed to water. This was also visually observed during the jar-slake tests in the laboratory as shown in Figure 21. Shale samples were placed in 6 different jars and water was added. All samples except Sample No. 3 reacted rapidly to the addition of water and tests were almost completed within the first 15 to 20 minutes. Sample No. 3 reacted slower than the other samples, and it took about one hour before its rate of disintegration was completed. All samples were left over night and inspected 24 hours later for jar-slake index evaluation.

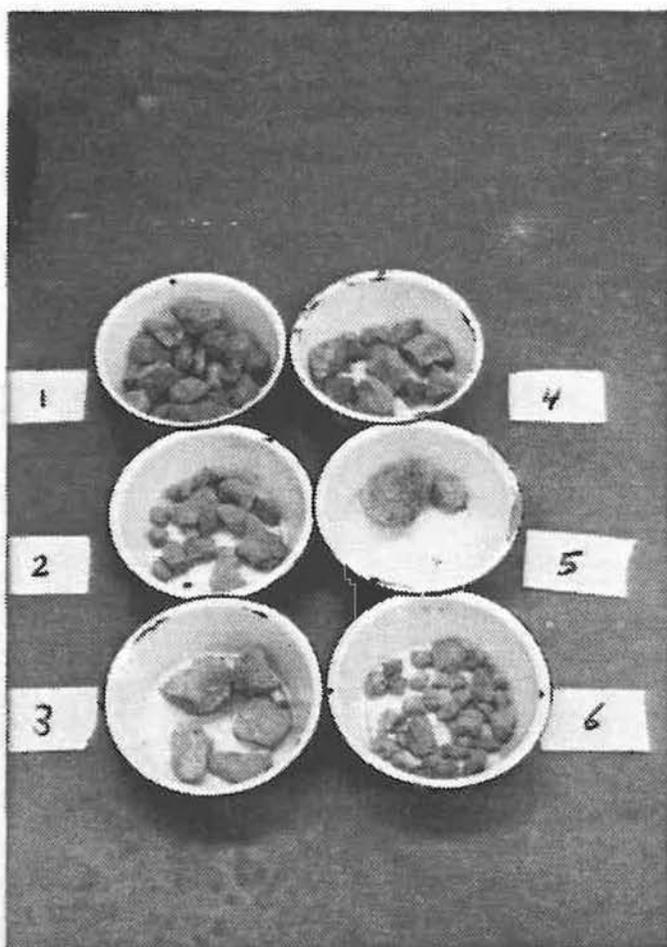
Figure 22. Samples prior to slake-durability test

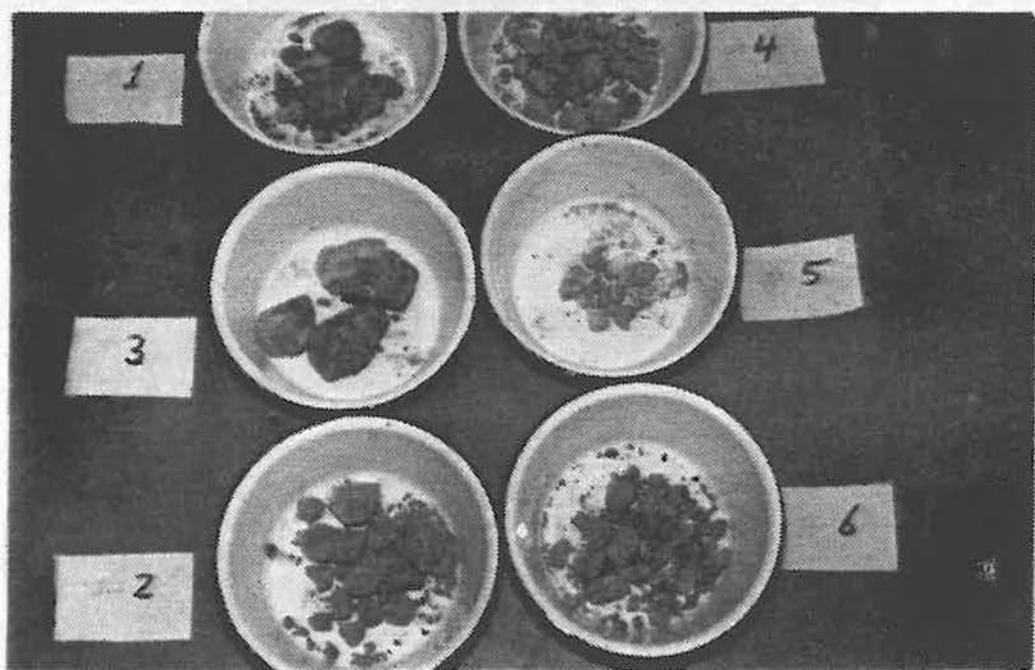
Figure 23. Remains of the samples after the slake-durability test
