FINAL Existing Transportation Conditions Report

I-70 & Kipling Interchange | PEL Study

I-70/Kipling Interchange Planning and Environmental Linkage (PEL) Study

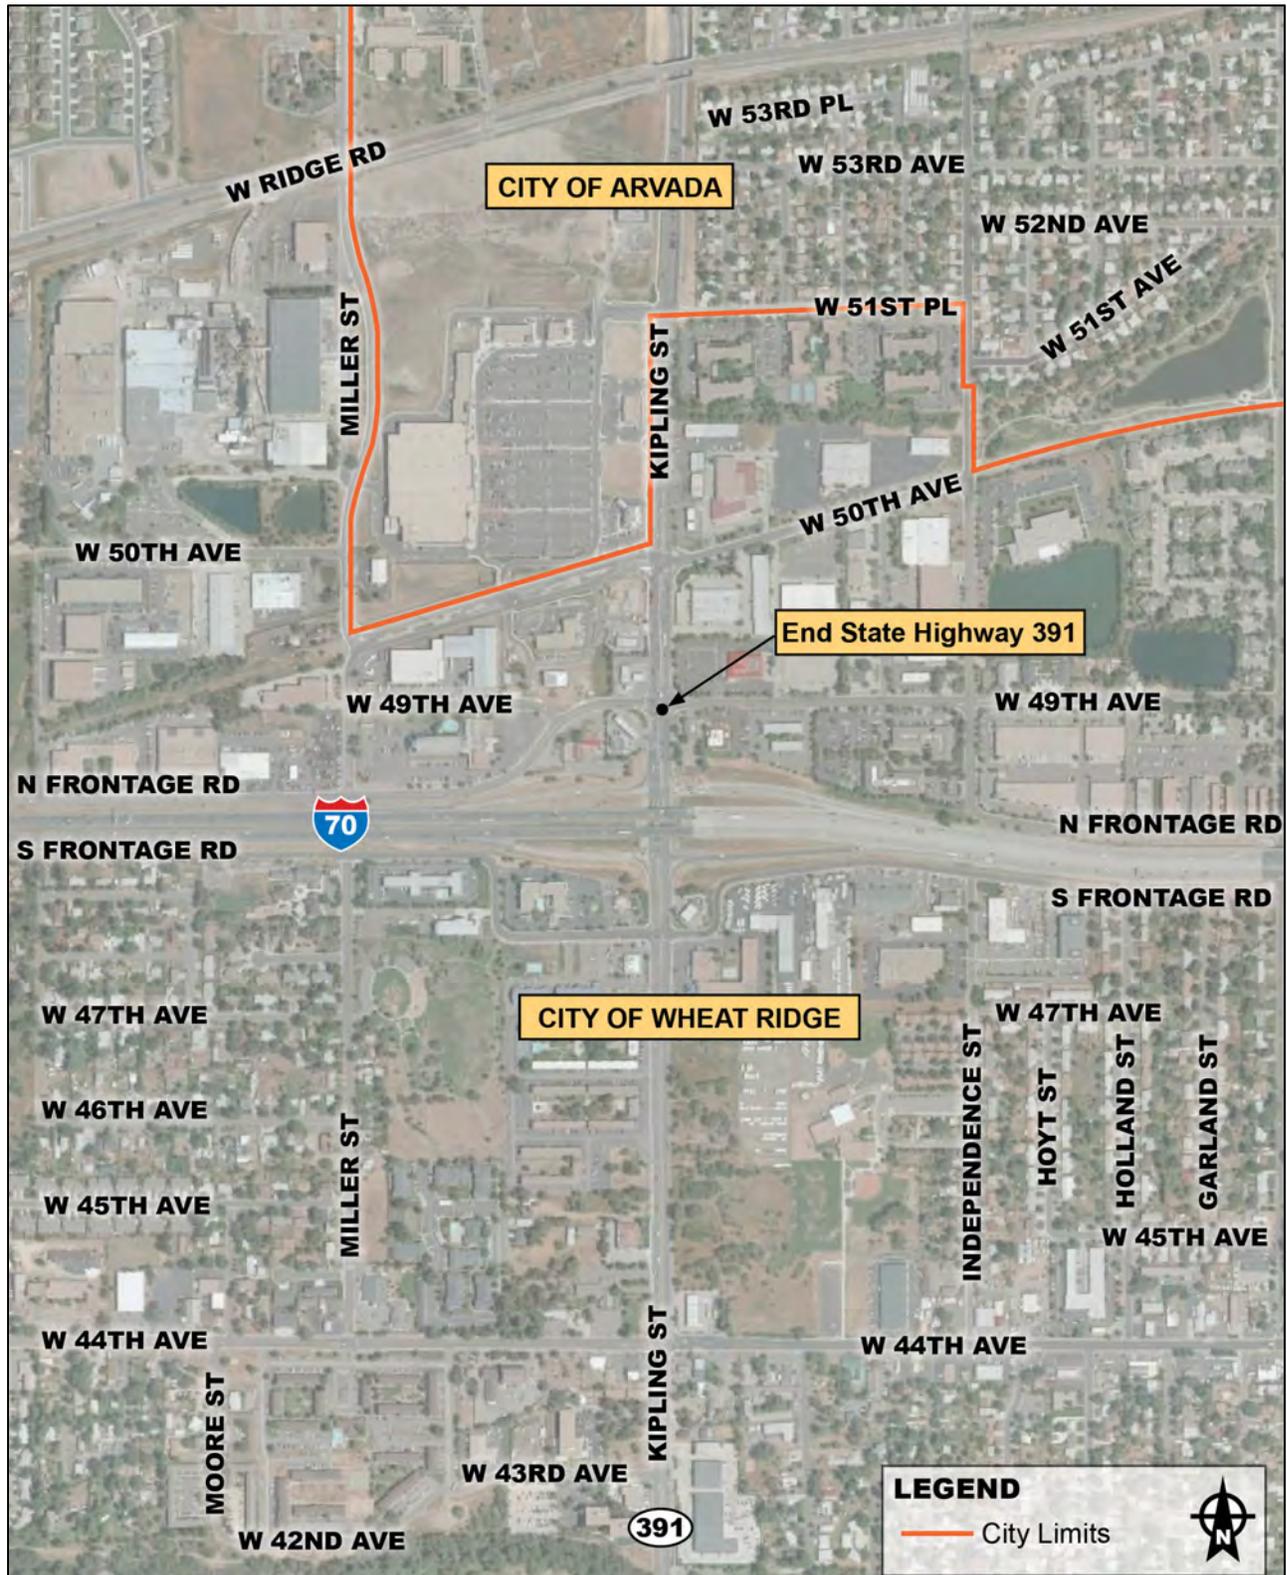
Figure 2: Jurisdictional Boundary

The I-70 and Kipling interchange is located within the City of Wheat Ridge in Jefferson County. The boundary for the City of Arvada runs between the 50th Avenue and 51st Place intersections. **Figure 2** illustrates the city boundaries surrounding the interchange.

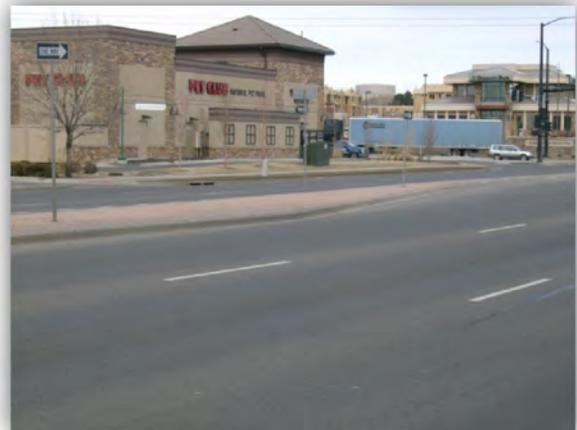
Raised median on Kipling Street north of I-70 interchange

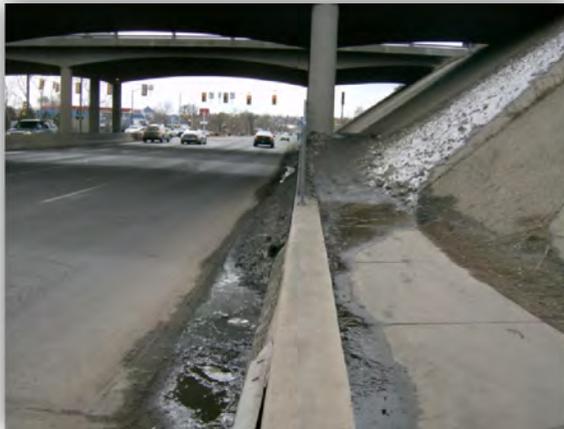
Concrete barrier on Kipling Street under the I-70 bridges

The guardrail is placed to protect against obstructions, steep slopes and errant cross-over traffic. Guardrail is placed on Kipling Street, under the I-70 bridges in front of bridge piers and slope paving.

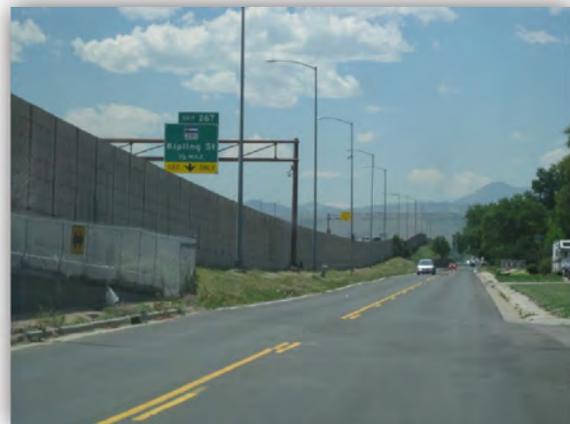
Noise wall along north side of I-70

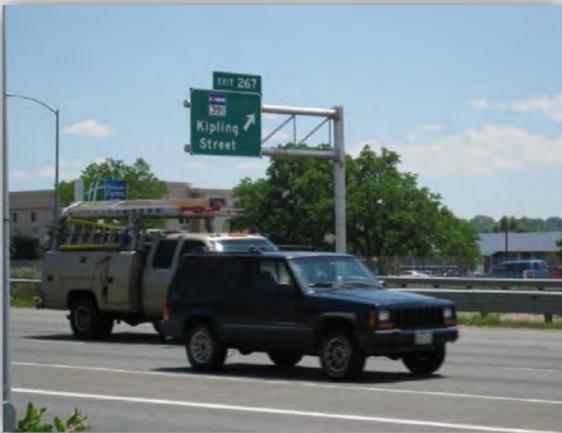
Cantilever-mounted guide sign at Eastbound I-70 Off Ramp

All of these signs are protected by concrete barrier or guardrail. The locations of the guide signs are outlined in **Table 6** and shown on **Figure 4**.

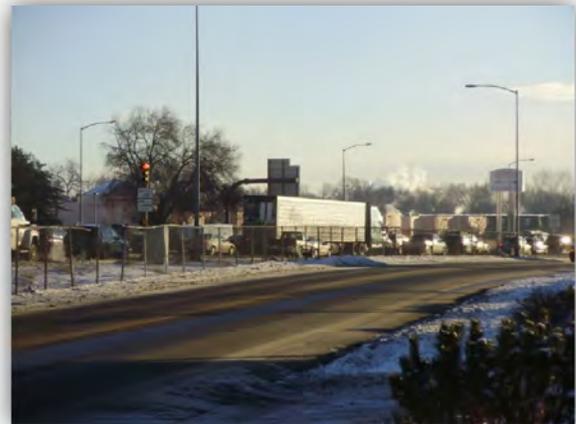
The eastbound I-70 ramp meter at Kipling Street is necessary to maintain acceptable freeway traffic flow during peak hours. However, in order to achieve freeway benefits, the ramp meter queues traffic from the meter back to the Kipling signalized intersection.

Eastbound I-70 congestion at Kipling Street On Ramp in AM peak hour

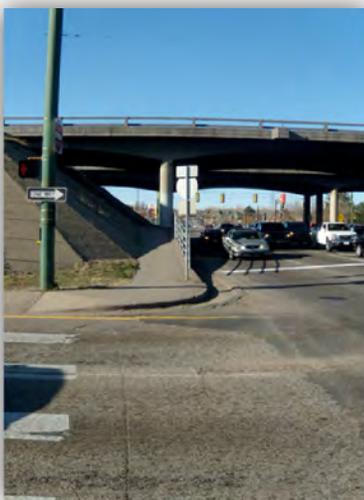
The sidewalk on the west side of Kipling Street under the I-70 bridge is unusual in terms of its proximity to the bridge piers and its vertical profile.

West side of Kipling Street under I-70 bridges

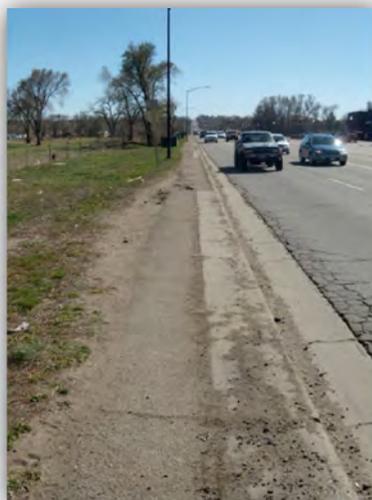
that is attached asphalt in poor condition, although newer sidewalk exists on both ends of the section. There are two segments along Kipling Street that have no sidewalk; between 43rd and 44th Avenue on the east side of Kipling Street and between 50th Avenue and 51st Place on the east side of Kipling Street.

East side of Kipling Street south of interchange – attached asphalt sidewalk

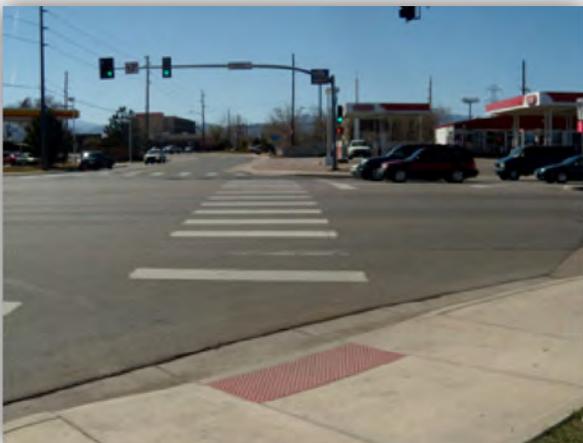
Non-directional pedestrian curb ramp at 49th Avenue/North Frontage Road intersection

There are a mix of older style curb ramps and newer style curb ramps with tactile strips along Kipling Street. There is also a mix of directional and non-directional curb ramps. Directional curb ramps are perpendicular to the curb and users generally travel perpendicular to vehicular traffic when they enter the street at the bottom of the ramp. A non-directional curb ramp consists of one ramp on each intersection corner that is located at the apex of the corner of the intersection. Users are traveling diagonal to traffic when they enter the street at the bottom of a non-directional ramp.
