Twin Tunnels Environmental Assessment and Frontage Road Project ALIVE Meeting*

January 20, 2012
CDOT Region 1

Twin Tunnels Environmental Assessment
Idaho Springs/Clear Creek County

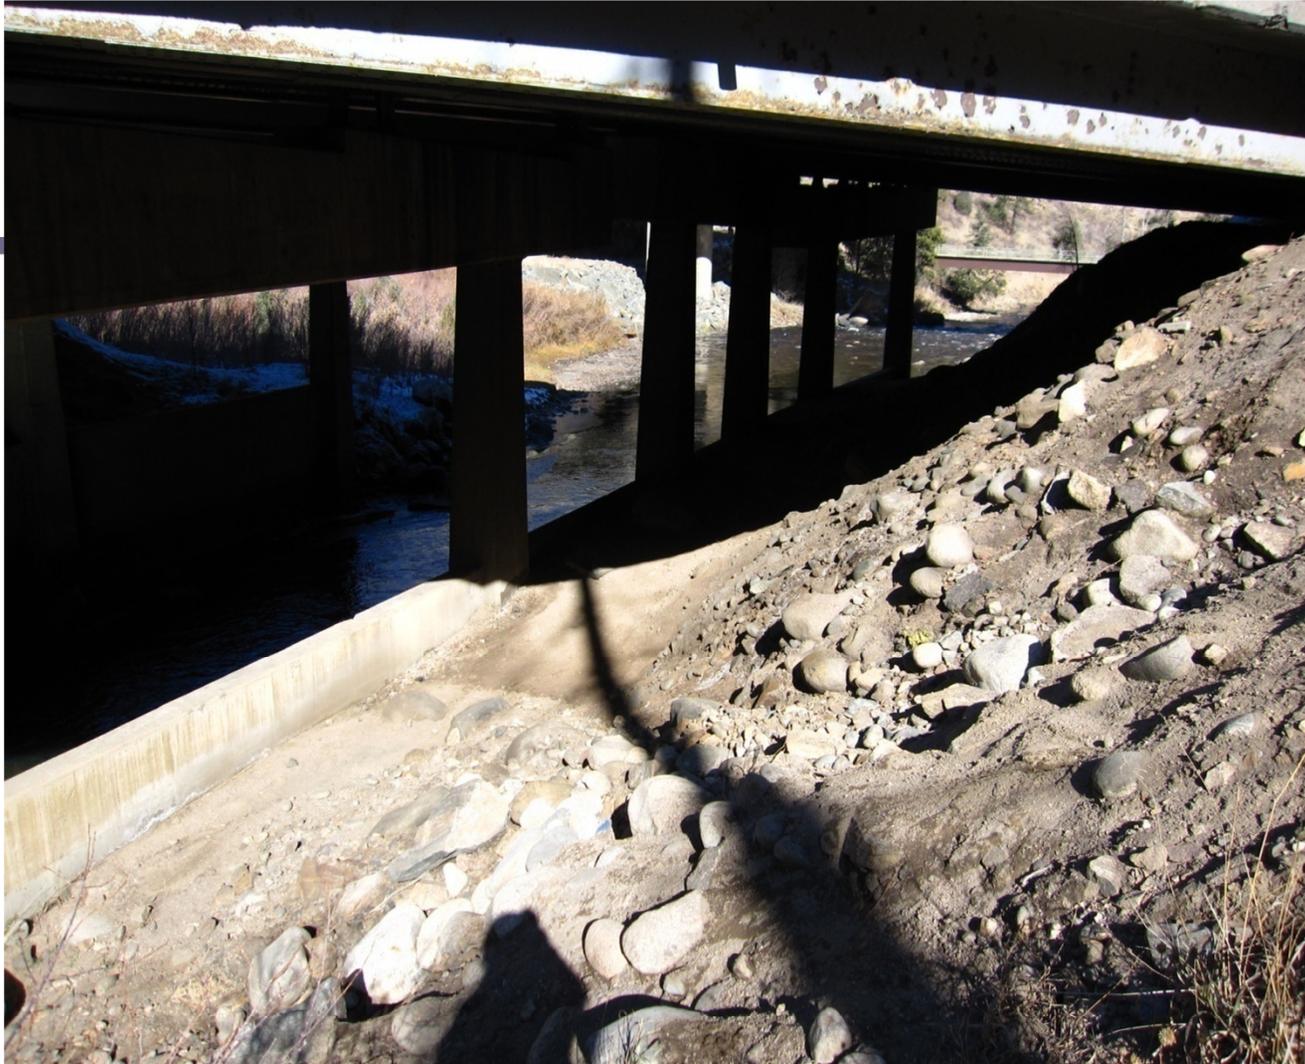
View of existing bench under the Hidden Valley Bridge

- When the bridge at this location is extended it is recommended to extend and maintain the existing bench.
- The approach on the upstream side of Clear Creek should be improved and “softened” to allow animals to move more freely (the approach on the upstream side of the creek is steep and there is large riprap).
- Replace large boulders and riprap with substrate that is more wildlife friendly.

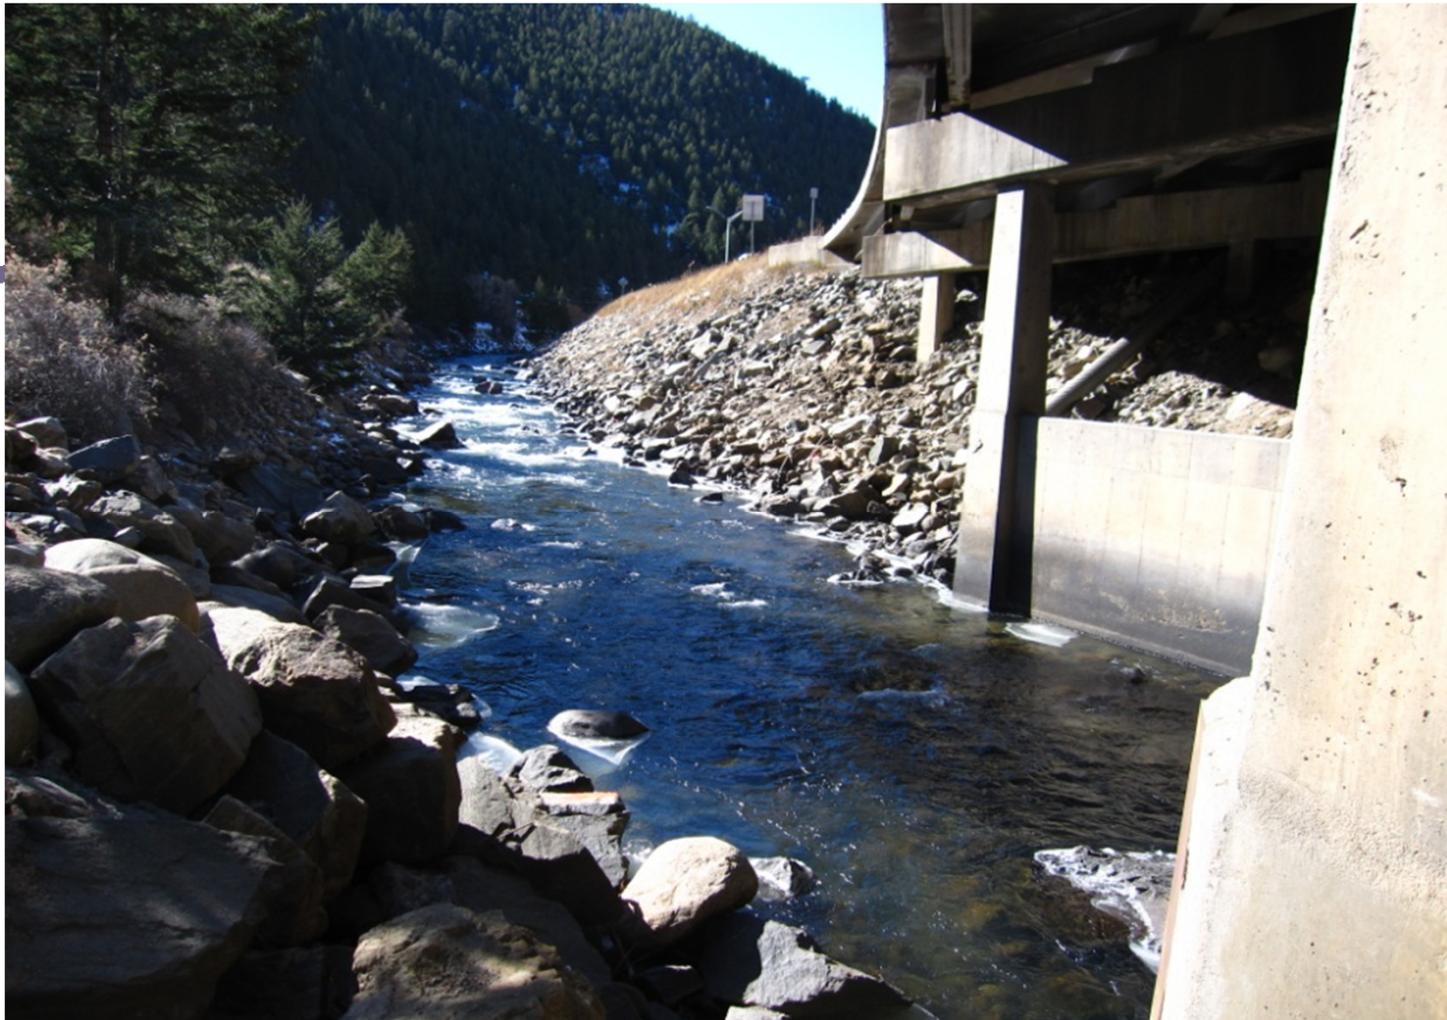
Hidden Valley Bridge over Clear Creek

View of habitat on the upstream side of the bridge- note steep banks and large riprap.

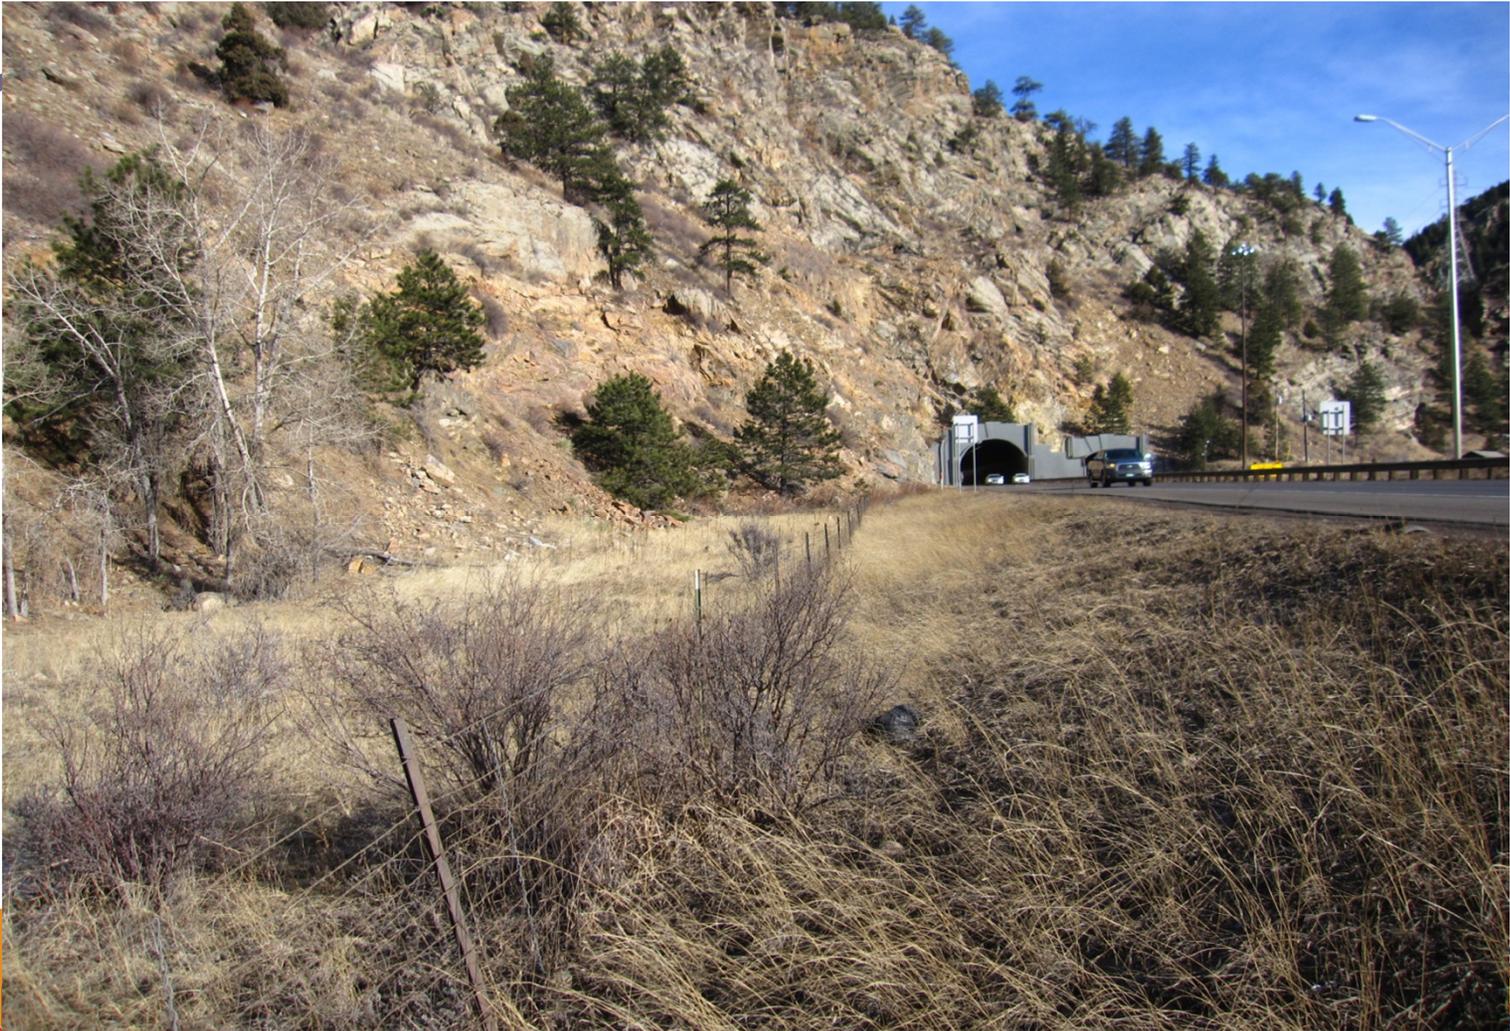
Existing Fence on North Side of I-70

Issues with existing fence:

- **Sheep have been tangled in fence.**
- **Fence has several different types of woven wire.**
- **Barbed wire is very loose and is on both the top and bottom strands, which is the most lethal fence to wildlife.**

- **Replace existing fence in the same location with more wildlife friendly fence per CPW recommendations.**
- **Fence should be replaced from the west portal to Clear Creek.**
- **Remove pines and junipers on north side of I-70 to improve motorists' ability to detect sheep as they exit the tunnel.**

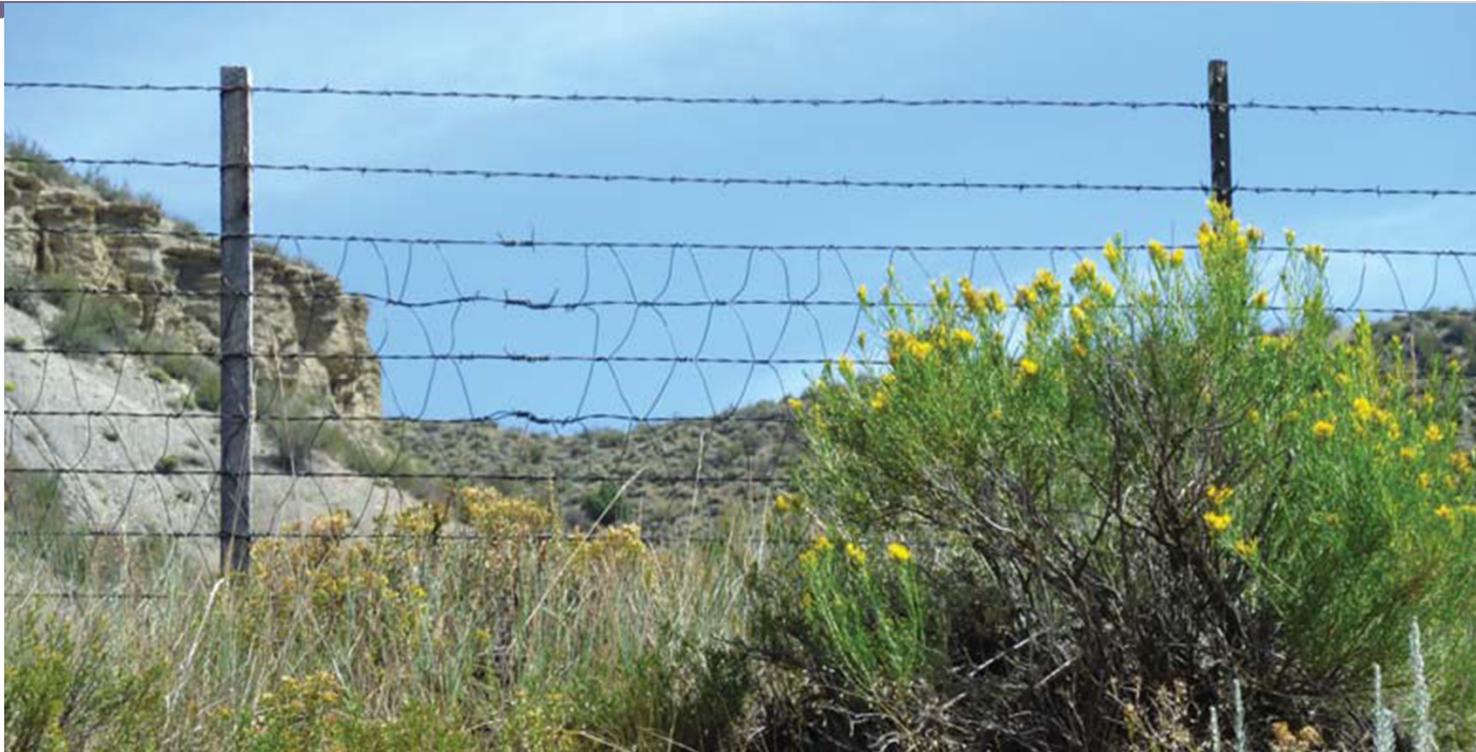
Woven-wire fence, especially if topped with barbed wire is the most lethal fence to wildlife.

» *Picture from Colorado Division of Wildlife:
Fencing with Wildlife in Mind, 2009 (Page 4).*

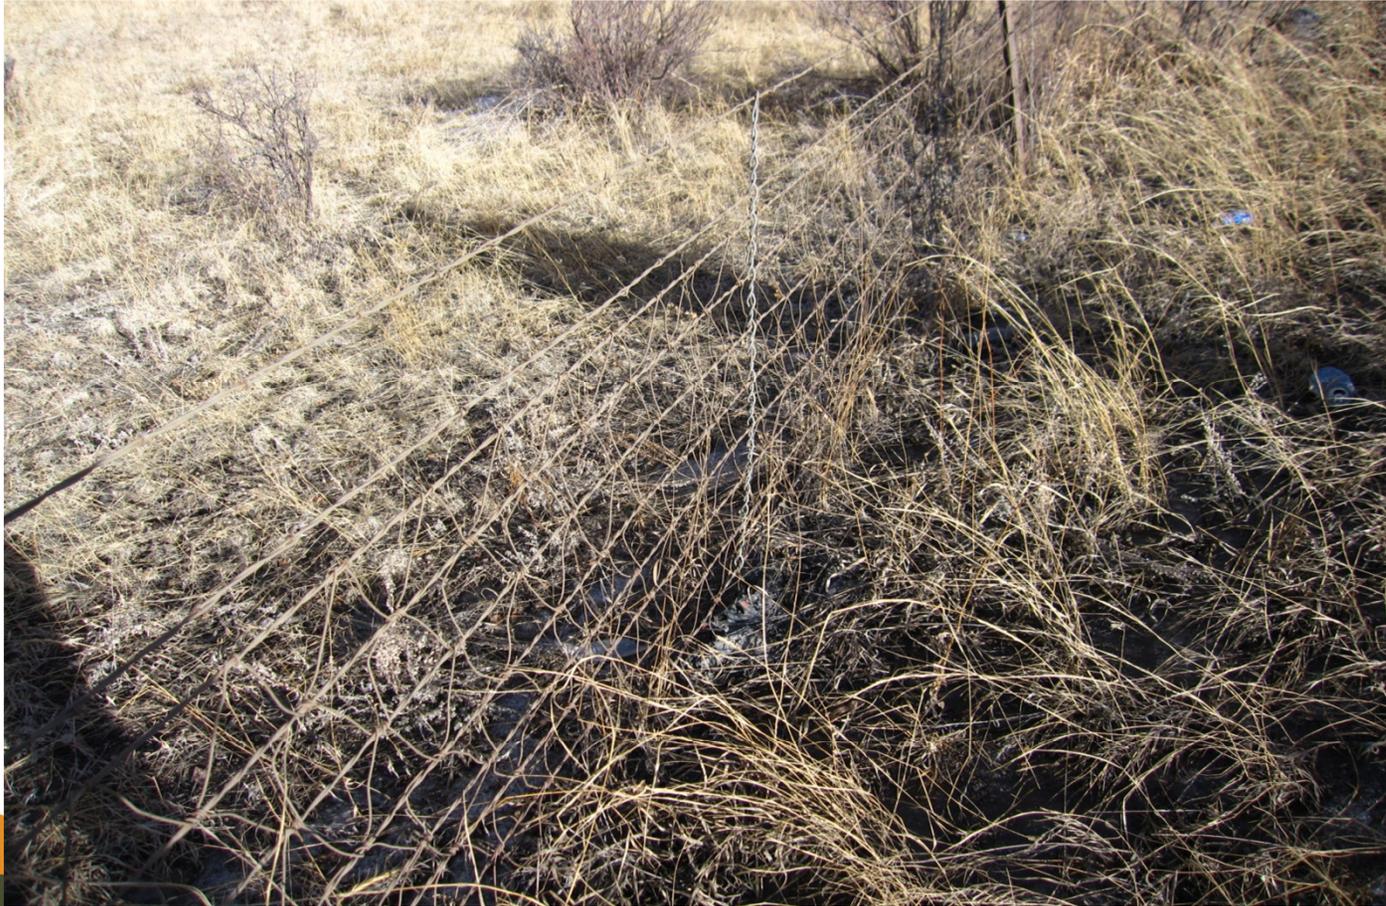
Existing fence on north side of I-70:

- Initial recommendation from CPW was complete removal of the fence.
- CDOT Region 1 contacted the landowner, Richard Young
- Landowner requested the fence remain in place because it is only fence that keeps his livestock of I-70

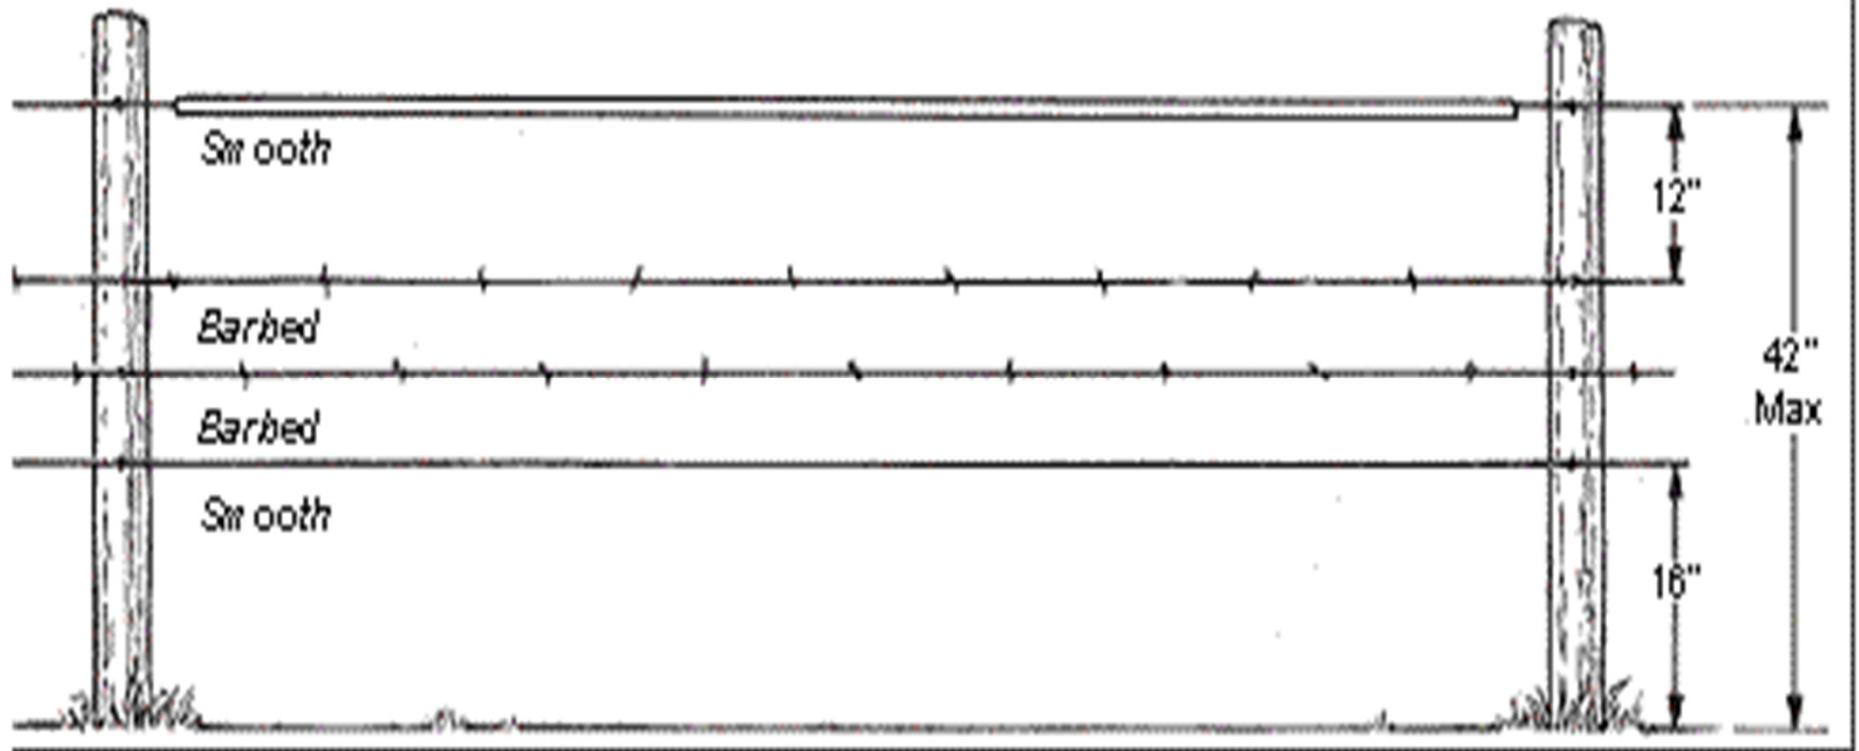
Colorado Parks and Wildlife Fencing Recommendation:

Graphic from Colorado Division of Wildlife: Fencing with Wildlife in Mind, 2009 (Page 7).

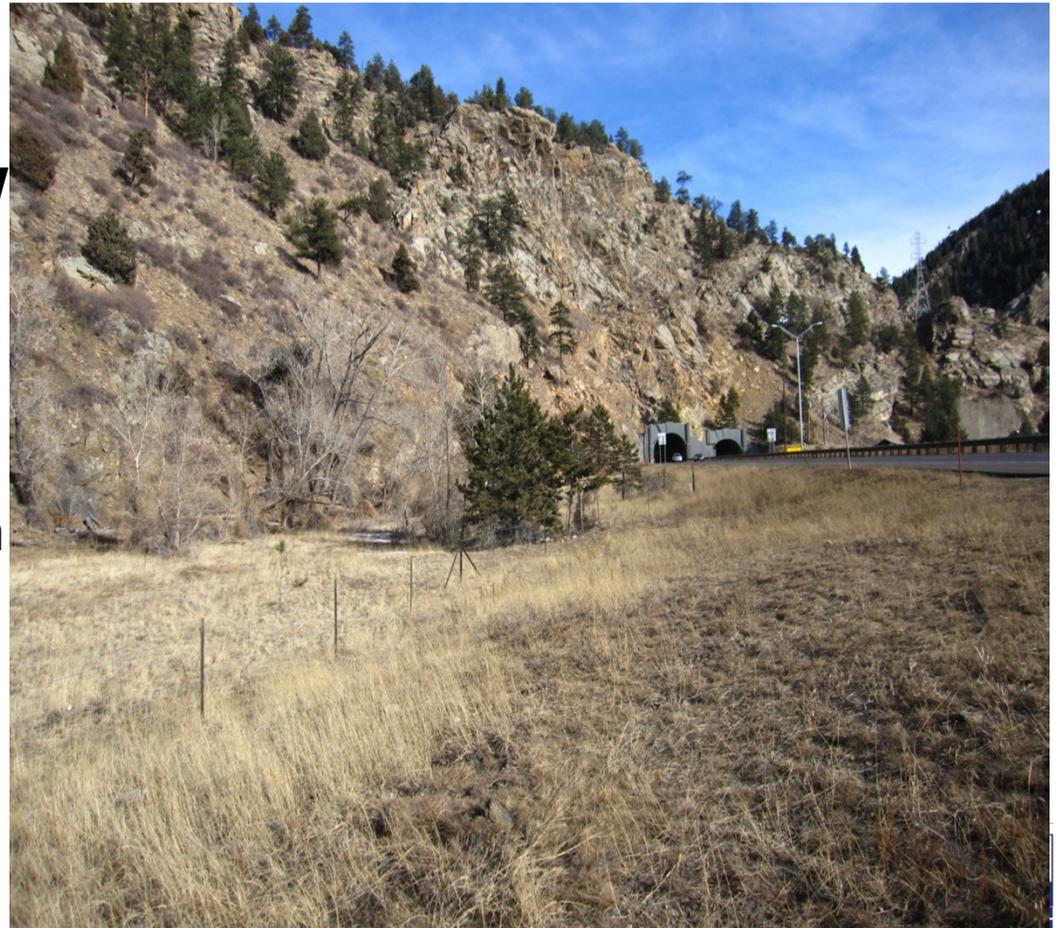
Recommended Wildlife Improvements on North Side of I-70

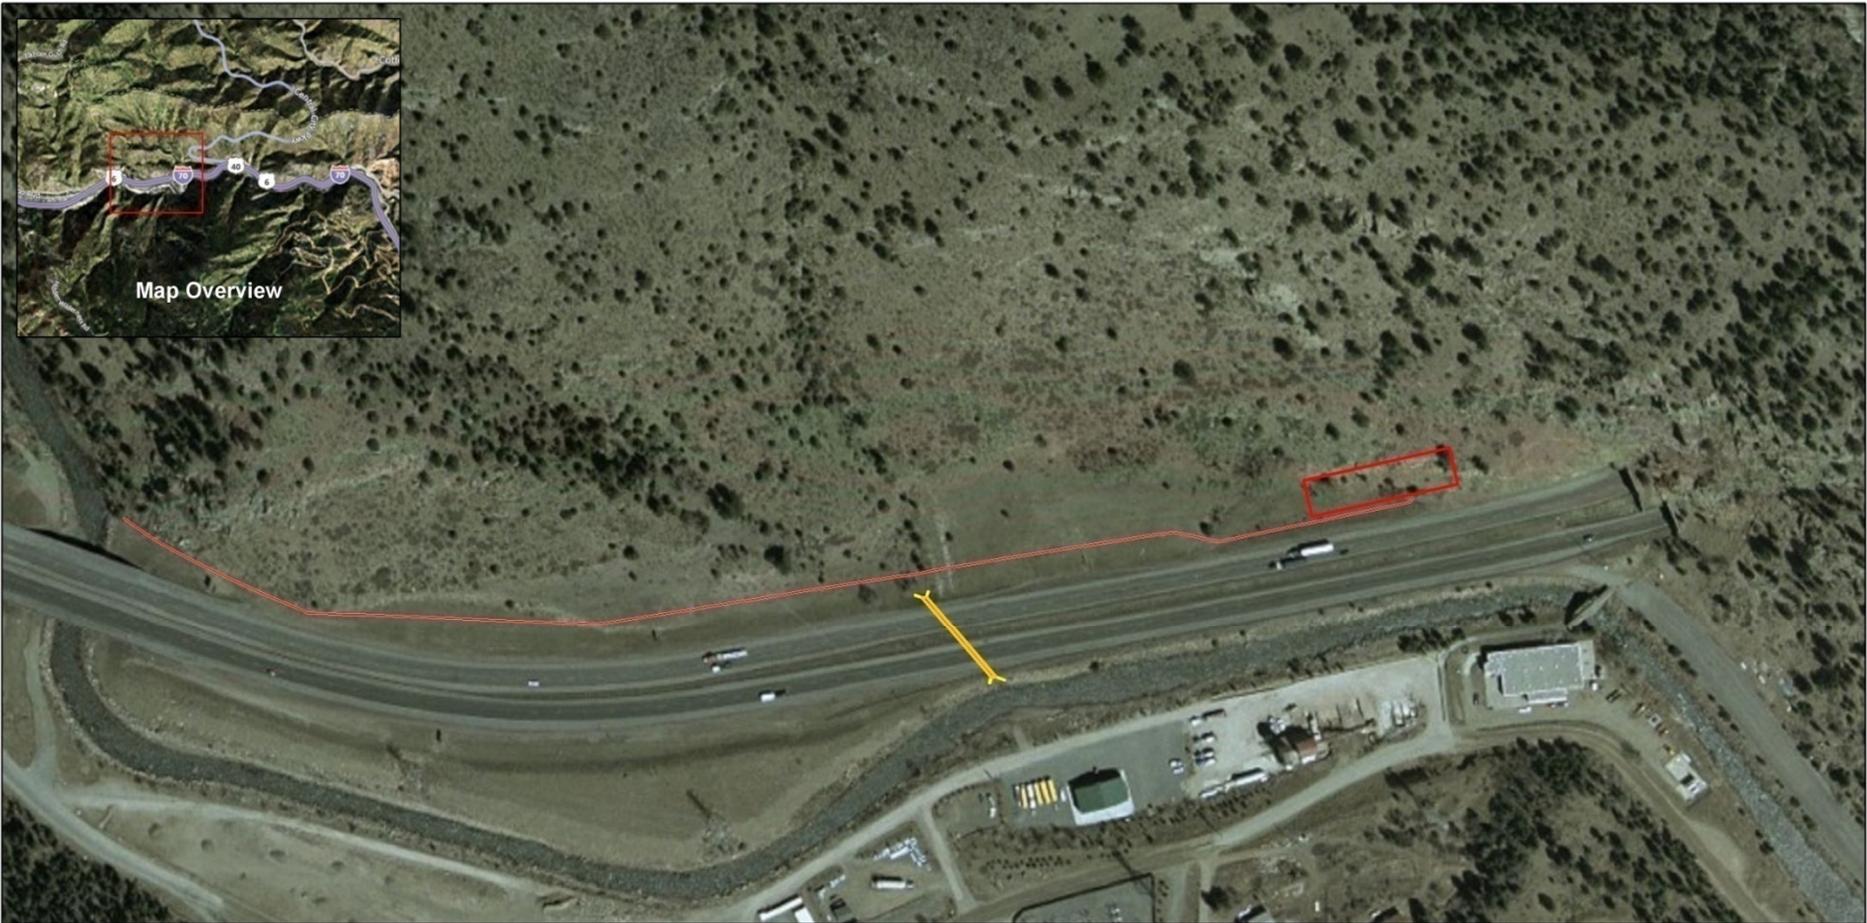
Existing fence: Combination woven-wire fence topped with barbed wire.

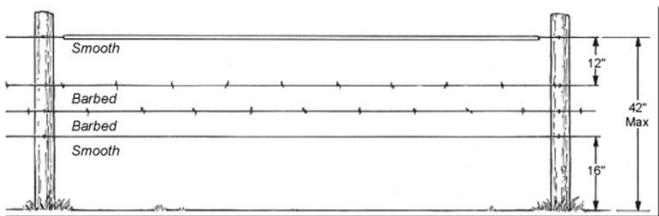
Schematic of Wildlife Friendly Fence

- Barbwire Fence
- Wingwall*
- Box Culvert
- Vegetation Removal

*Fence will be tied into the wingwalls of the CBC to encourage wildlife usage.

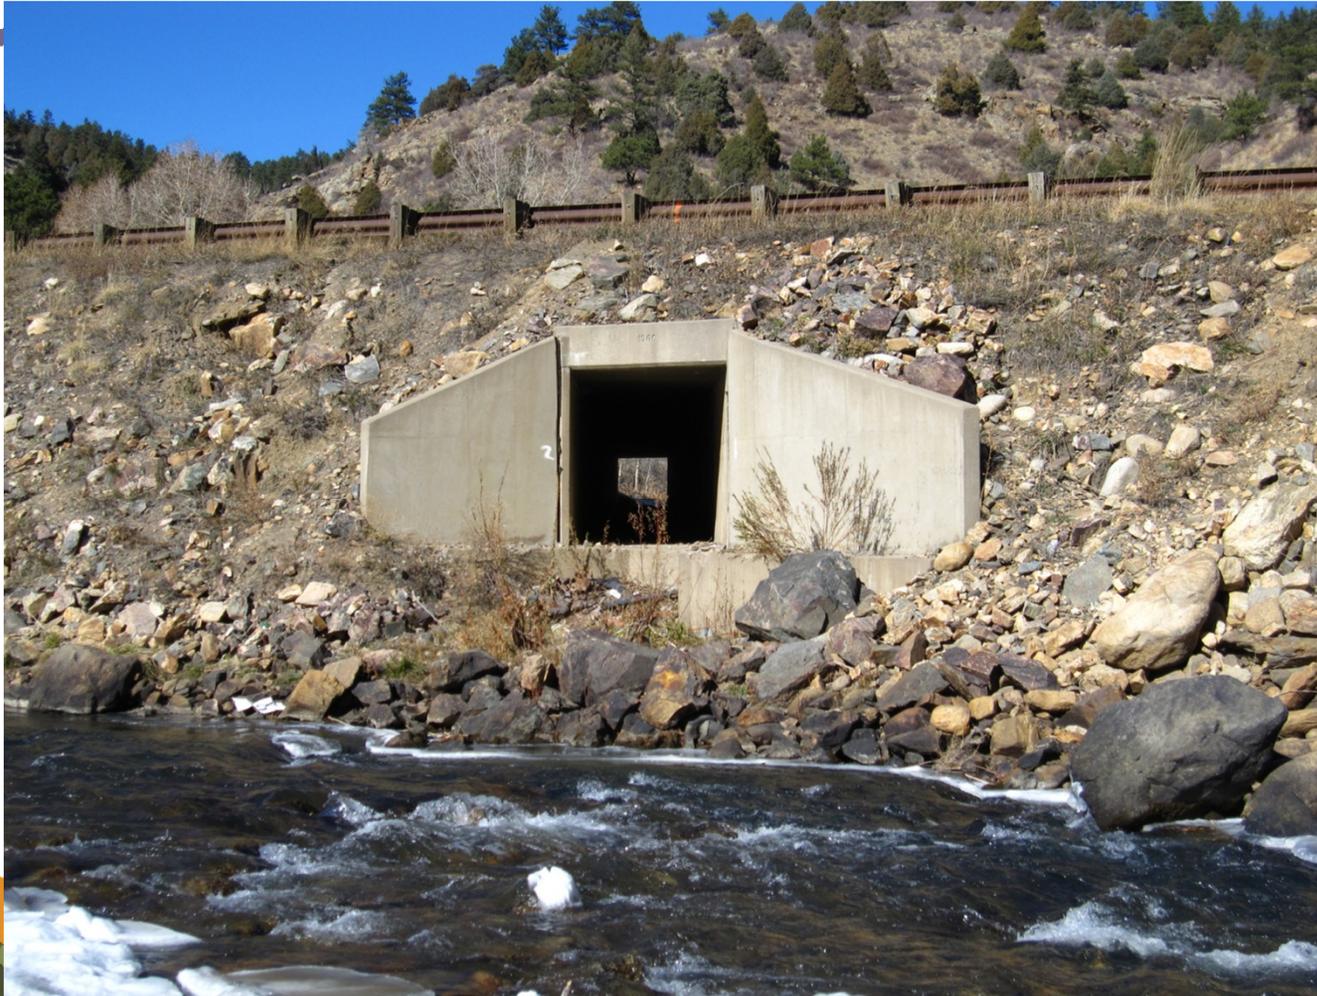
Consider Opportunities to Enhance Wildlife Movement in Concrete Box Culvert near Mile Marker 242

- **The existing barbed wire fence crosses one intermittent drainage just west of the west portal near MM 242. There is a concrete box culvert (CBC) at this location that carries flows from this drainage under I-70 and discharges to Clear Creek.**
- **Enhancement opportunities at this location are being recommended to enhance wildlife movement/connectivity. The CBC currently has a concrete bottom and the discharge point at Clear Creek has a steep drop-off.**

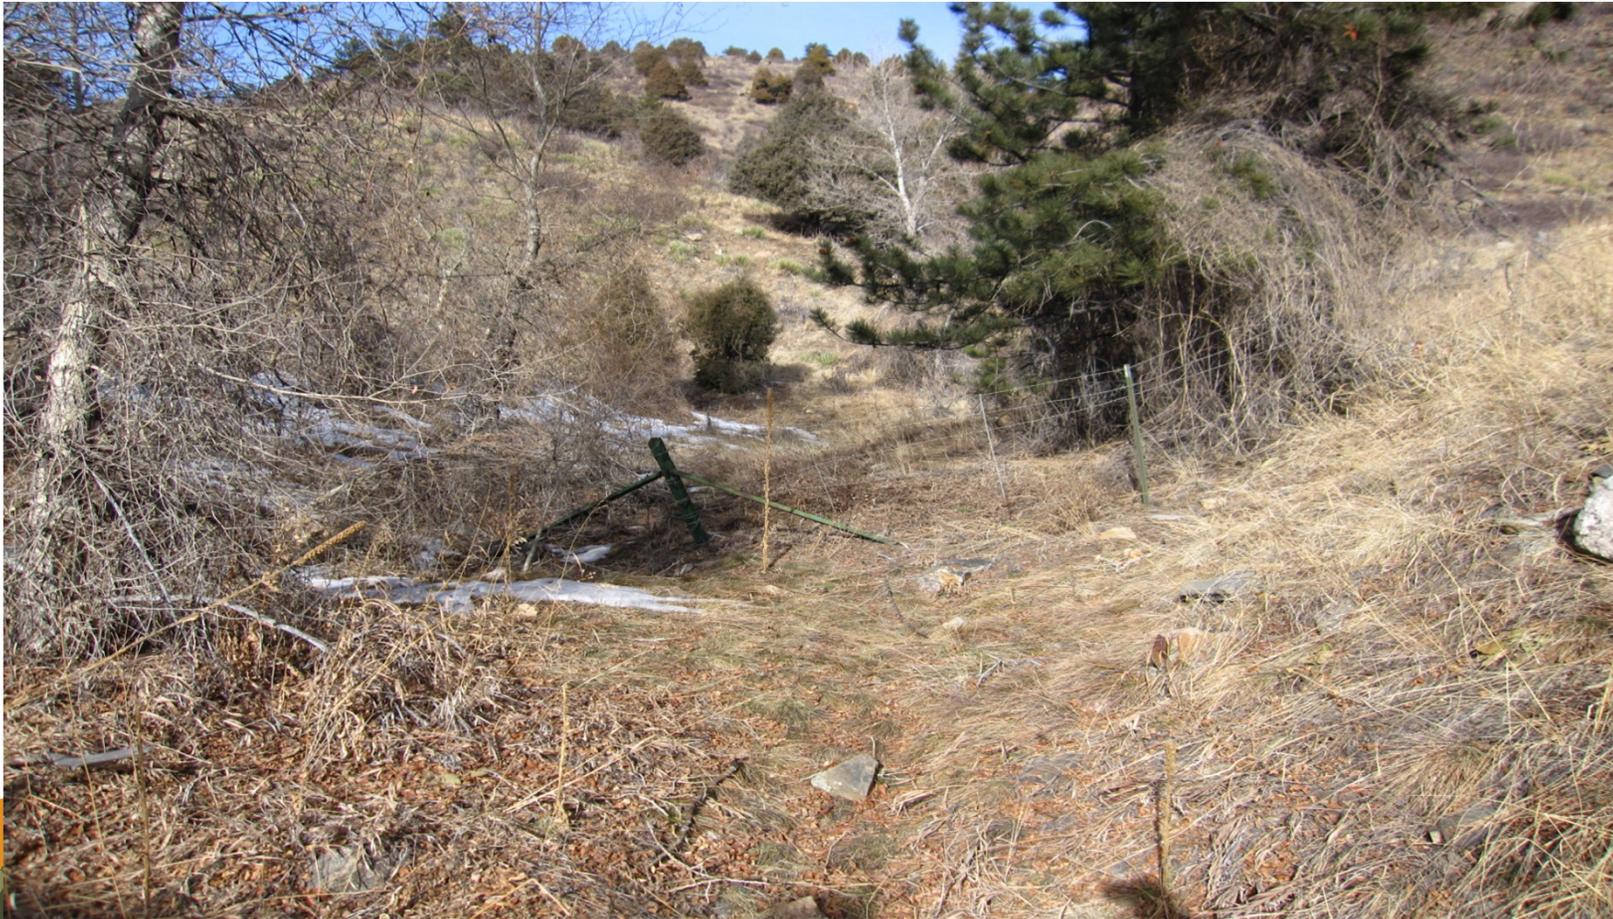
View of intermittent drainage- facing north (note existing barbed wire fence across drainage)

- If the fence is replaced, it is recommended that the drainage be left open- and instead of fencing across the drainage (like the existing condition) the fence should be tied in to the wing-walls of the CBC to encourage wildlife usage.
- It is recommended that the CBC be retrofitted to provide a more natural substrate on the bottom. Baffles could be installed to retain sediment and prevent scour. A natural substrate on the bottom is recommended to promote usage by wildlife.

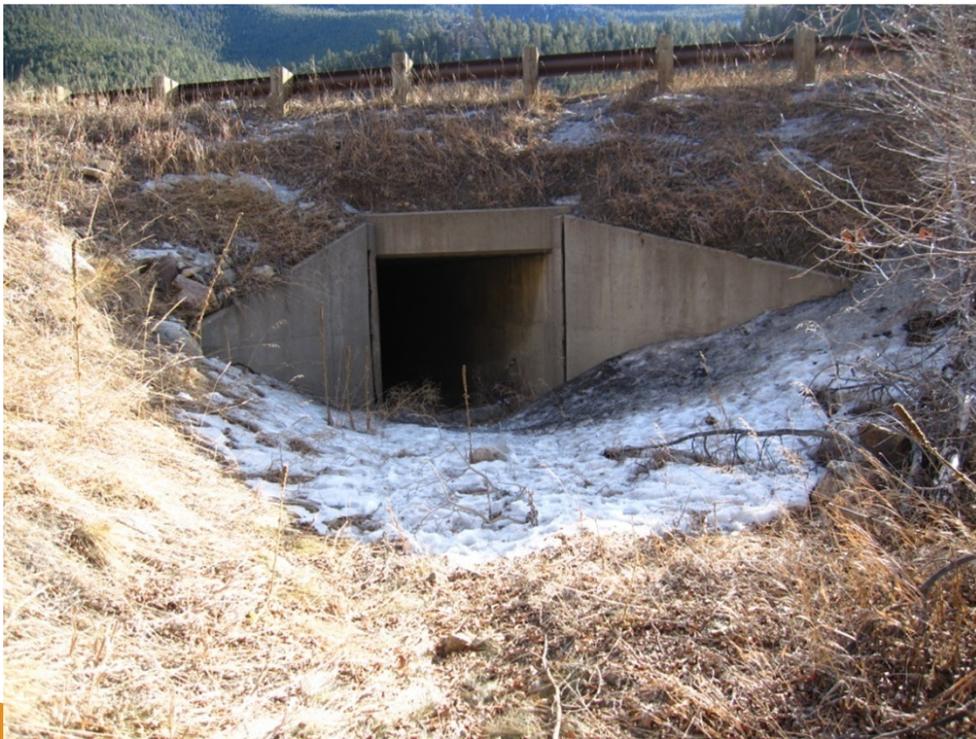
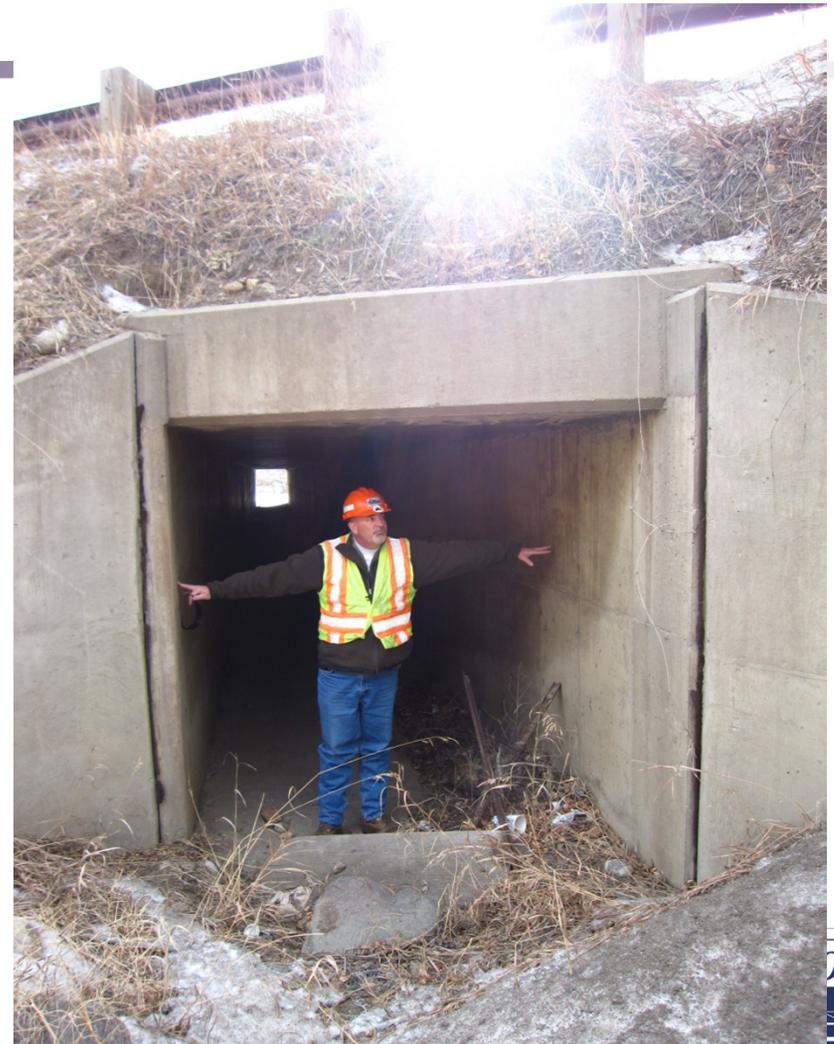
Concrete Box Culvert- view from north side of I-70

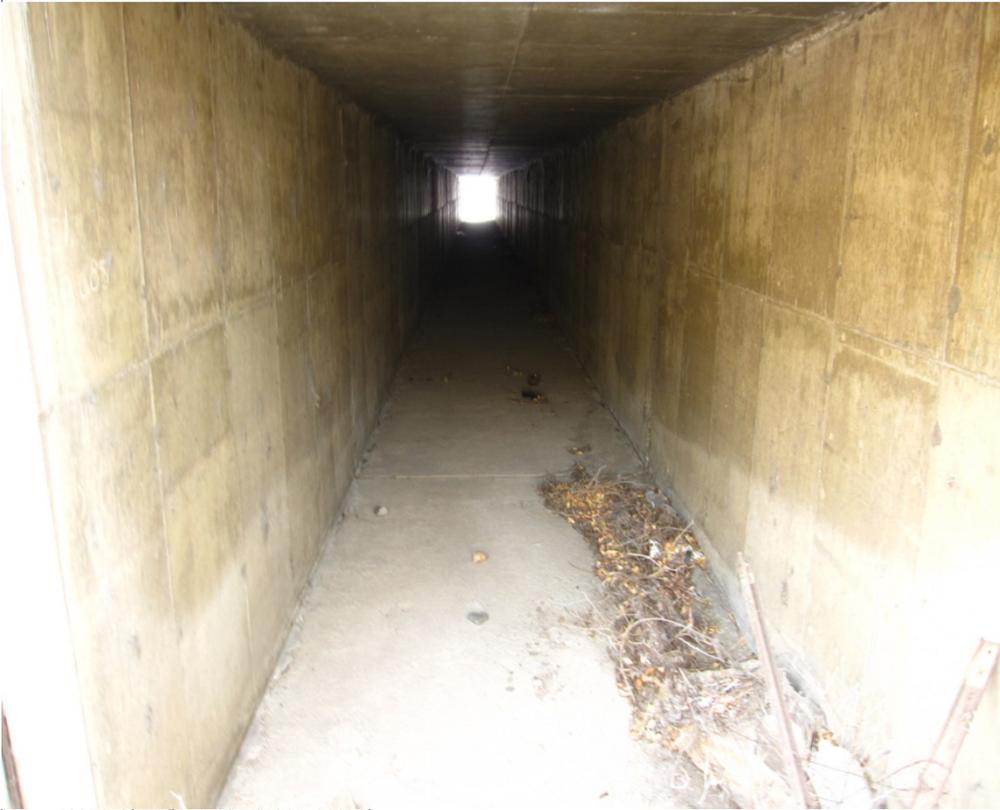
Concrete Box Culvert-

Concrete Bottom

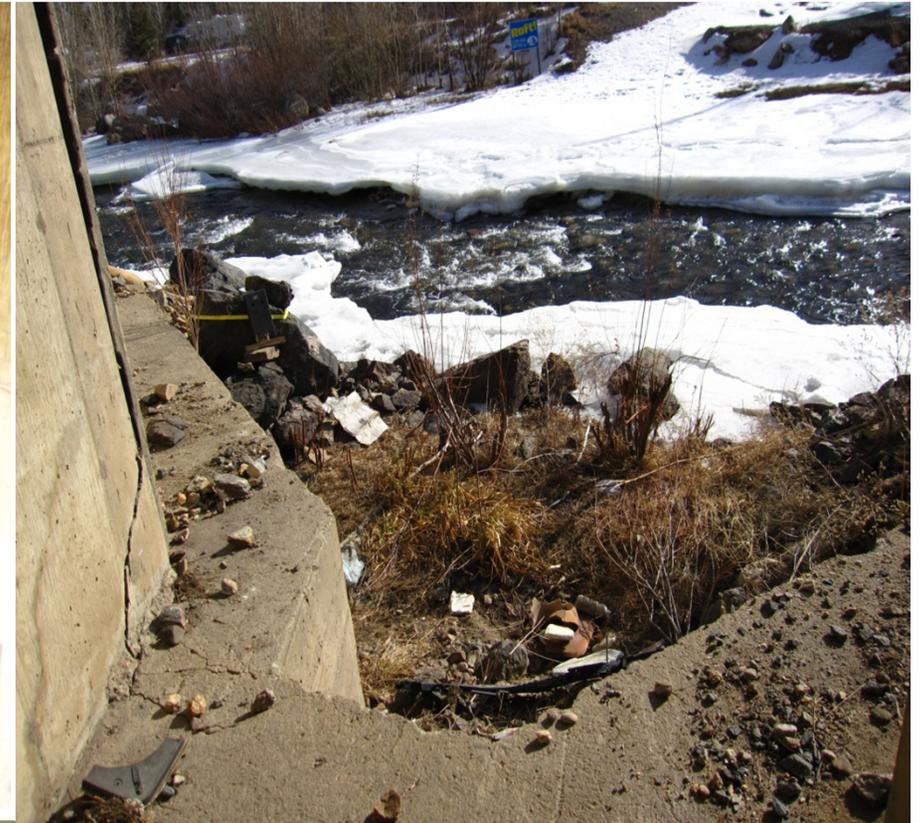
Steep Drop-Off

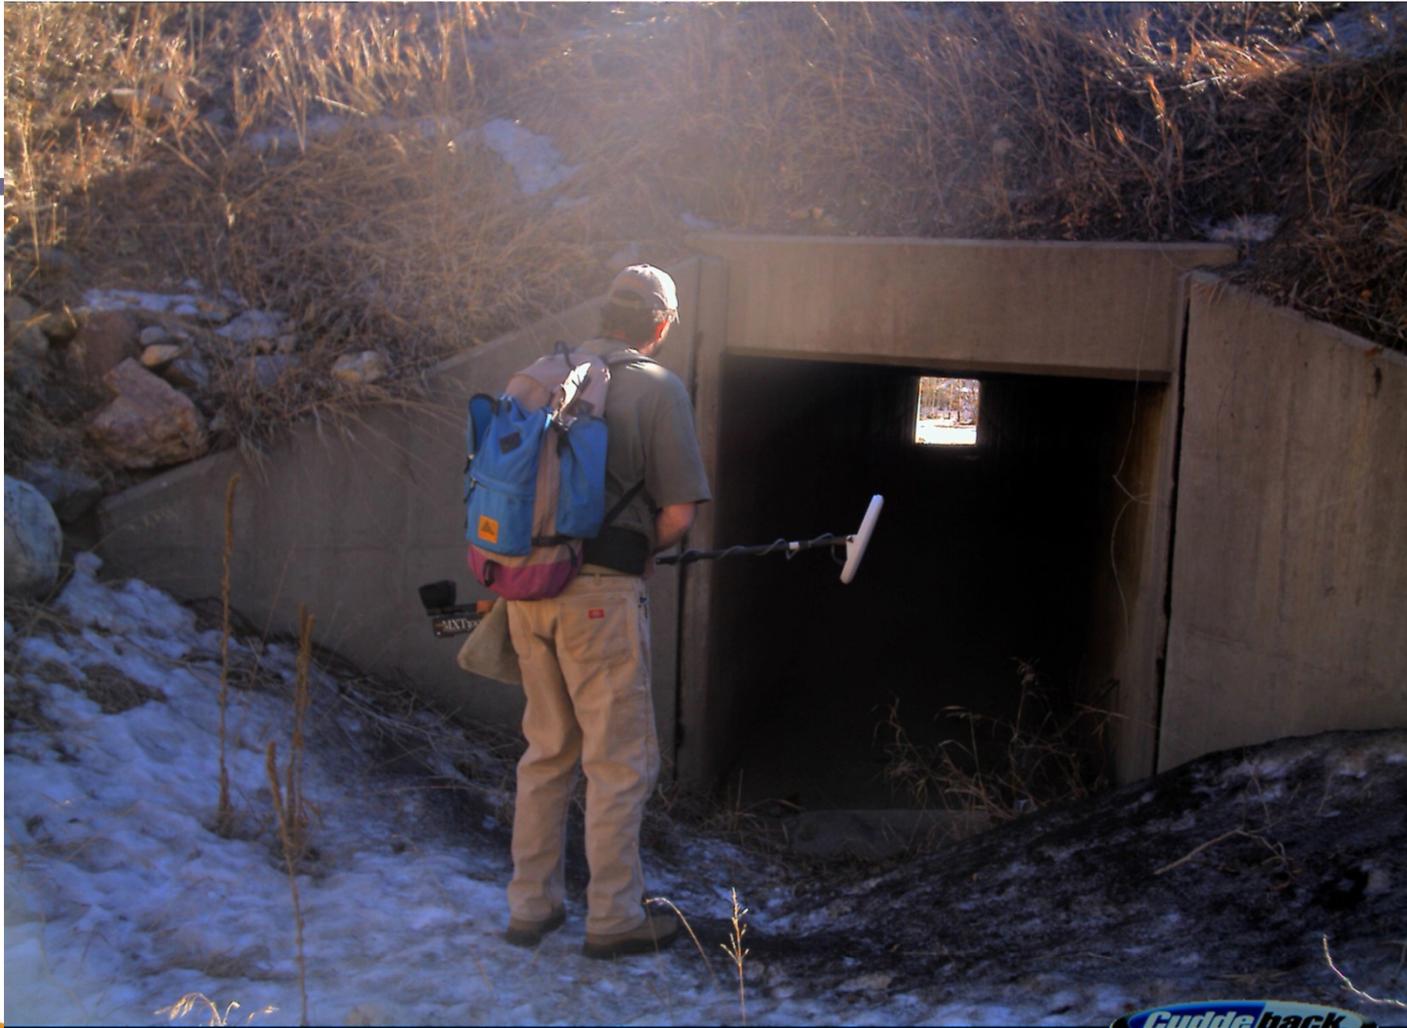
CBC Wildlife Monitoring

Motion detection wildlife cameras have been in place since January 4, 2012....

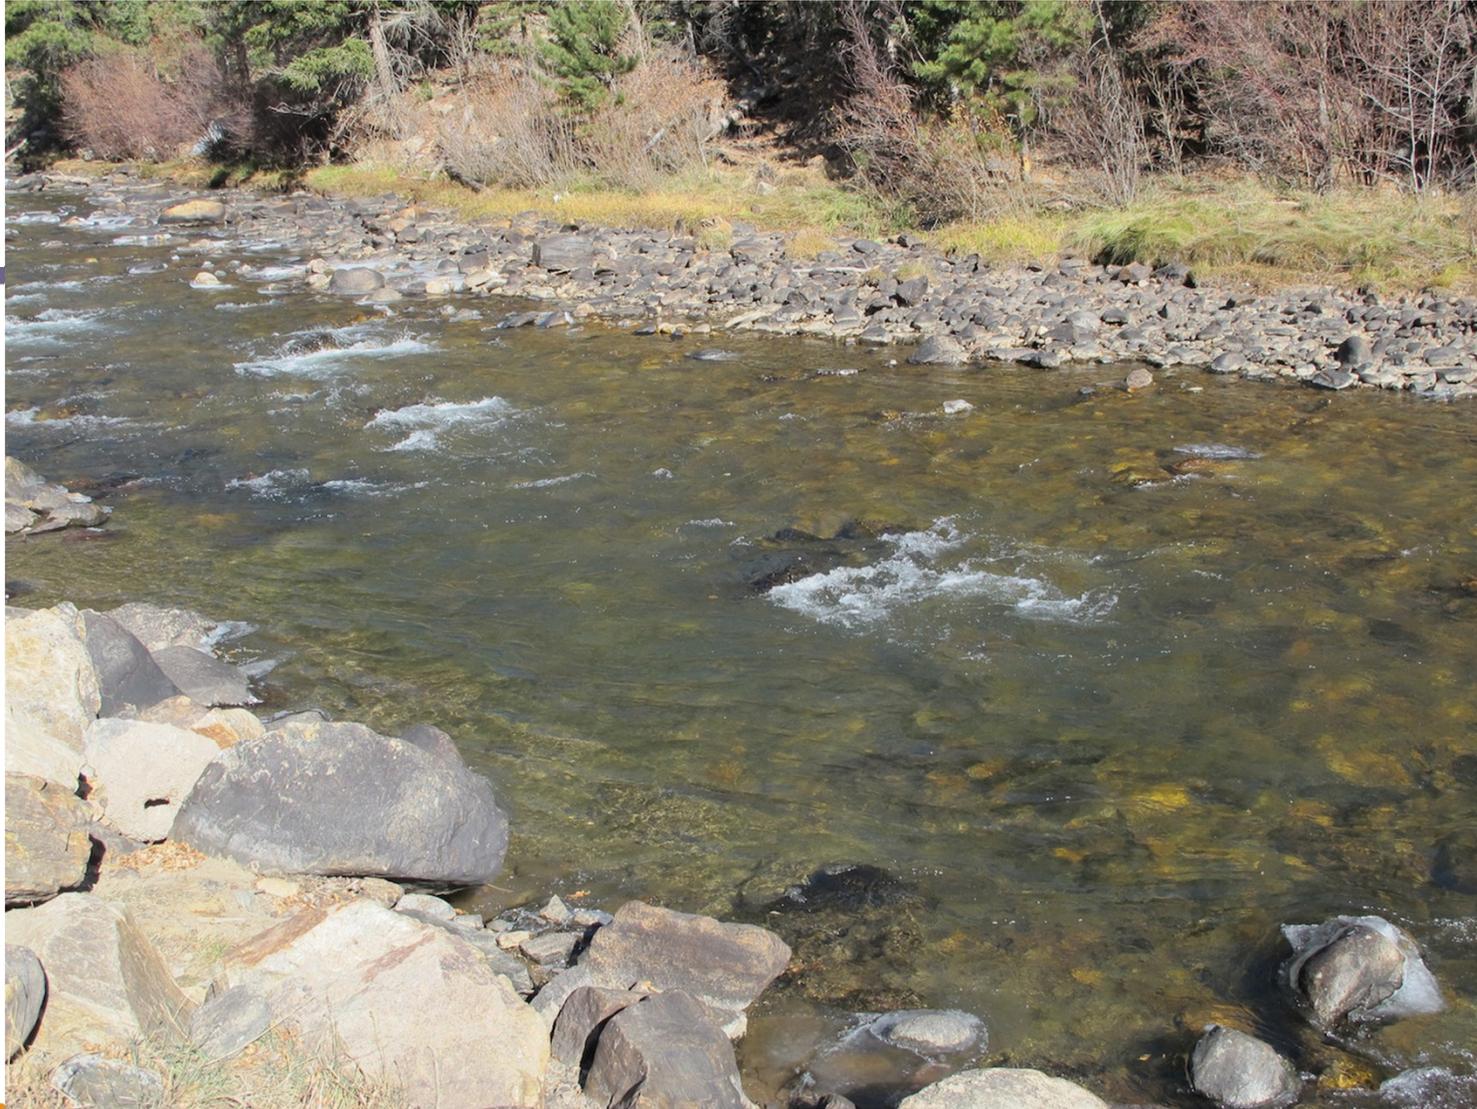
Reference Habitat Section upstream of I-70 Bridge Near Idaho Springs

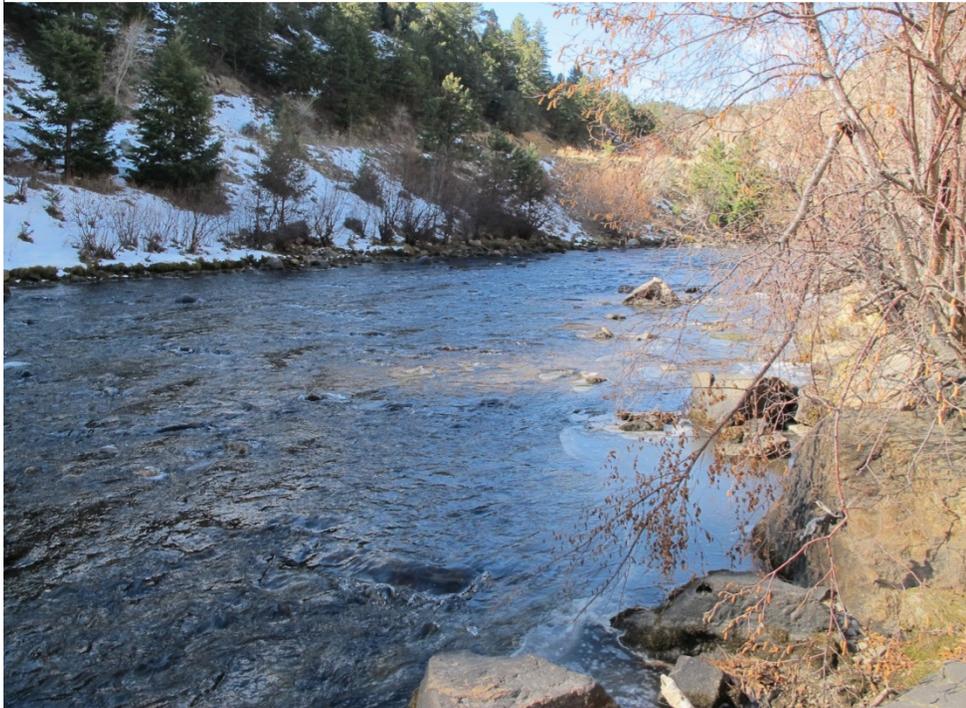
Potential habitat improvement site upstream of Dog House Bridge

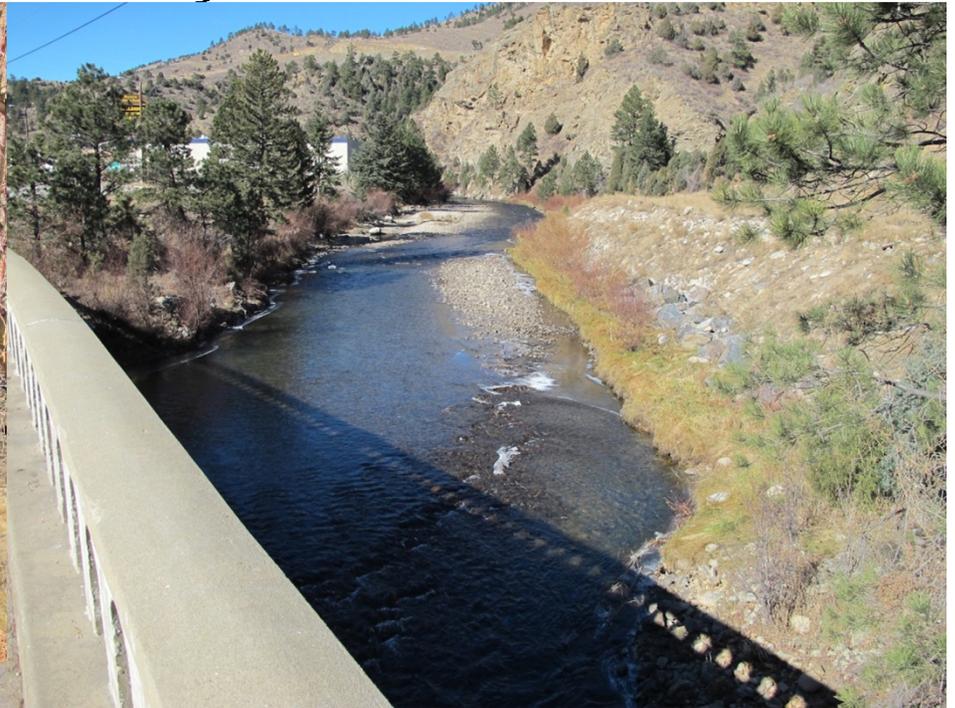
Potential habitat improvement site upstream from Central City Parkway
