Twin Tunnels Environmental Assessment and Frontage Road Project ALIVE Meeting*

January 20, 2012
CDOT Region 1

Twin Tunnels Environmental Assessment
Idaho Springs/Clear Creek County

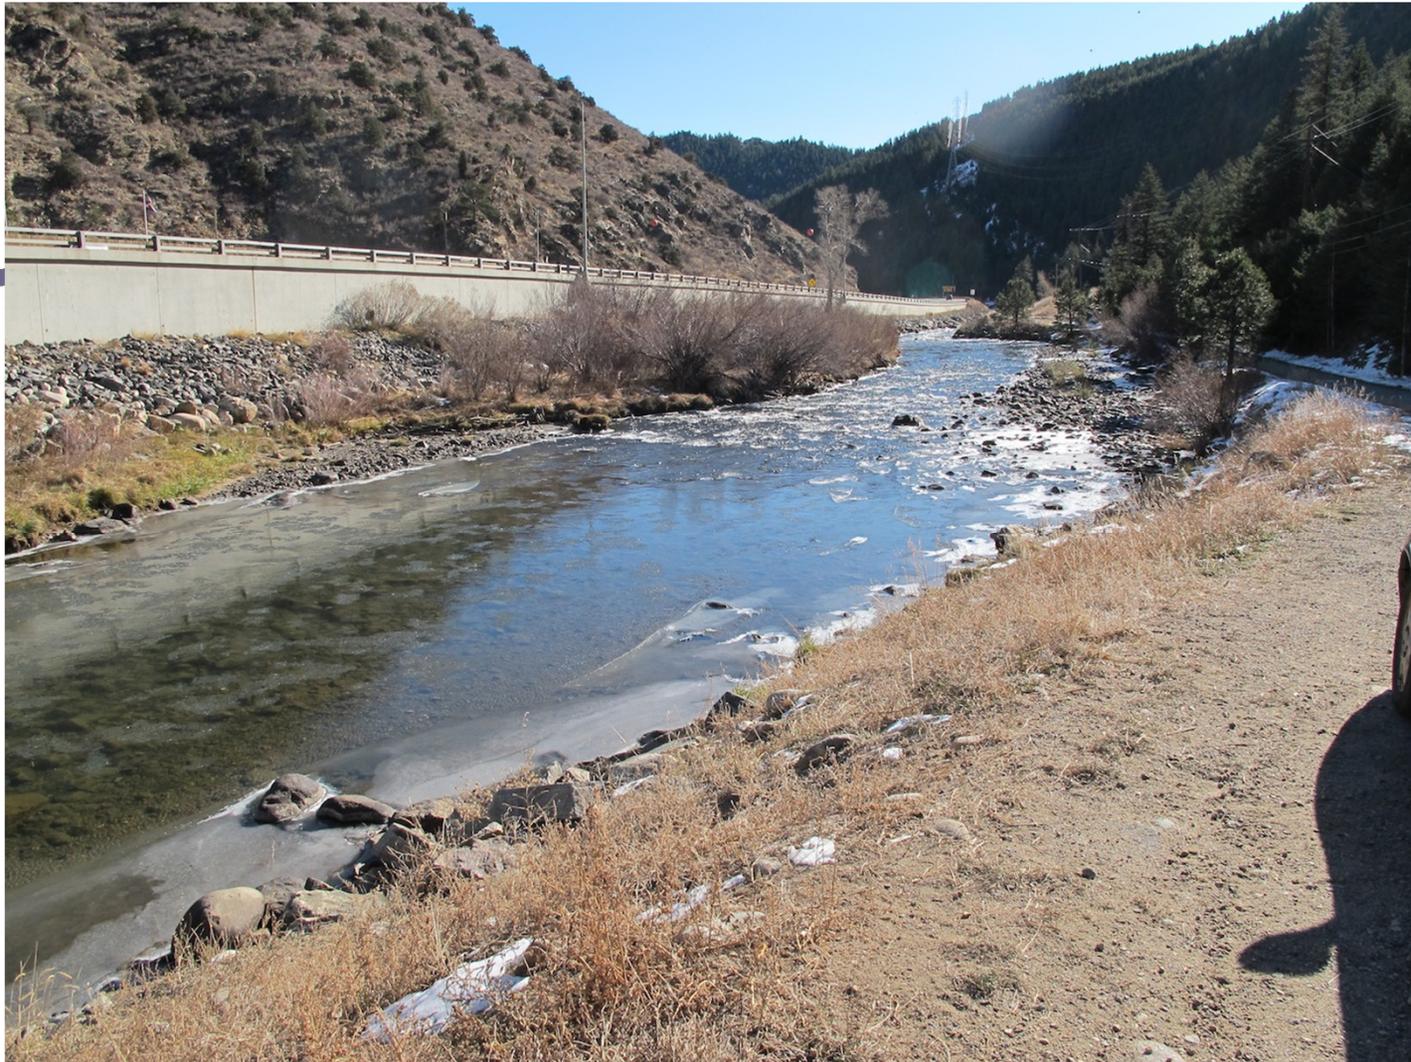
Potential habitat improvement site downstream from Hidden Valley exit

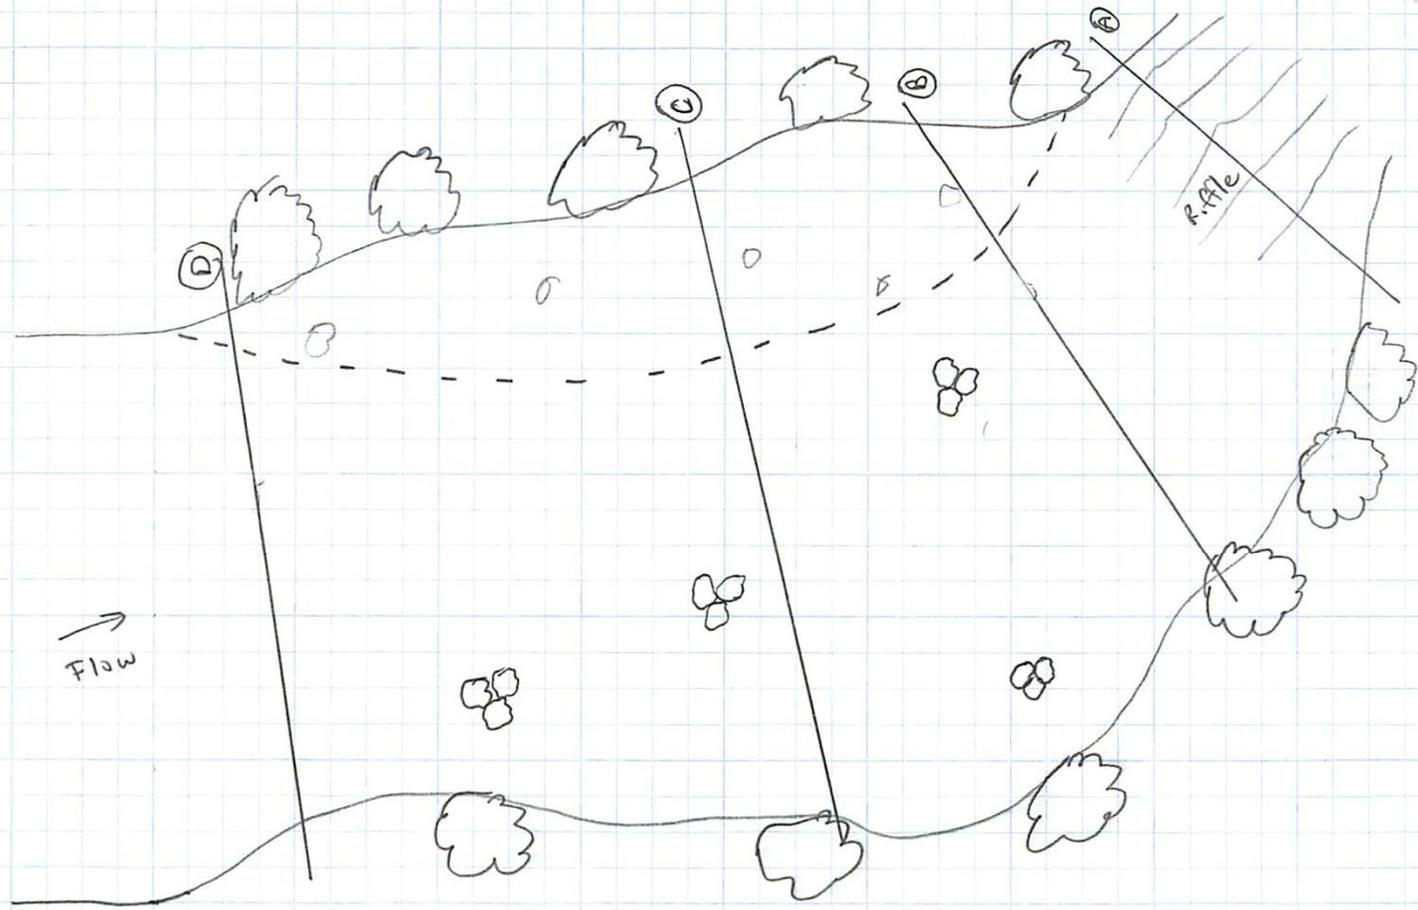
Sheet 1 - Example habitat improvement plan view.

Example habitat improvement plan view in wider stream section. Dotted line represents edge of constructed point bar at low flow

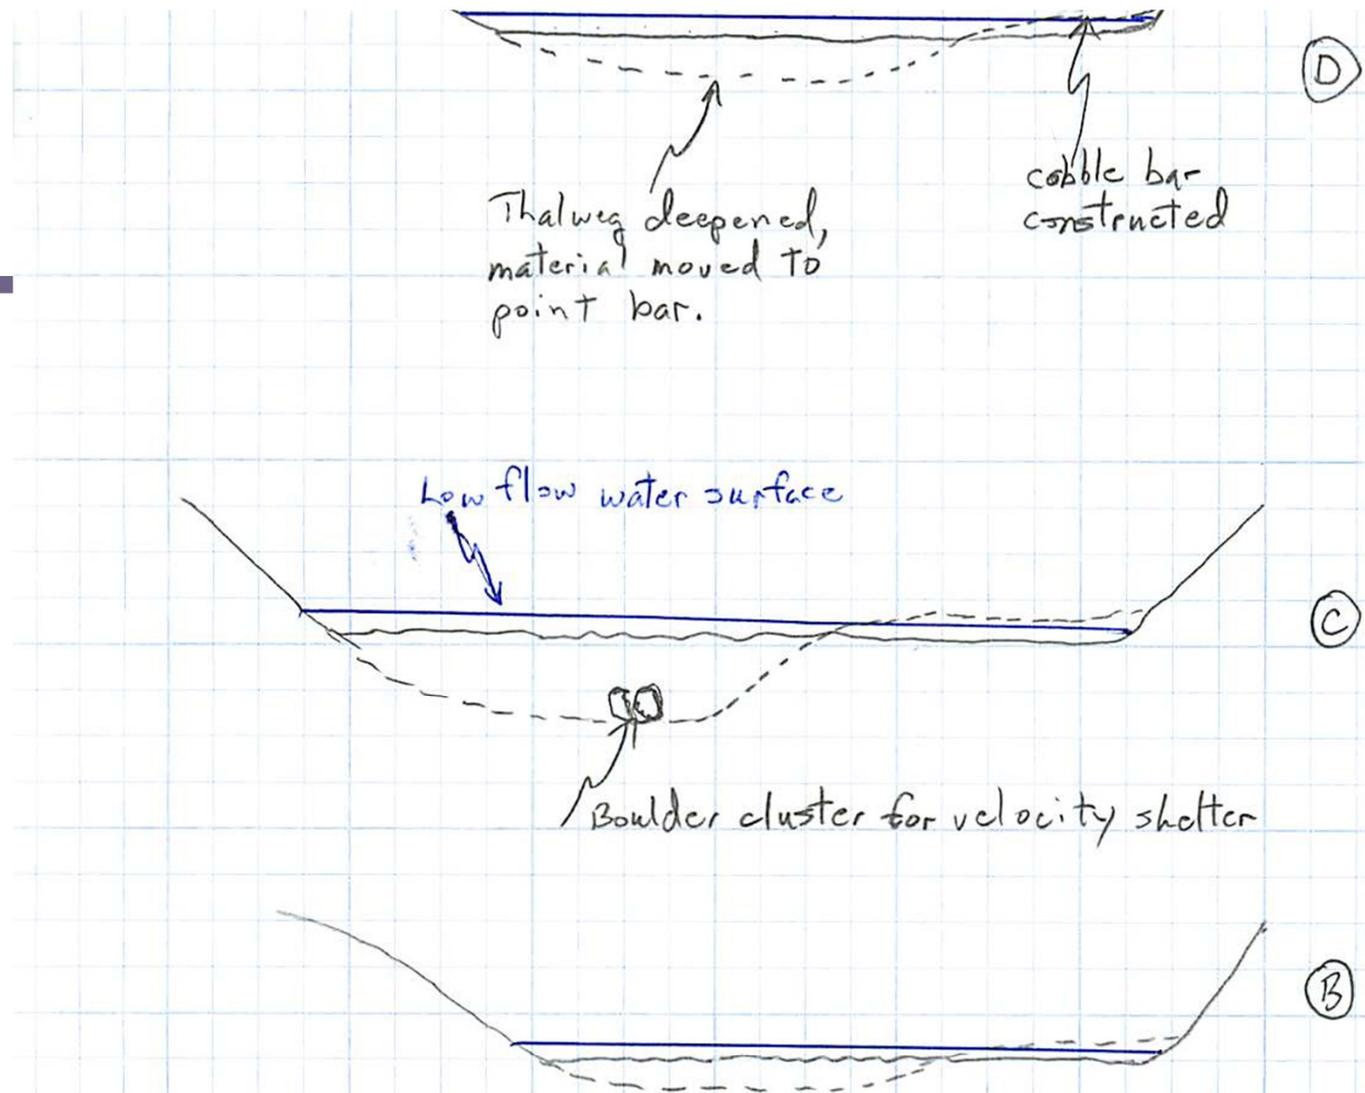
Example of cross sections in habitat improvement sites. Dotted line represents future bed profile and point bar construction

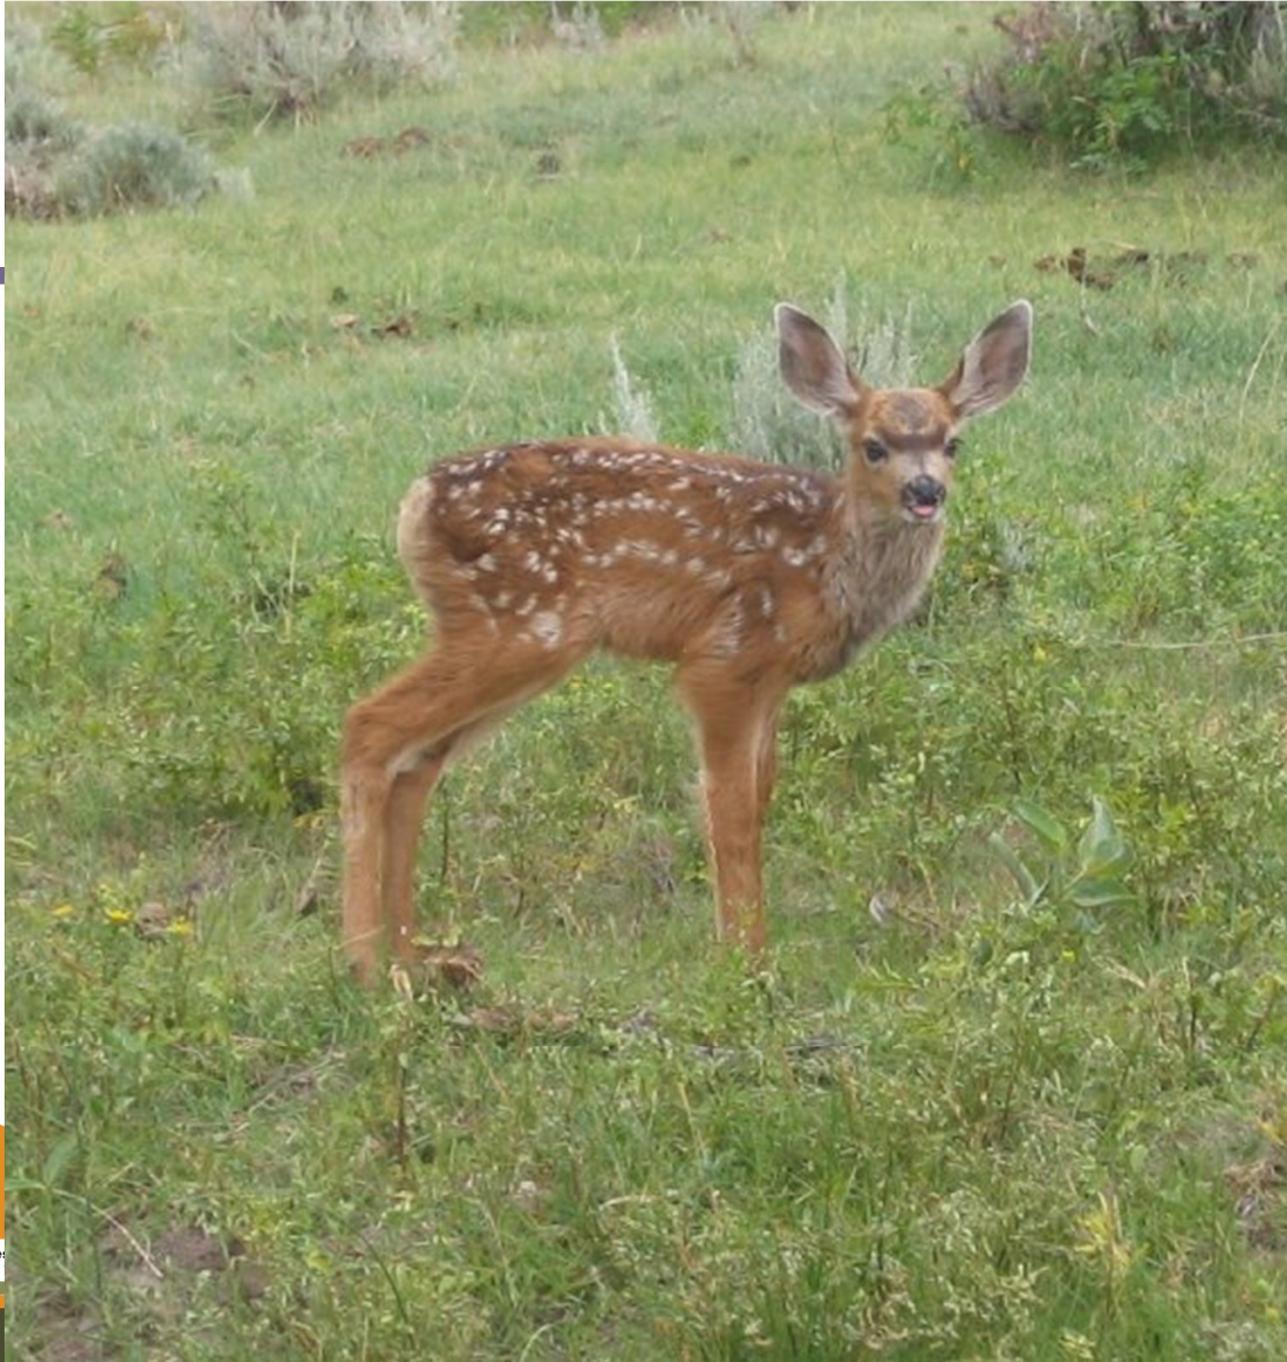
(Conceptual Design- Subject to Revision)
