SUBJECT: **Abbreviated Safety Assessment Report:
SH 50B: MP 386.00 - 397.00, Las Animas West**

Abbreviated Safety Assessment Report

SH 50B: MP 386.00 - MP 397.00
March 2008

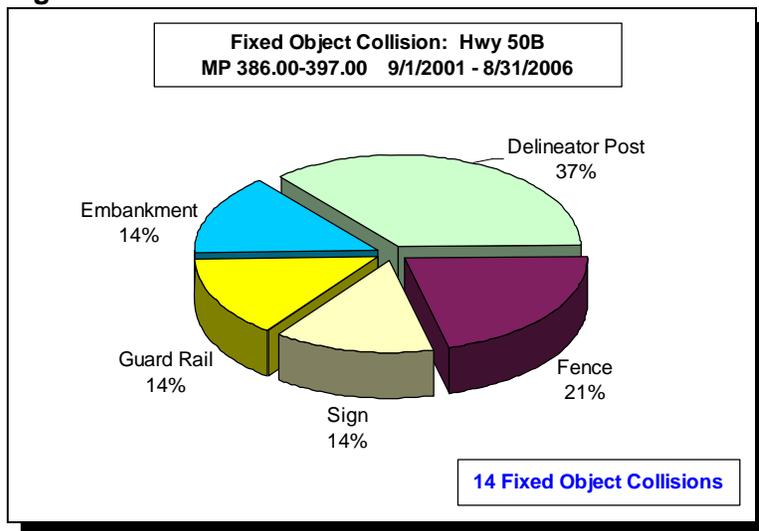
Figure 1a

Figure 1 presents a breakdown of the accident type detected along this highway. Running off the road and colliding with various fixed objects was the most frequently occurring type, accounting for 14 accidents or 35% of the total. Among the fixed objects struck, delineator posts and roadside fencing were most common. Collisions with deer or other wild animals were next in frequency of occurrence, accounting for an additional 5 of the 39 total accidents. Various other crash types were identified, all of which were reported at frequencies of 3 or less during the 5 year study period.

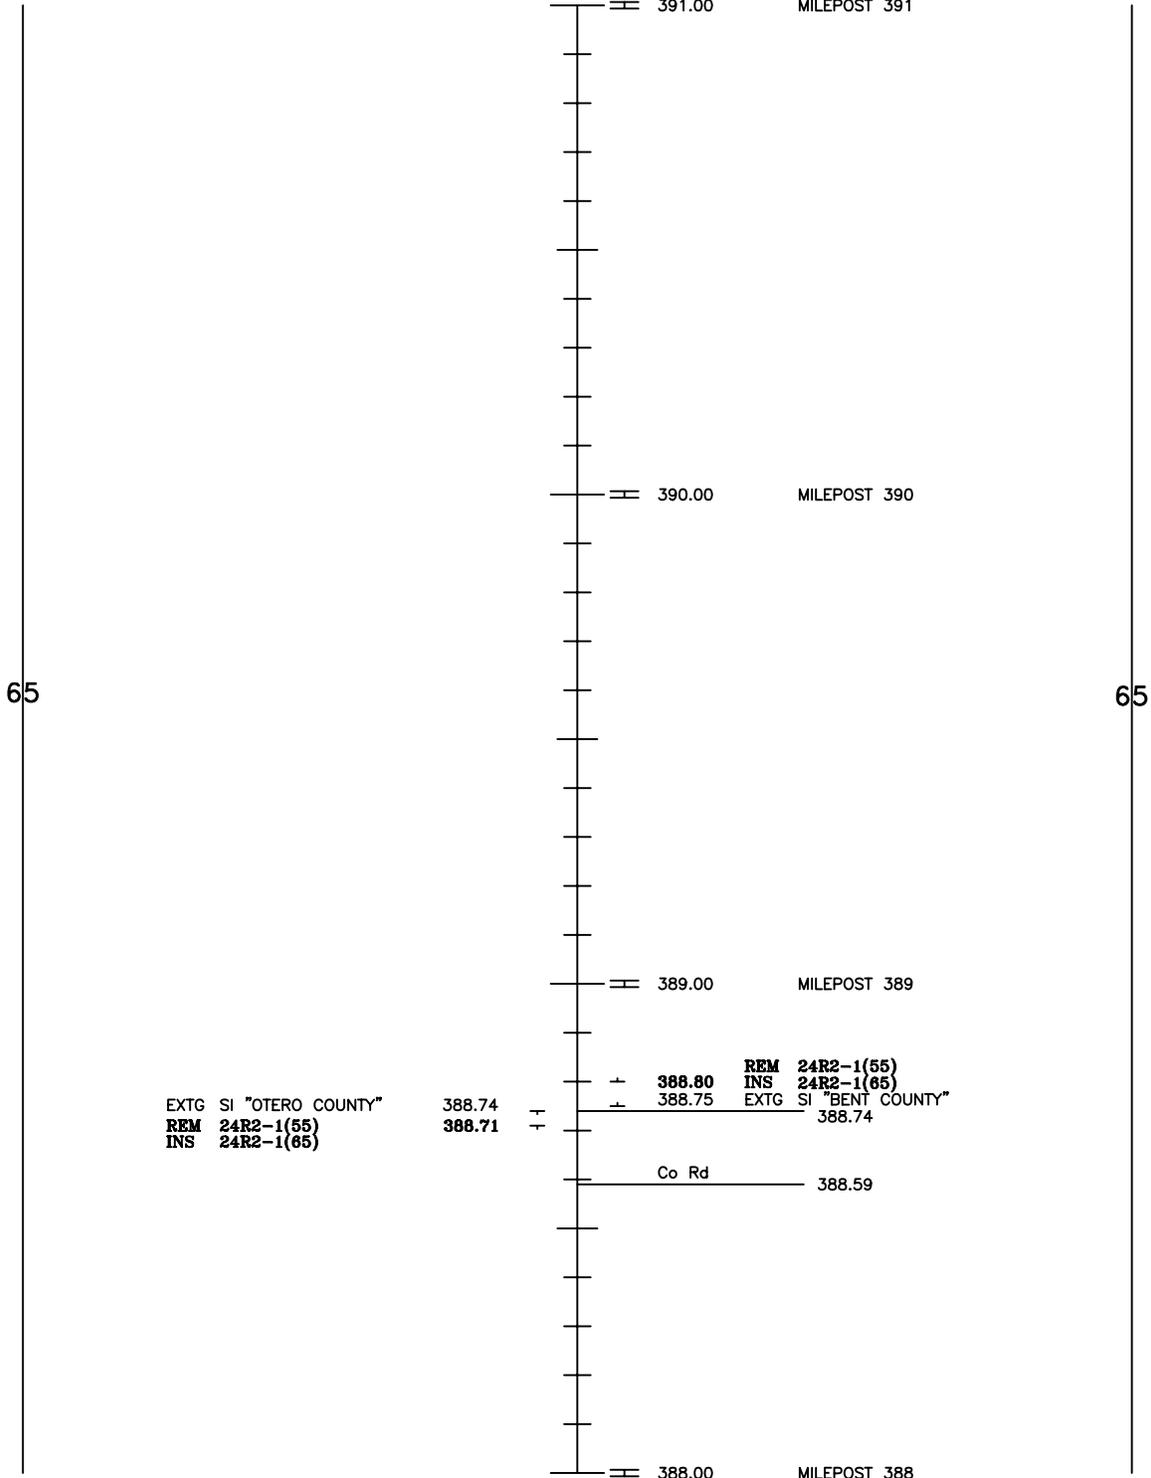
EXTG SI "OTERO COUNTY"
REM 24R2-1(55)
INS 24R2-1(65)
