C-470 & University Blvd. Interchange

C-470 and Quebec St. Interchange

C-470 & Quebec St. Interchange

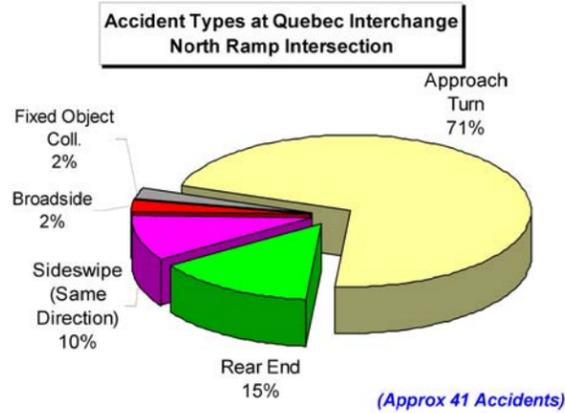
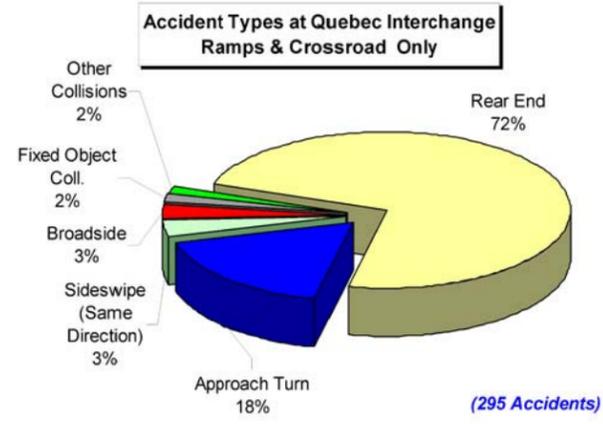
The north ramp intersection at this interchange was experiencing significant approach-turn collision frequency involving northbound vehicles on Quebec St. turning left in front of southbound through vehicles on Quebec. Presently, this left turn movement includes double left turn lanes and protected/permitted signal intervals. Consideration may be given to implementing a fully protected left turn scheme at this intersection.

Accidents at north ramp intersection
Significant approach turn collision frequency at intersection

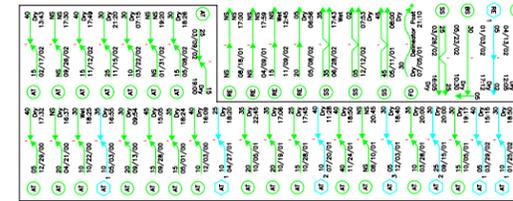
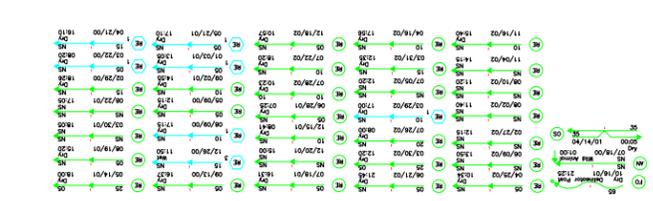
At both north and south ramp intersections we note rear-end collisions occurring in the channelized right turn lanes. Extension of the right turn acceleration lanes, particularly the eastbound to southbound movement at the south intersection, may help moderate this type of collision.

Accidents on eastbound C-470 exit ramp to Quebec
Significant rear-end collision frequency at right turn movement to SB Quebec

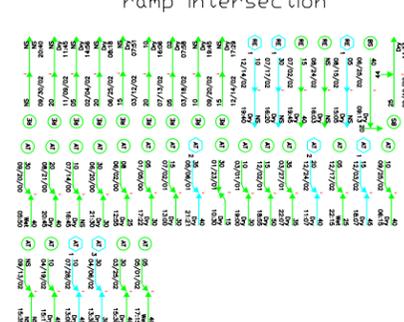
Accident Types at Quebec Interchange South Ramp Intersection

Accidents at south ramp intersection
