*styrofoam
highway insulation
on colorado
mountain passes*

Robert L. Hayden
Herbert N. Swanson
Planning and Research Division
Colorado Division of Highways
4201 E. Arkansas Avenue
Denver, Colorado 80222

March 1972

FINAL REPORT

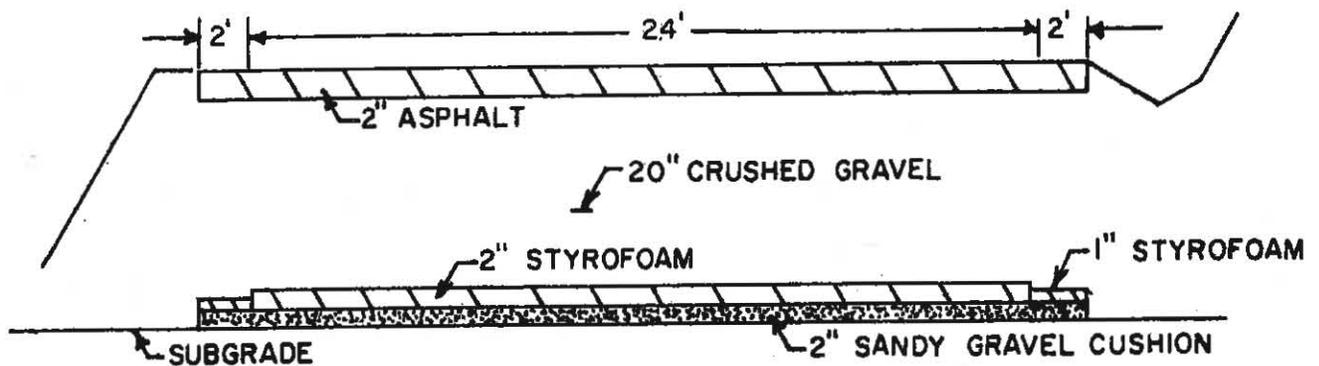
FIGURE 1

The Styrofoam test section on Vail Pass is located on U. S. Highway 6 approximately two miles west of Wheeler Junction. The insulated section is 200 feet long. It is shown in cross section in Figure 1 on the following page.

Installation was completed in August 1970 by Colorado Division of Highways maintenance personnel. The asphalt pavement and base were removed to a depth of 24 inches below the original pavement level. The exposed material consisted of a rocky clay having a moisture content of 5.5% and below the clay was a fine sand with 14.8% moisture.

A two inch thick sandy gravel cushion was placed on the subgrade and the Styrofoam was placed on the cushion. The Styrofoam was then covered with 20 inches of crushed gravel, care being taken not to damage or move the Styrofoam. The test section was finished with a two inch layer of asphalt pavement. The construction procedure is shown in Figures 2 through 5.

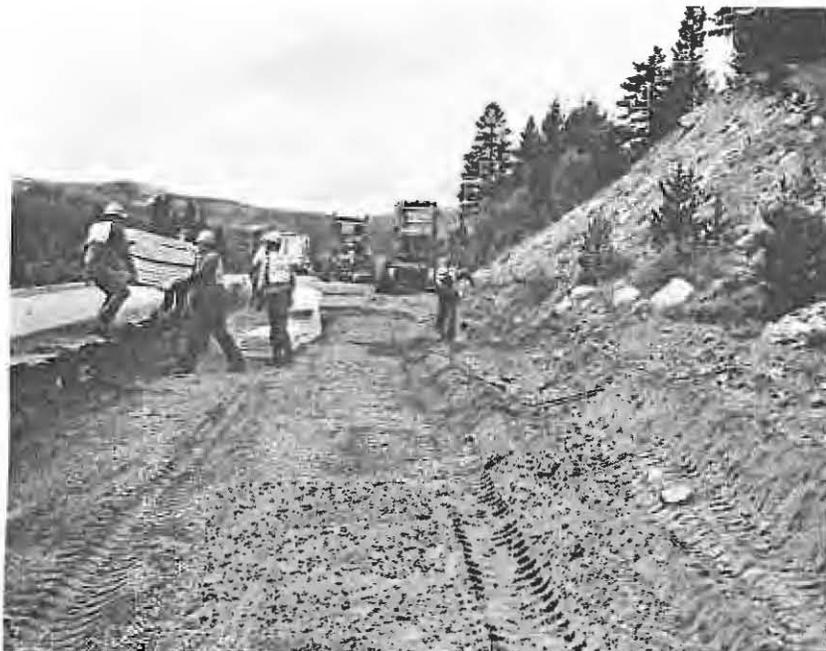
Figure 2

2 Inch Sandy Gravel Cushion on Top of Subgrade prior to placement of Styrofoam Insulation.

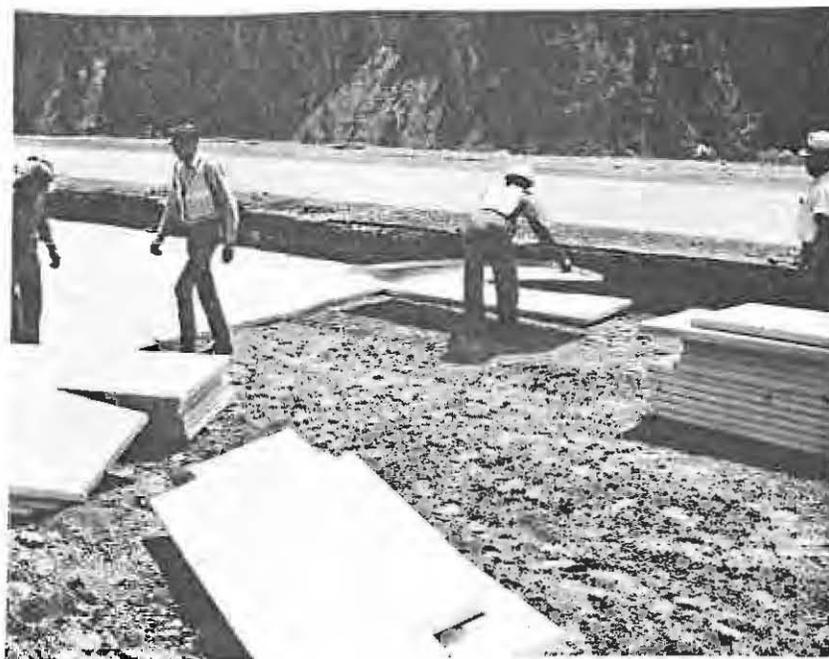
Figure 3

Hand Placement of Insulation on 2 Inch Cushion of Sandy Gravel.

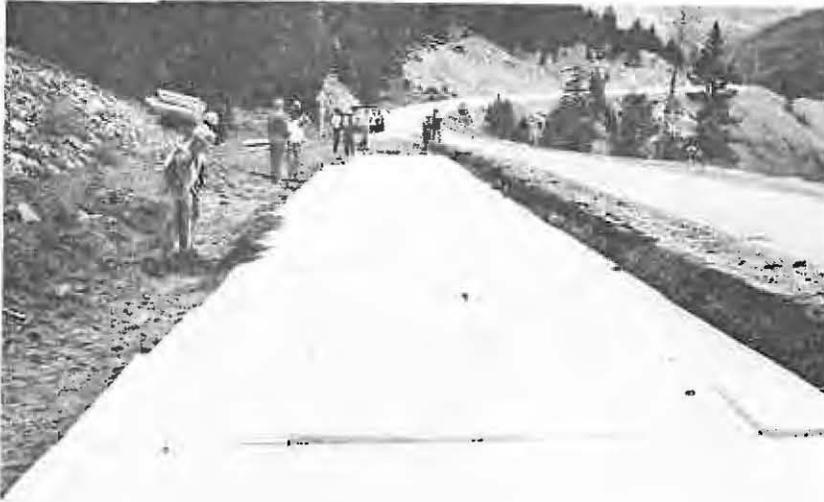
Figure 4

Insulation In Place Before Application of
Crushed Gravel.

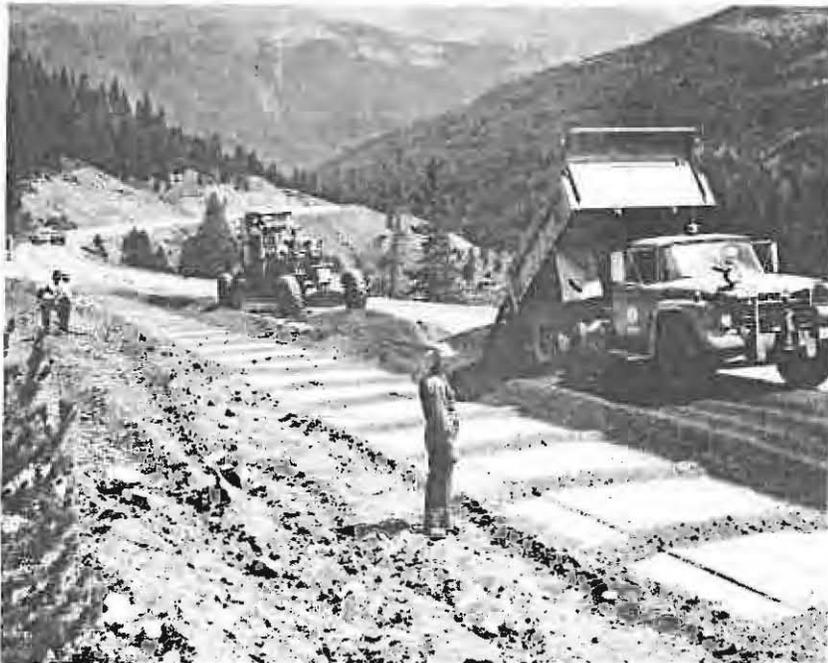
Figure 5

Dumping Crushed Gravel Followed by Blade
Working Material on to Styrofoam.

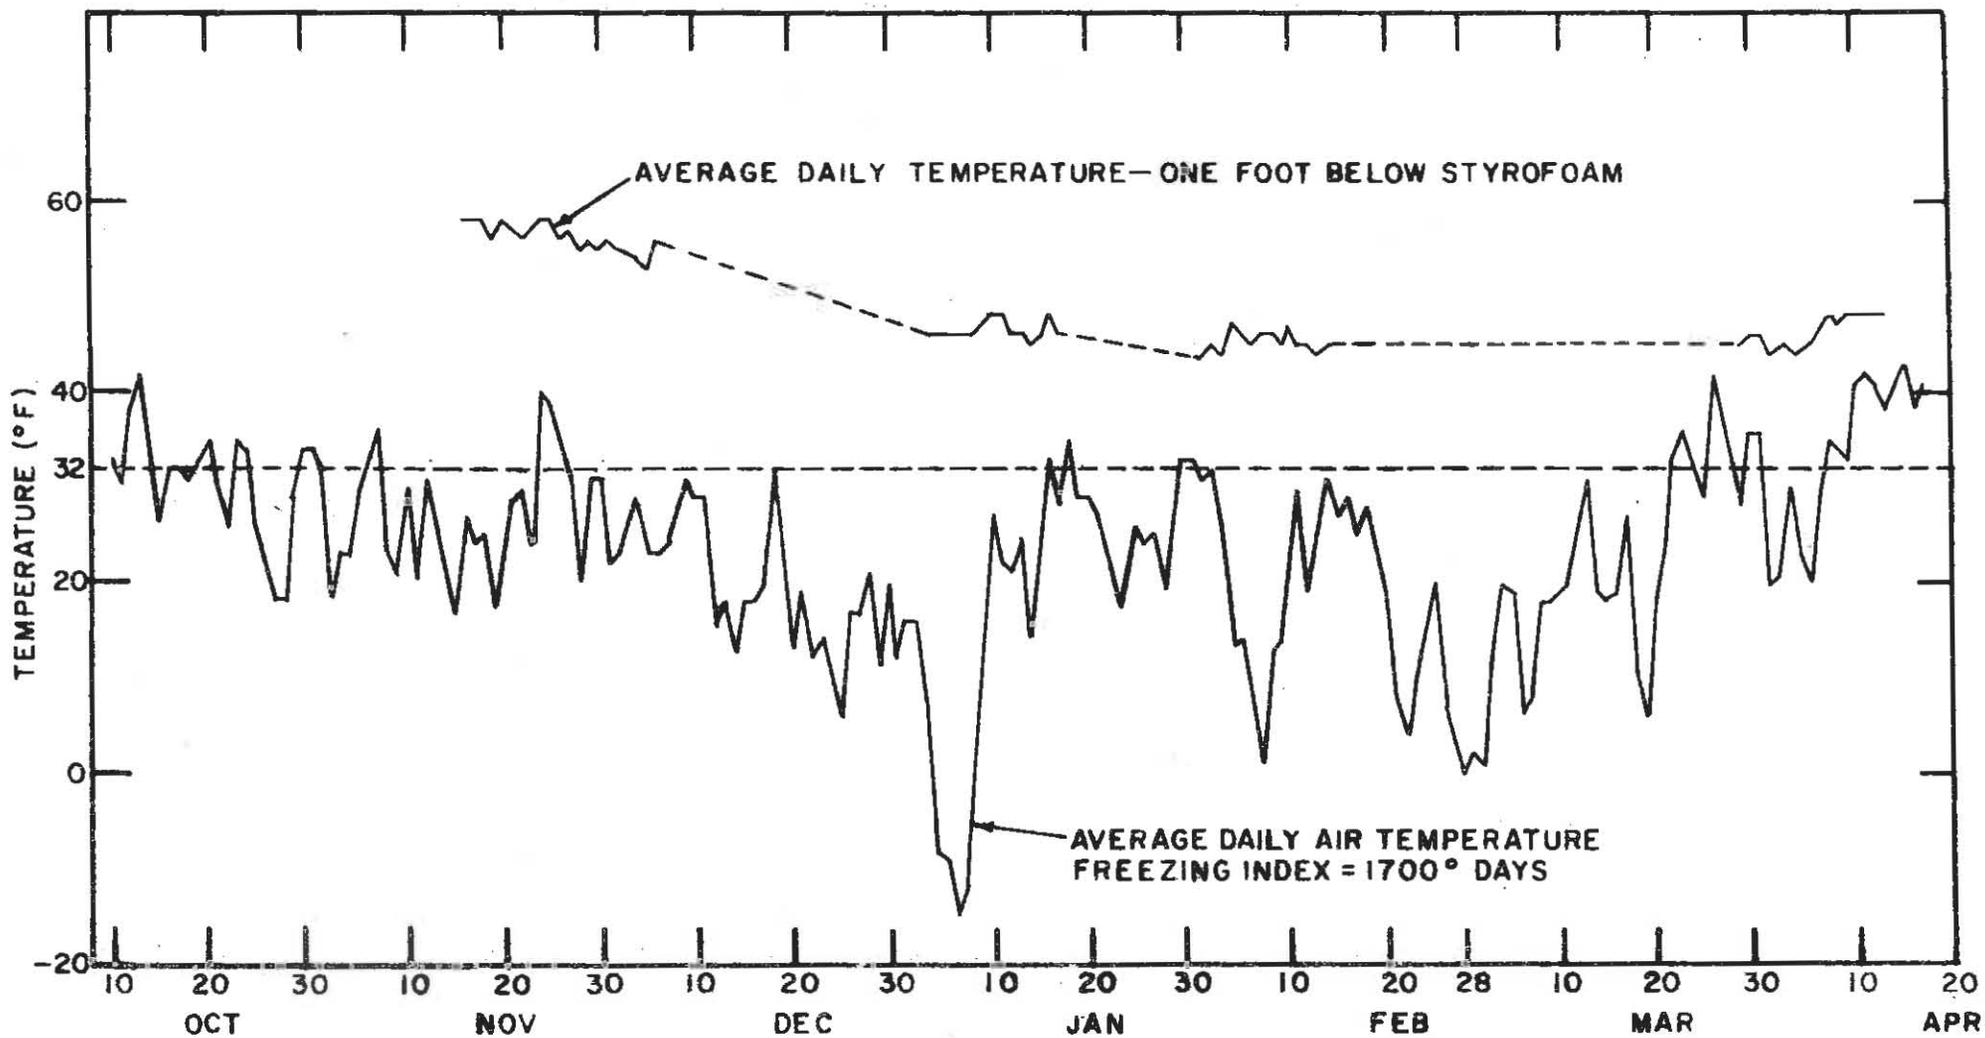
FIGURE 6
VAIL PASS TEST SITE
WINTER 1970-1971

The Tempscribe charts were changed every two weeks by the maintenance crew that worked on the pass, and the results were sent directly to the Colorado Division of Highways central office in Denver.

Difficulty was encountered with the Tempscribes. The ones reading immediately above and immediately below the Styrofoam appeared to have gotten out of calibration, and unfortunately, this was not realized until the end of the freezing season when all data was available for analysis. The clock drive mechanism also malfunctioned sometimes during extremely cold weather, and it is likely that the maintenance crew forgot to wind the clocks occasionally. The average daily air temperature and the average daily temperature one foot below the Styrofoam are plotted in Figure 6. The difference between the daily high and low temperature one foot below the insulation never varied by more than one or two degrees.

While the Styrofoam was being installed, provision was made for the later insertion of temperature sensing probes. Three sections of plastic tubing were placed with one end beneath the centerline of the roadway and the other end running out to the ditch. The ends beneath the centerline were located, respectively, immediately above the Styrofoam, immediately below the Styrofoam, and one foot below the Styrofoam. Bacharach Instrument Company #14-0068 Tempscribes were placed in a shelter box mounted on a pole several feet from the roadway. The Tempscribe probes were inserted into the plastic tubing so that the temperature could be read at the three depths beneath the centerline.

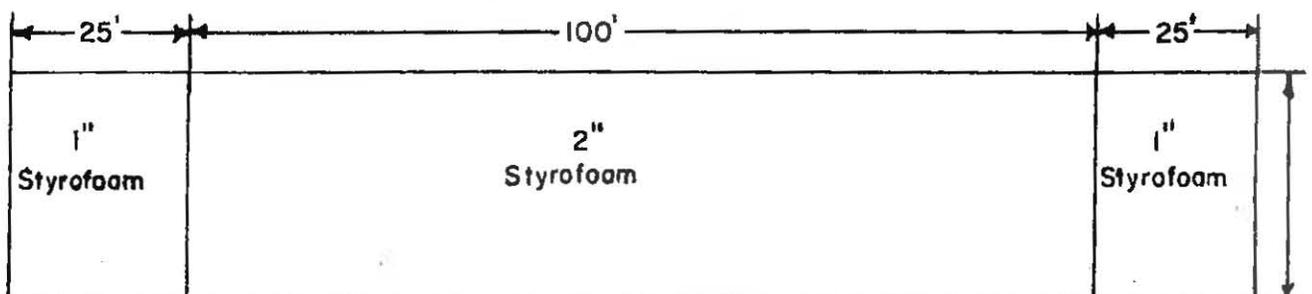
FIGURE 7

The Styrofoam test section on Wolf Creek Pass is located on U. S. Highway 160, approximately one-half mile west of the summit. The insulated section is 150 feet long and is shown in Figure 7.

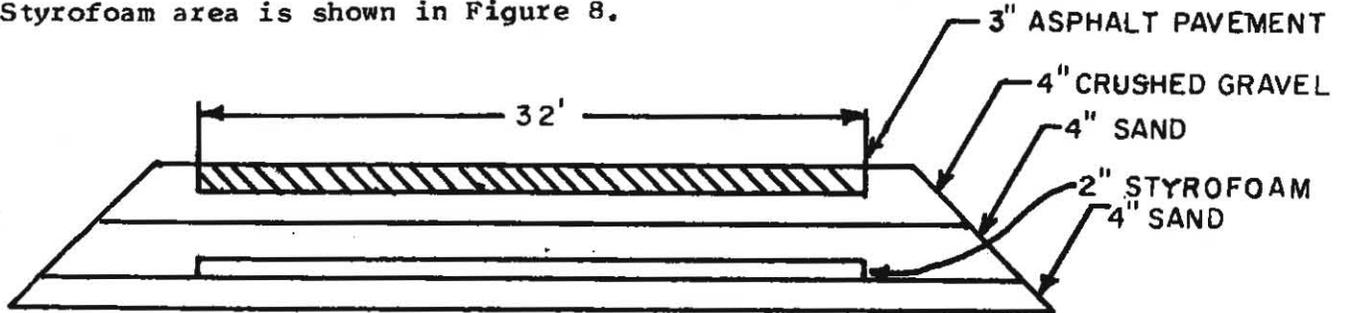
Two inches of sand was placed on the subgrade, followed by the Styrofoam, four more inches of sand, four inches of crushed gravel, and three inches of asphalt pavement. A section through the two inch Styrofoam area is shown in Figure 8.

FIGURE 8
WOLF CREEK PASS CROSS SECTION

Installation was done in August 1970 by Colorado Division of Highways maintenance personnel. The pavement and base course were excavated to a depth of 15 inches. Deeper excavation was done in three locations to obtain a soil profile. The following profile was obtained.

0.0 feet - 0.25 feet	Asphalt pavement
0.25 feet - 0.50 feet	Crushed gravel
0.50 feet - 1.5 feet	Pit run gravel
1.5 feet - 3.5 feet	Yellow sandy clay
3.5 feet - 7.5 feet	Blue gray sandy clay
7.5 feet	Hard rock

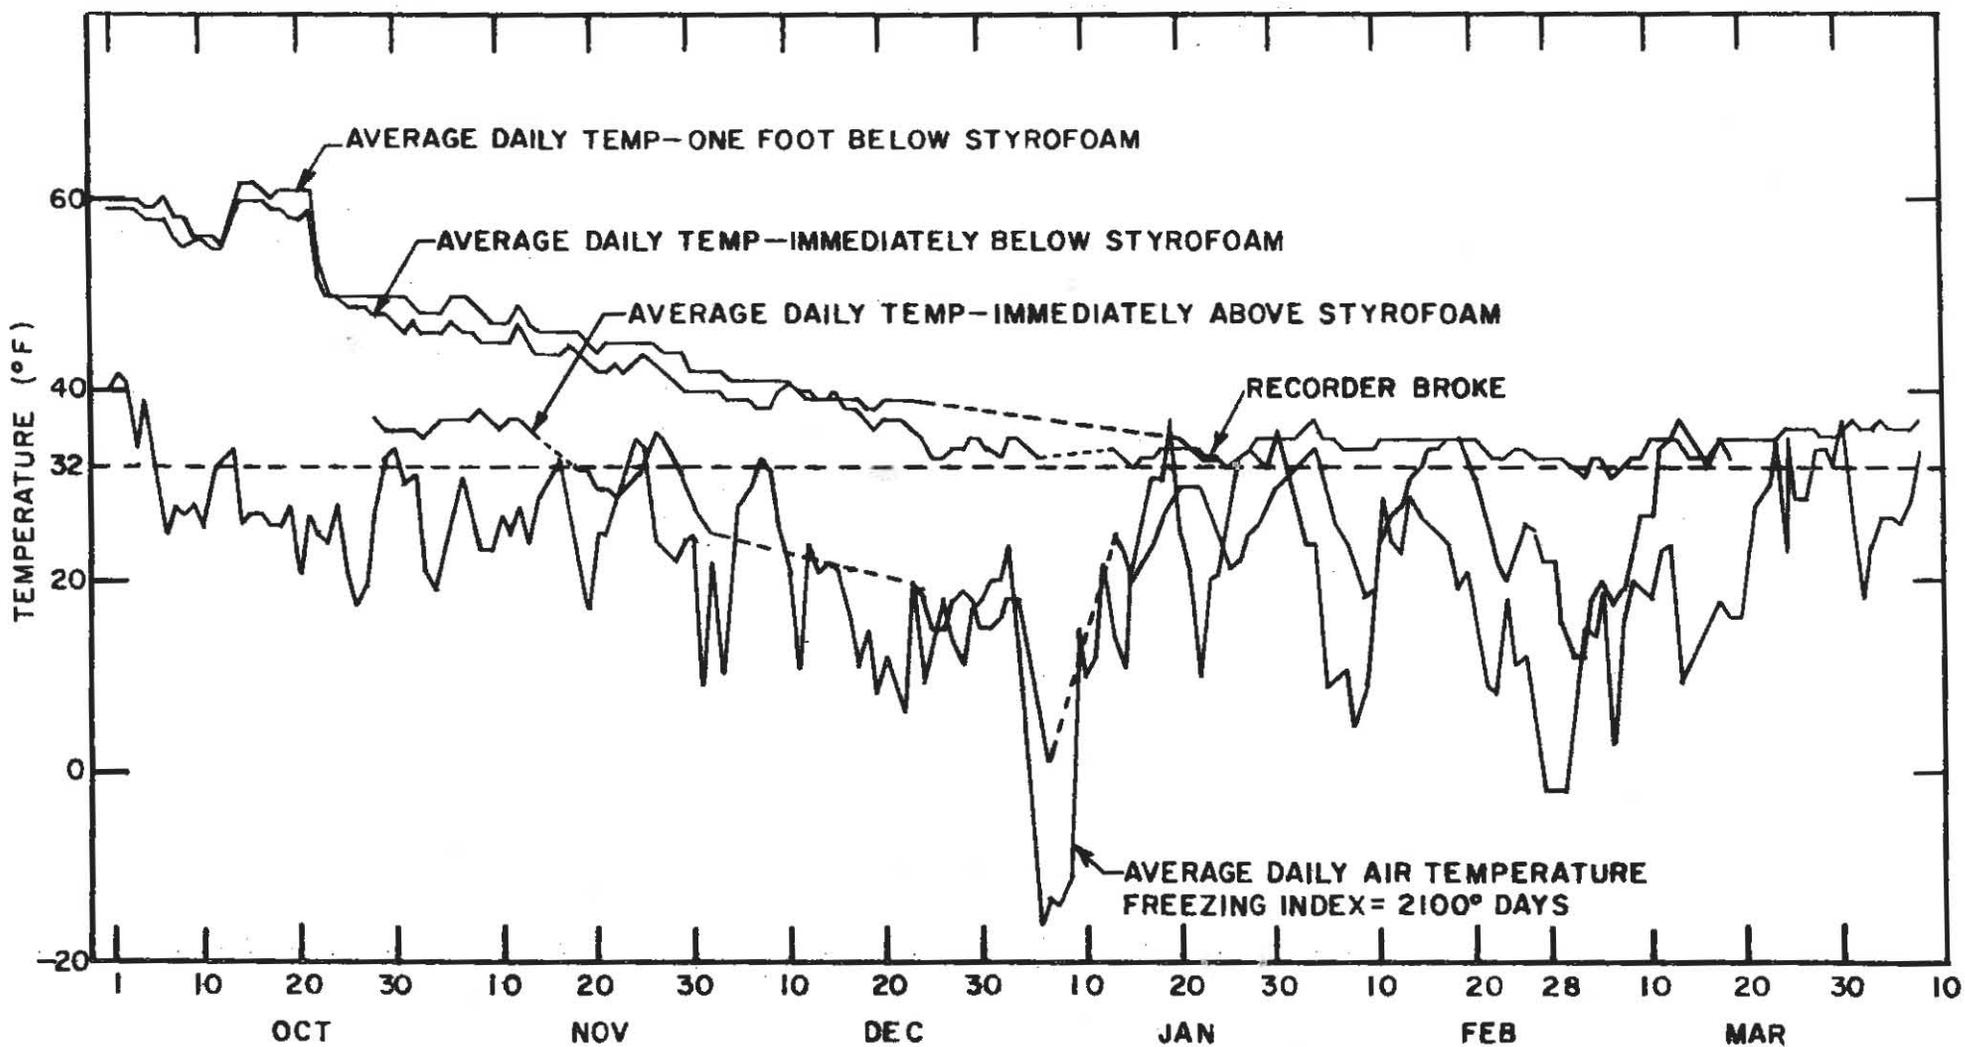
As was done at the Vail Pass test site, plastic tubing was installed for the insertion of Tempscribe probes. The probes were placed beneath the center of the two inch Styrofoam and located nine feet from the centerline of the roadway. Probe depths were immediately above the Styrofoam, immediately below, and one foot below. Better luck was experienced with the clock drive mechanisms on Wolf Creek Pass. The results are shown in Figure 9.

FIGURE 9
WOLF CREEK PASS TEST SITE
WINTER 1970-1971

The Styrofoam insulation on Wolf Creek Pass was very effective in reducing frost heaving. Elevations had been taken at the test location during the winter before installation and heaving of as much as six inches was found. After installation, heaves were less than one-half inch. The 25 foot long transition of one inch Styrofoam at the east end solved the problem encountered on Vail Pass where no transition was used. Some heaving was found at the west end, apparently because the test section was not long enough to cover the entire area where the most severe heaving had been encountered.
